## Long-Term Stewardship Assessment Report

Boeing - Philadelphia

Assessment Date: November 14, 2018

Report Date: November 30, 2018

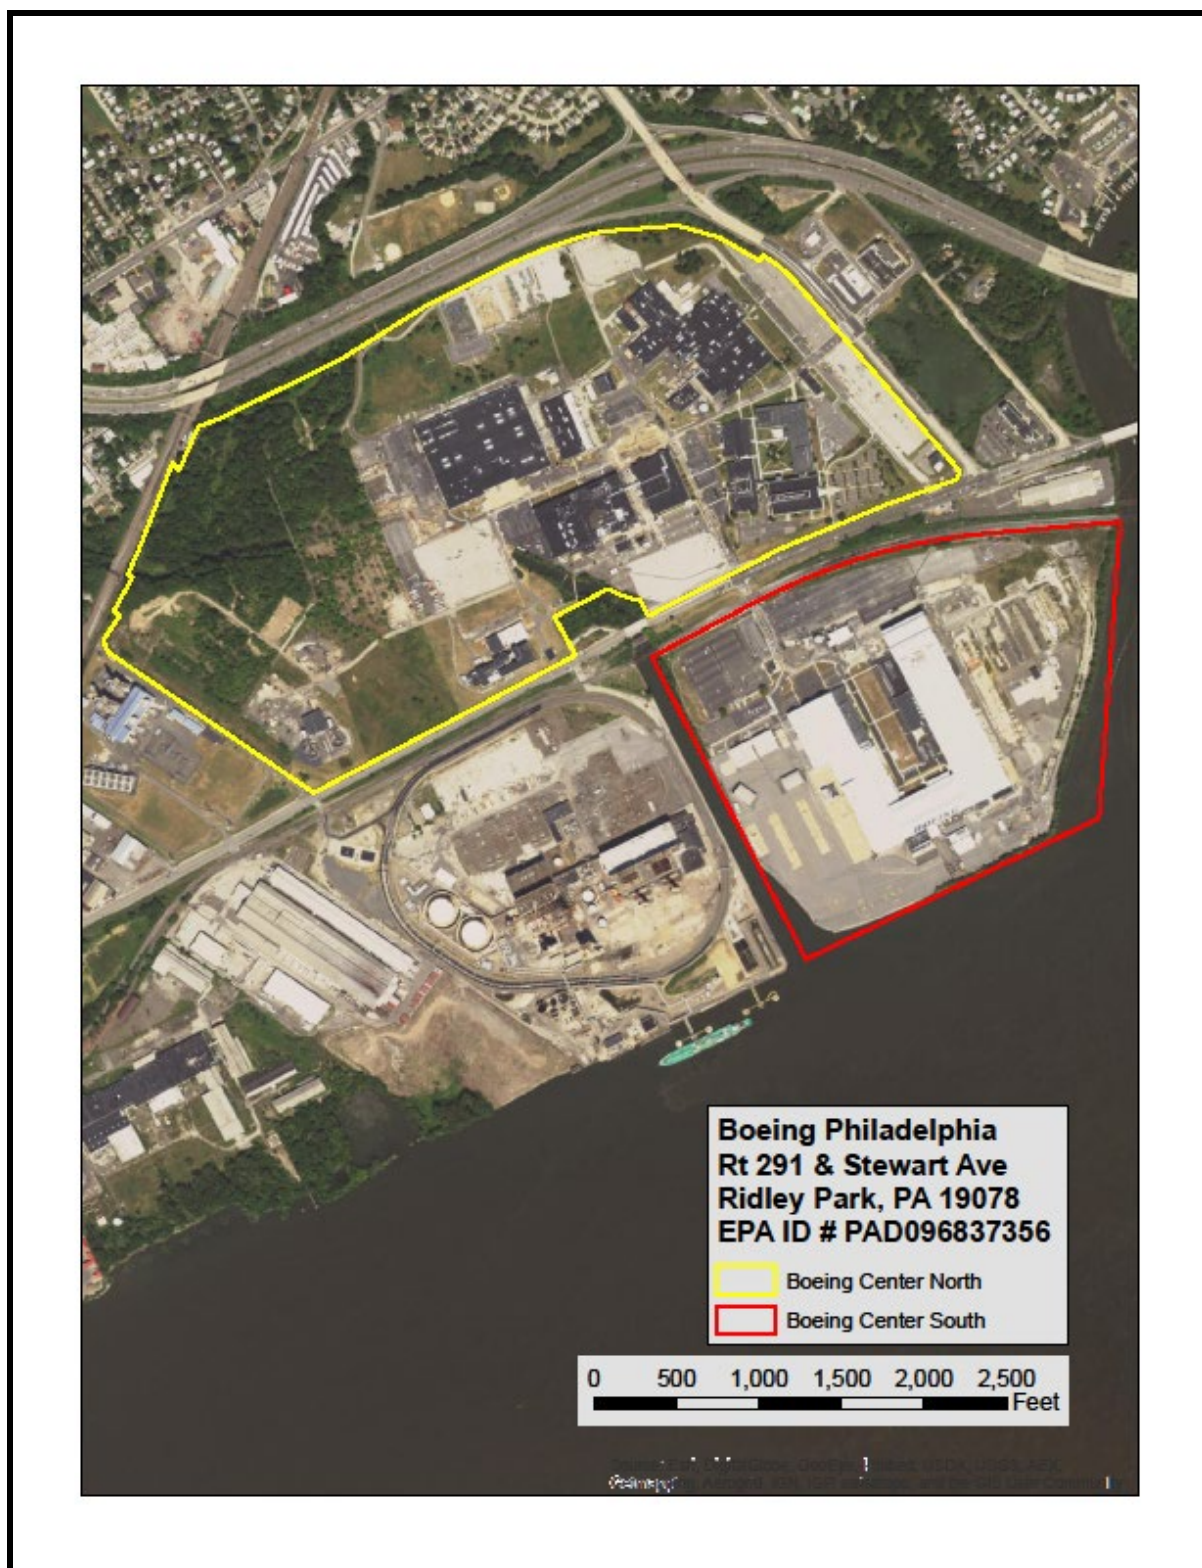
Figure 1: Aerial Map of Boeing – Philadelphia

***Deed Restriction:*** Two Declaration of Restrictive Covenants are the method for implementing institutional controls required as a condition of the Statement of Basis and Final Decision. The following ICs apply to the North and South Areas of the Facility, shown on Figure 1:

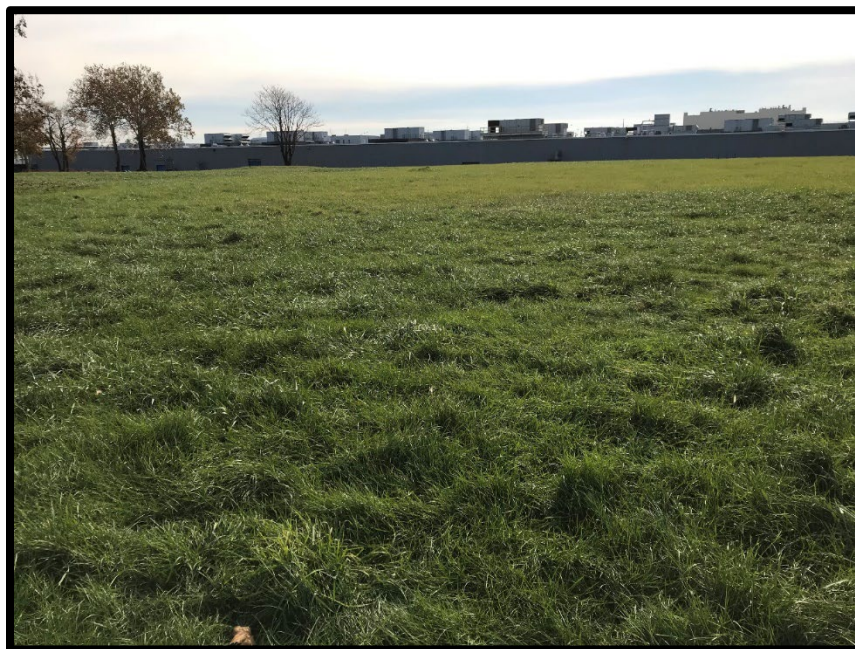
Picture 6:

*Old Landfill:* Located in the northern area of the facility. The Old Landfill is not inspected annually. The Old Landfill had pools of water, holes and trees growing on the edge of the landfill. Pictures 5-17 of Attachment B show the Old Landfill.

*Picture 6: The Old landfill area, facing southeast.*

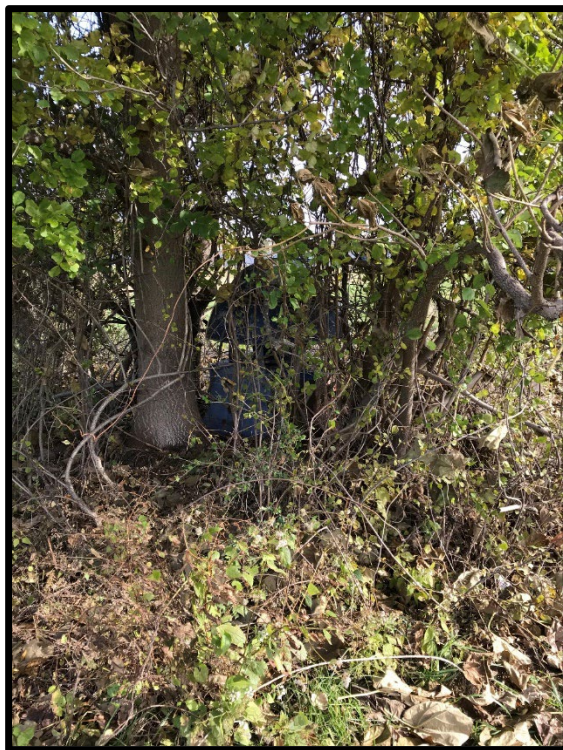
Picture 7:

*Picture 7: The North edge of the Old Landfill Area, facing North.*

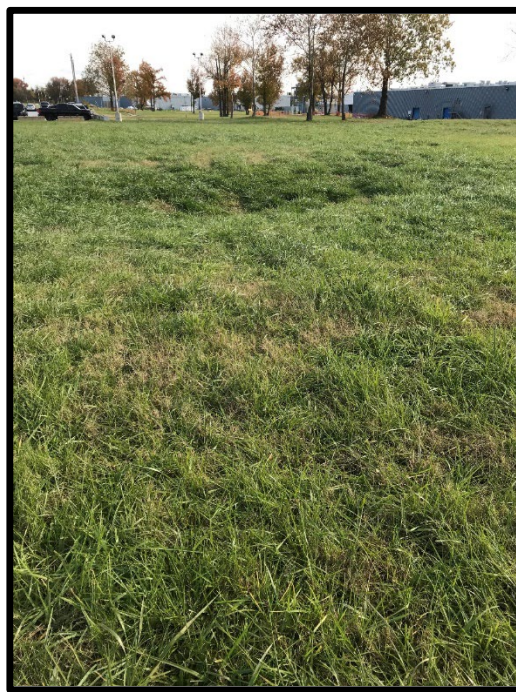
Picture 8:

*Picture 8: A depression in the Old Landfill Area, facing the North.*

- Holes in the Old Landfill need to be filled
- Due to water on Old Landfill (see Picture 11) regrading of the landfill may be needed
- Determine the approximate extent of Old Landfill and type of lining/cap based on historical drawings or figures

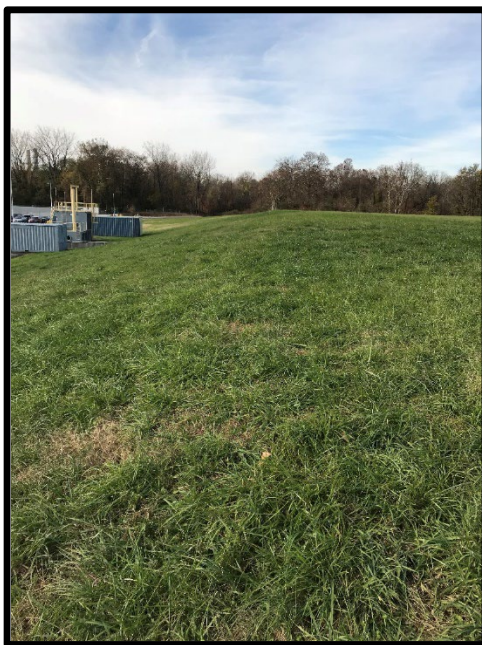
Picture 9:

*Picture 9: The Sothern boundary of the Old Landfill Area, facing the West.*

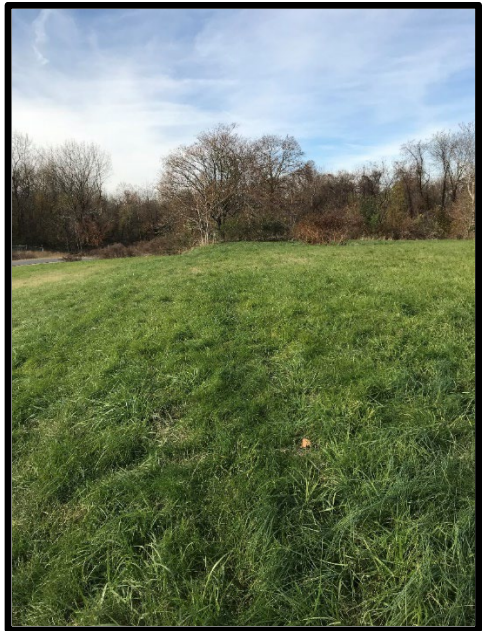
Picture 10:

*Picture 10: The Southwest corner of the Old Landfill Area, with trees that may have to be removed. Facing the west.*

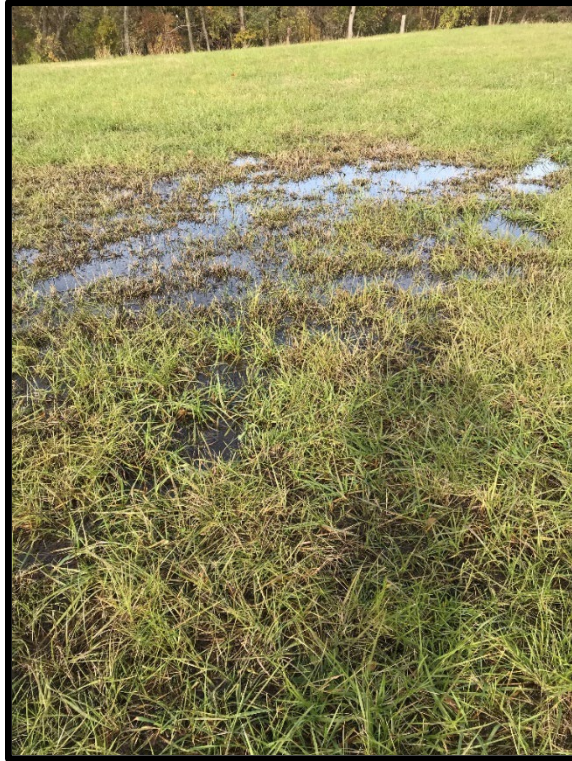
Picture 11:

*Picture 11: Pooled water on the western edge of the Old Landfill Area, facing the northwest.*

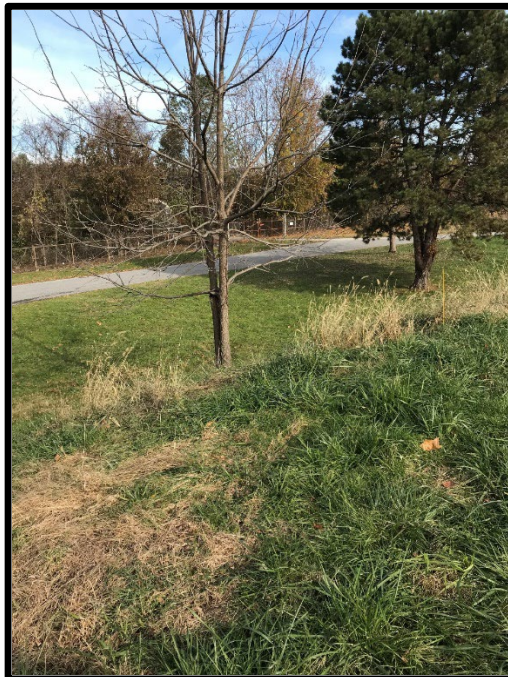
Picture 12:

*Picture 12: The Northern edge of the Old Landfill Area, facing the North.*

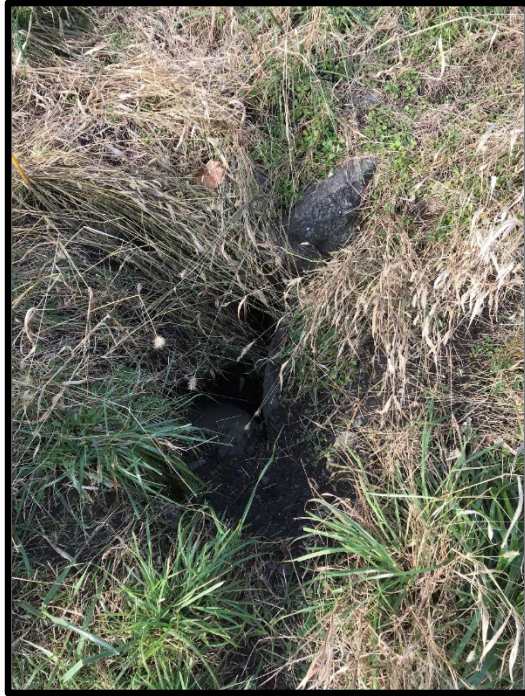
Picture 13:

*Picture 13: Holes in the Northern edge of Old Landfill Area, facing the south.*

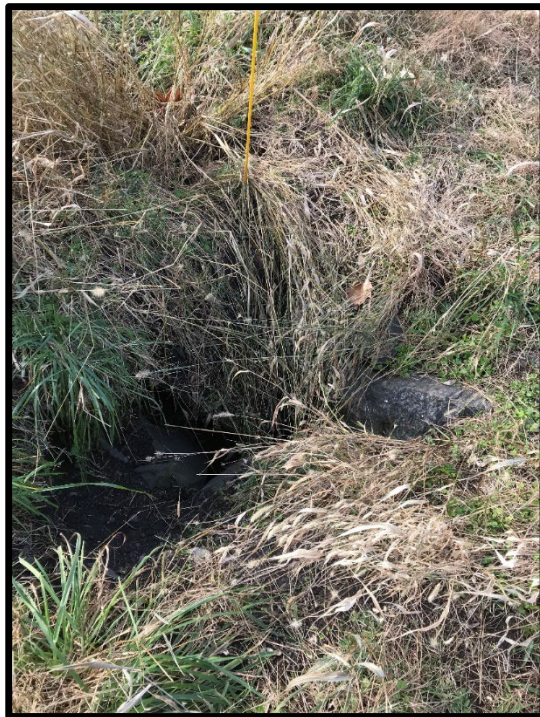
Picture 14:

*Picture 14: Holes in the Northern edge of Old Landfill Area, facing the south.*

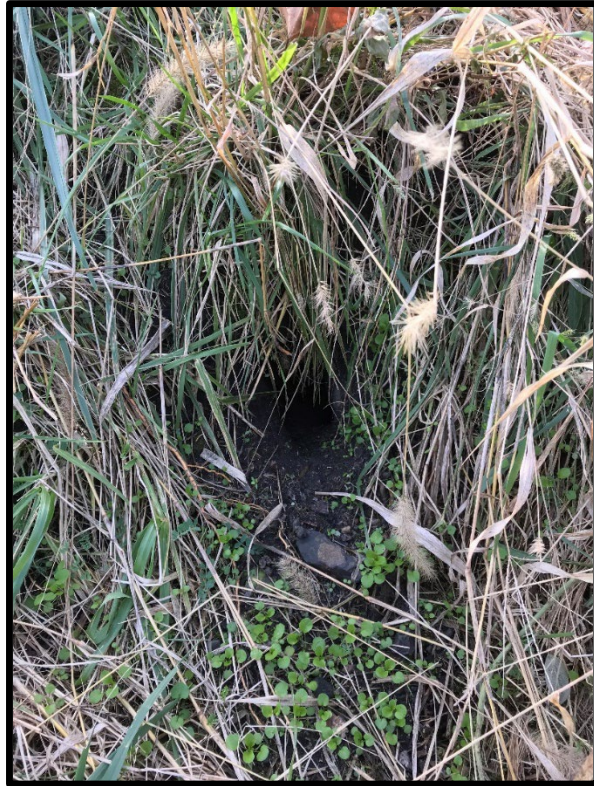
Picture 15:

*Picture 15: Holes in the Northern edge of Old Landfill Area, facing the south.*

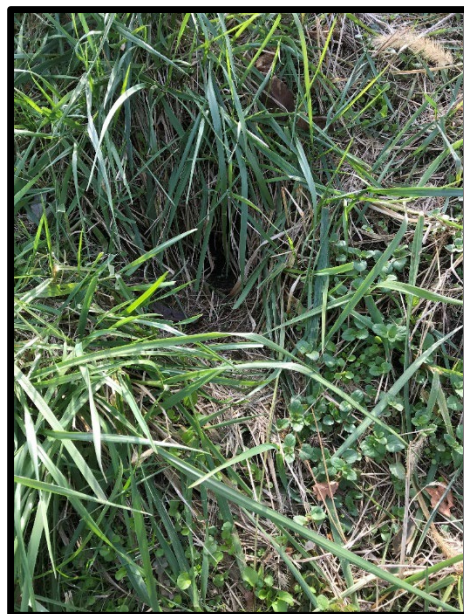
Picture 16:

*Picture 16: Holes in the Northern edge of Old Landfill Area, facing the south.*

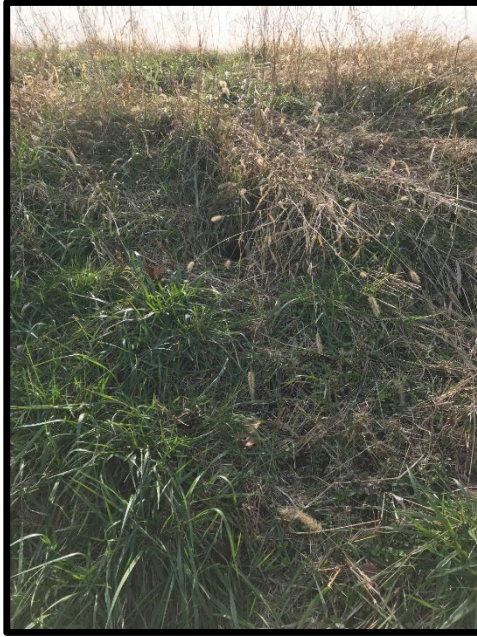
Picture 17:

*Picture 17: Holes in the Northern edge of Old Landfill Area, facing the south.*

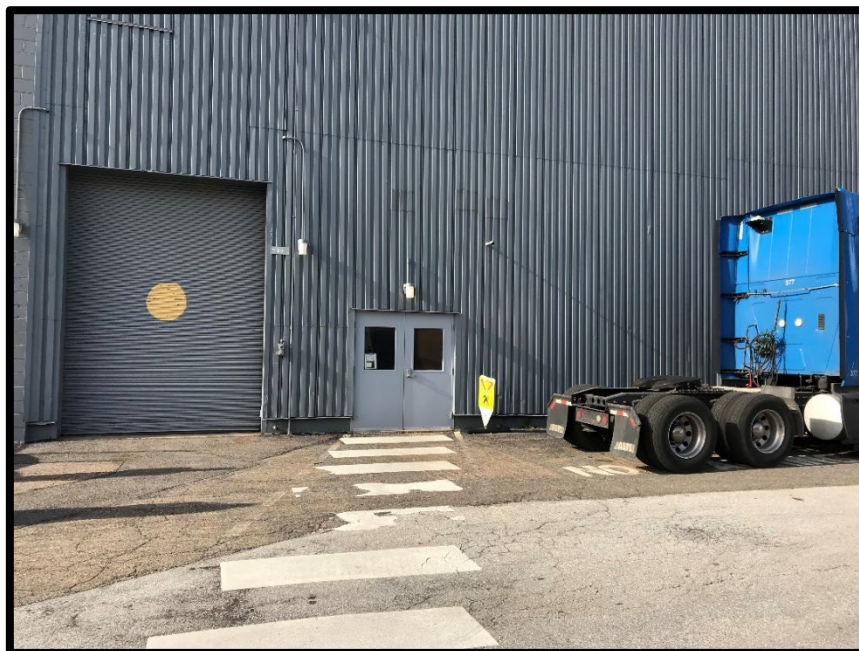
Picture 19:

*Former Lagoon Area:* Located in the northern area of the facility. Currently a building resides over the Former Lagoon Area. The pavement in the building is inspected annually. Boeing-Philadelphia provided EPA with a copy of the inspection records. Picture 19 shows the Former Lagoon Area.

*Picture 19: The East wall of building 3-24, which is above the Former Lagoon Area.*

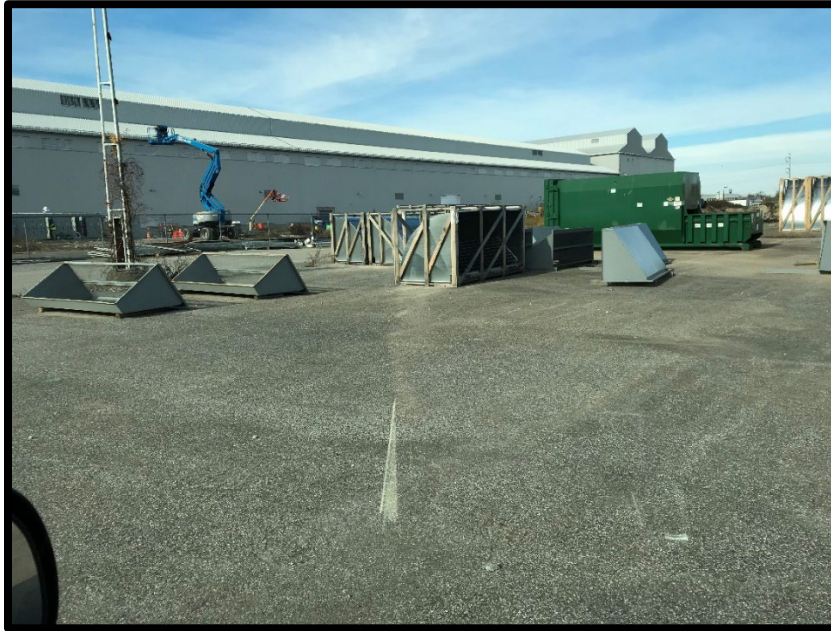
Picture 23:

*Asphalt Cover:* Located in the southern area of the facility. The Asphalt Cover is inspected annually. Boeing-Philadelphia provided EPA with a copy of the inspection records. Pictures 23 and 24 of Attachment B show the Asphalt Cover.

*Picture 23: Asphalt Cap area in Southern Area, facing northwest.*

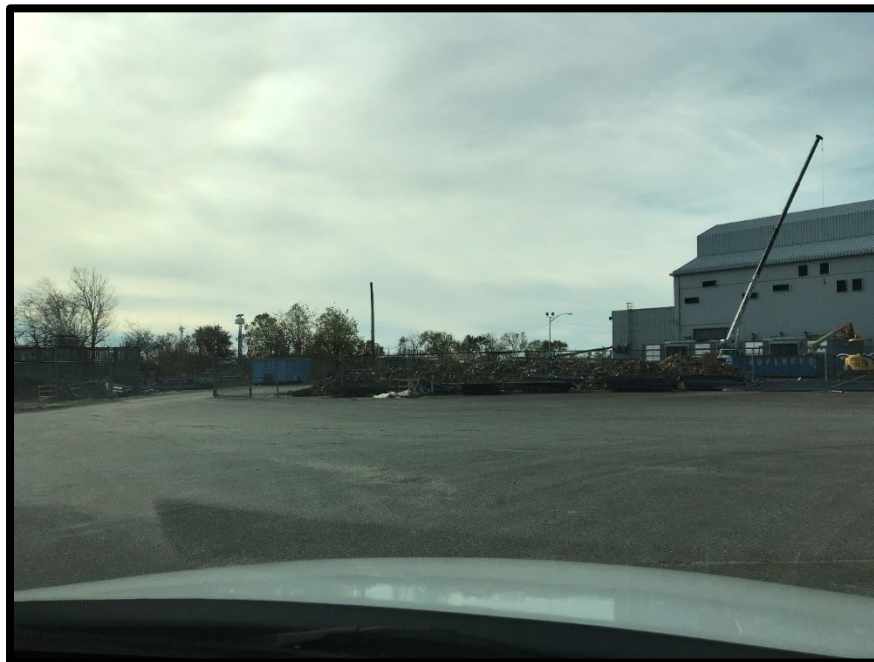
Picture 24:

*Picture 24: Asphalt Cap area of the southern area facing south.*
