Sanitary Survey

Joint Base Pearl Harbor-Hickam

PWS 360

April 4-5, 2017

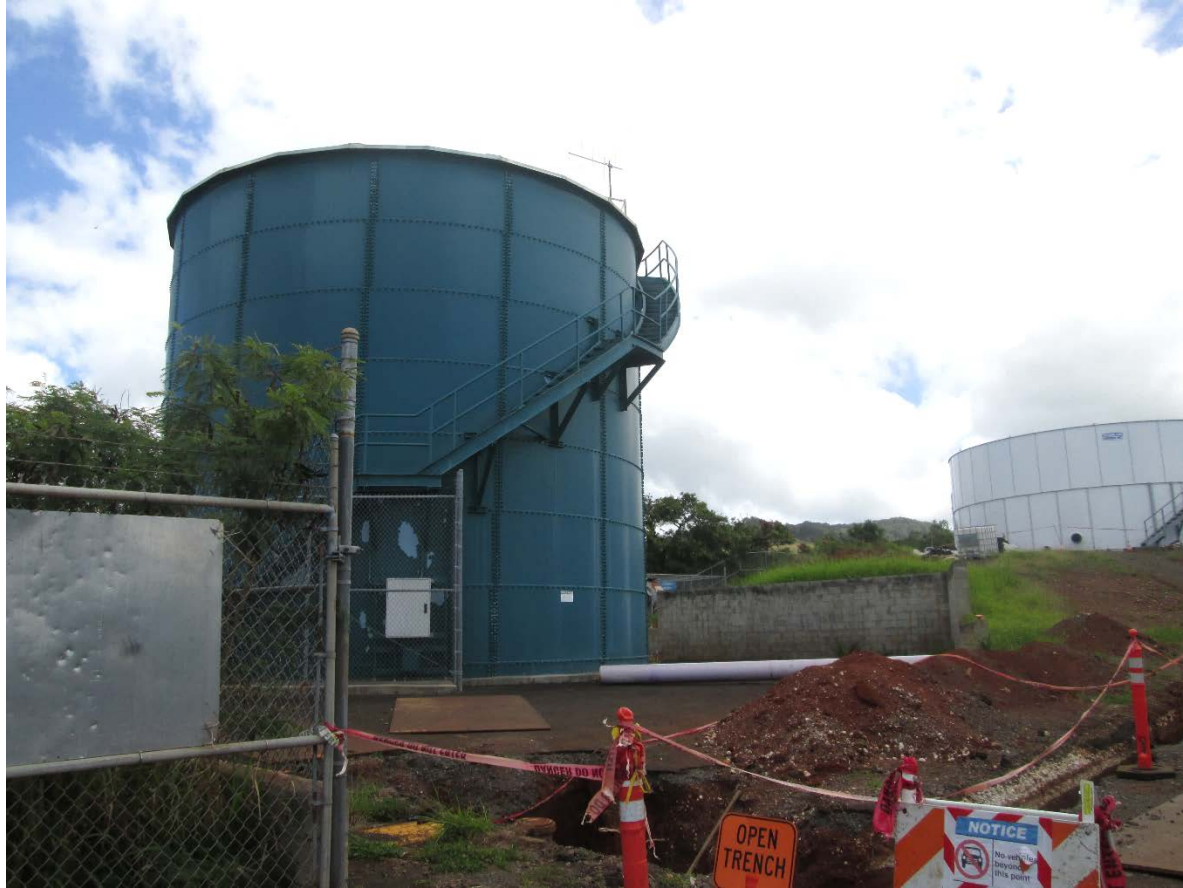
Red Hill Tank. Unapproved tank (white) under construction.

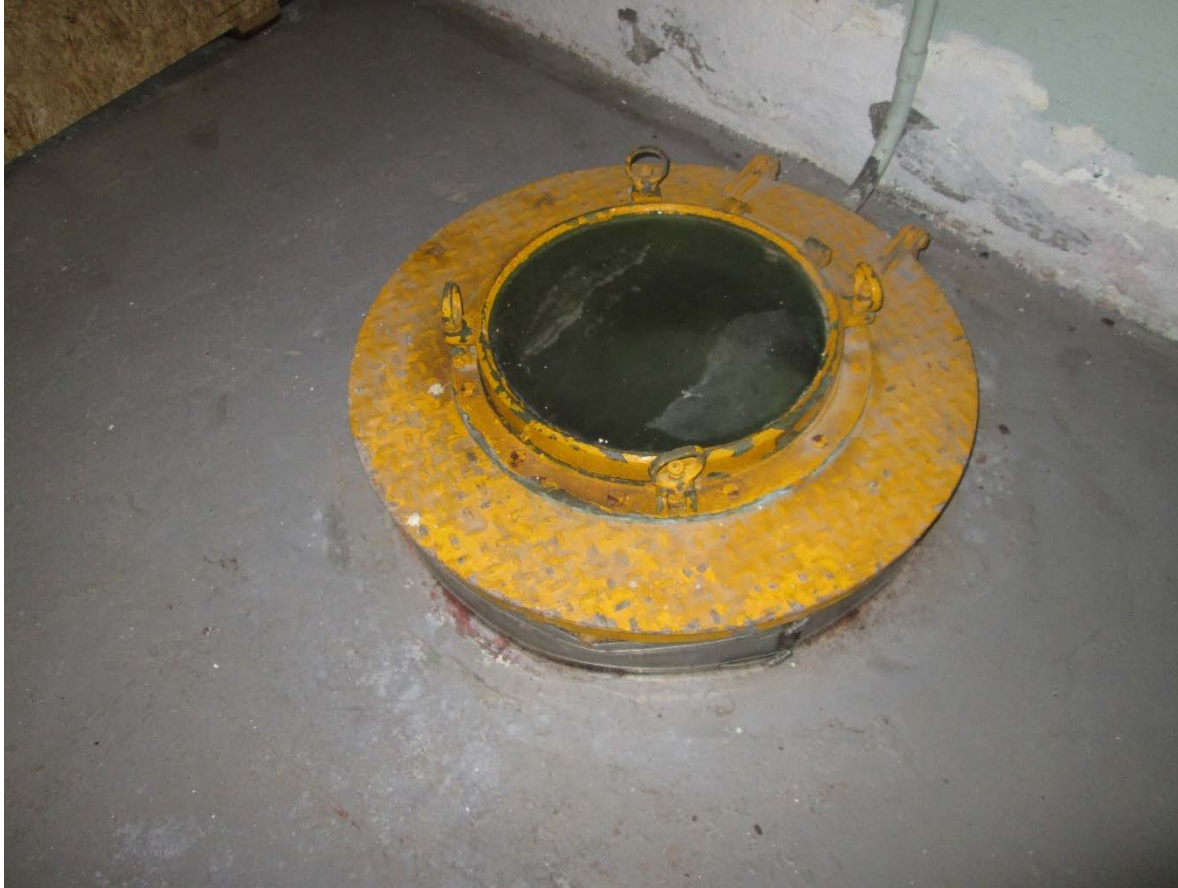
Halawa Shaft: confirm that the shaft viewing hatch has a gasket between the cover and the frame curb.

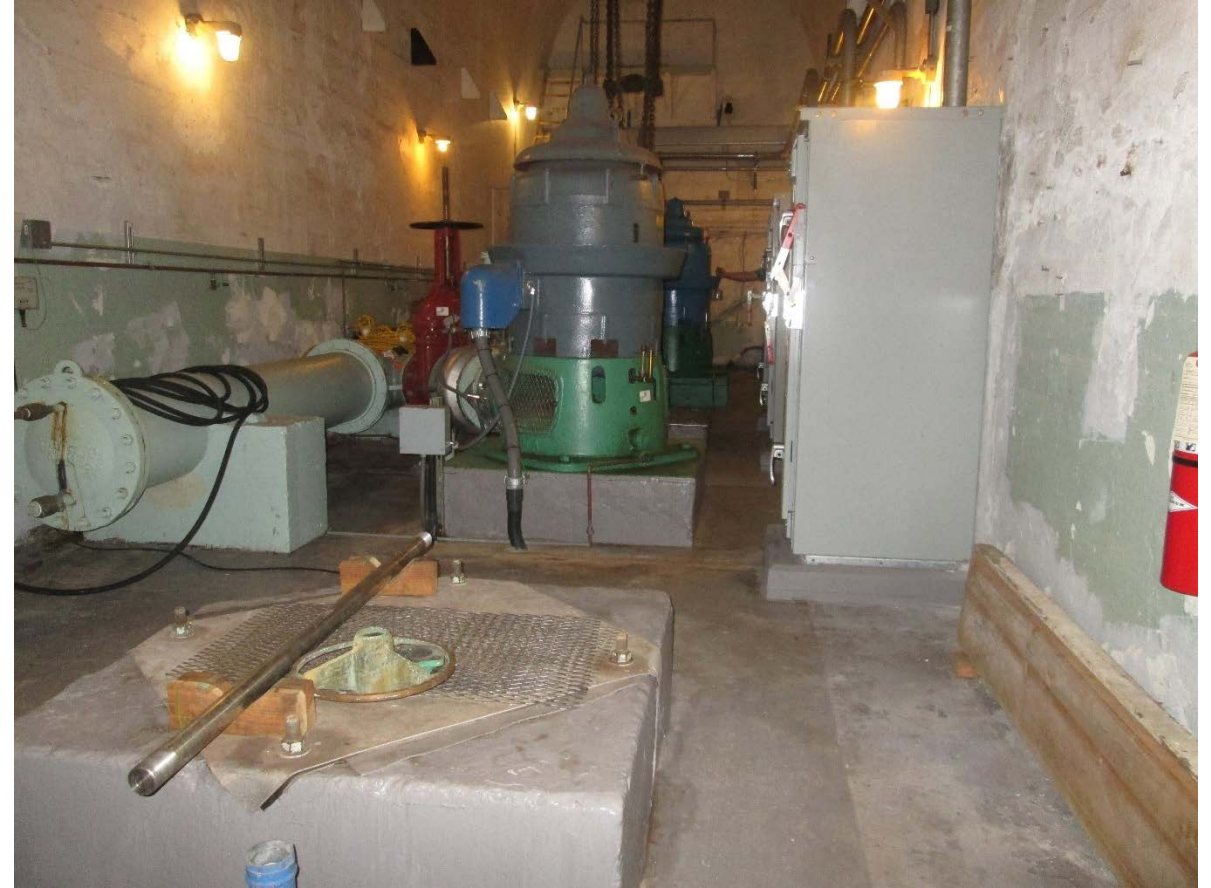
Halawa Shaft: confirm that the opening into the shaft where the pump and motor was permanently removed from service is sealed.

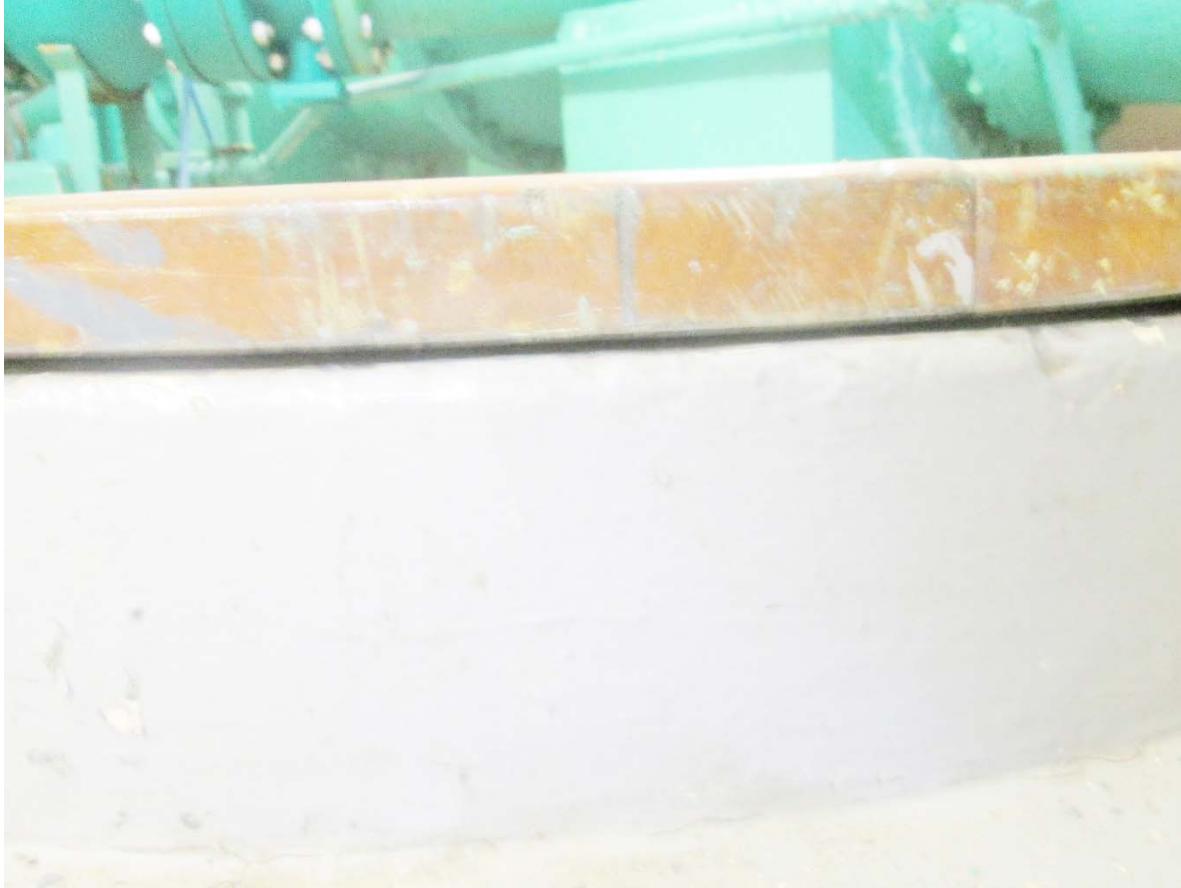
Waiawa Shaft: confirm that the shaft viewing hatch has a gasket between the cover and the frame curb.

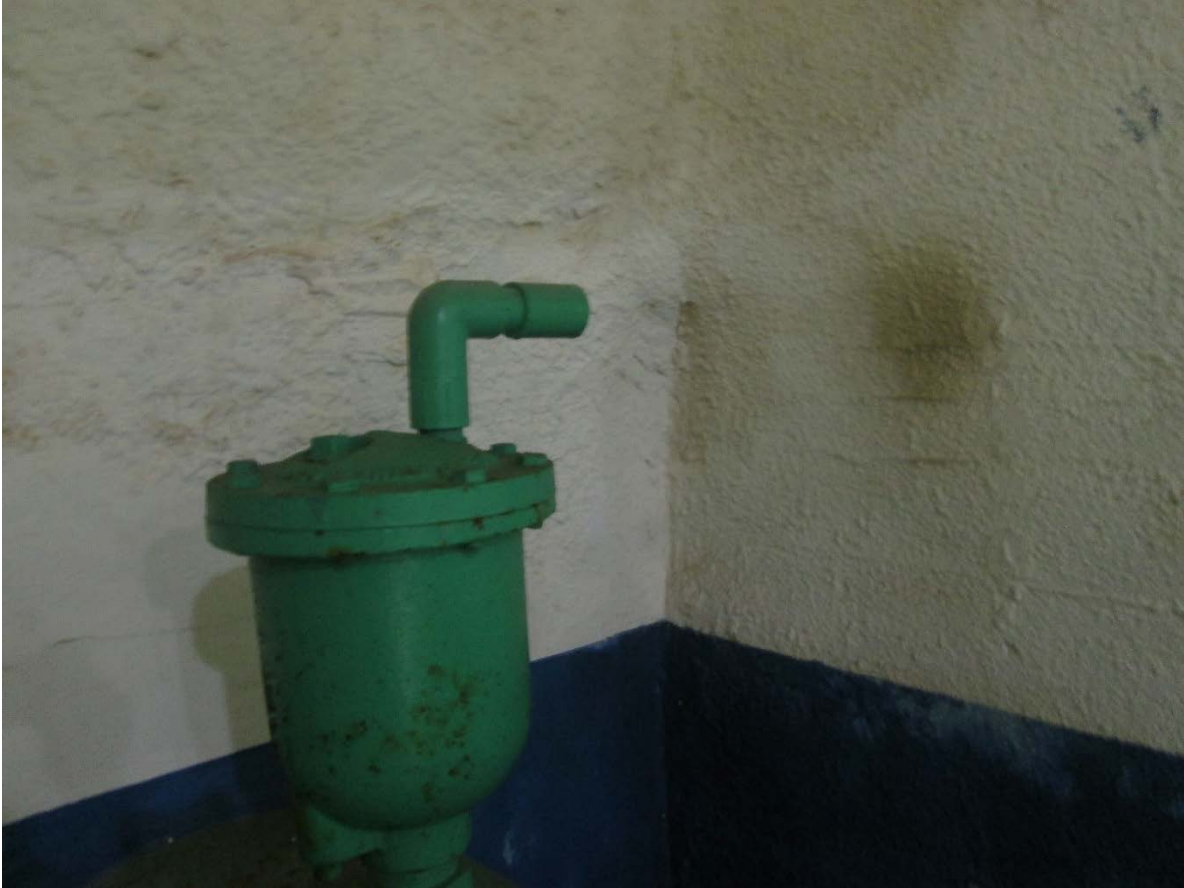
- b. an ARV on the discharge pipe is pointed sideways and does not have an insect screen. ARV should be pointed down and covered with an insect screen.

Red Hill Shaft: an ARV on the discharge pipe is pointed sideways and does not have an insect screen. ARV should be pointed down and covered with an insect screen.

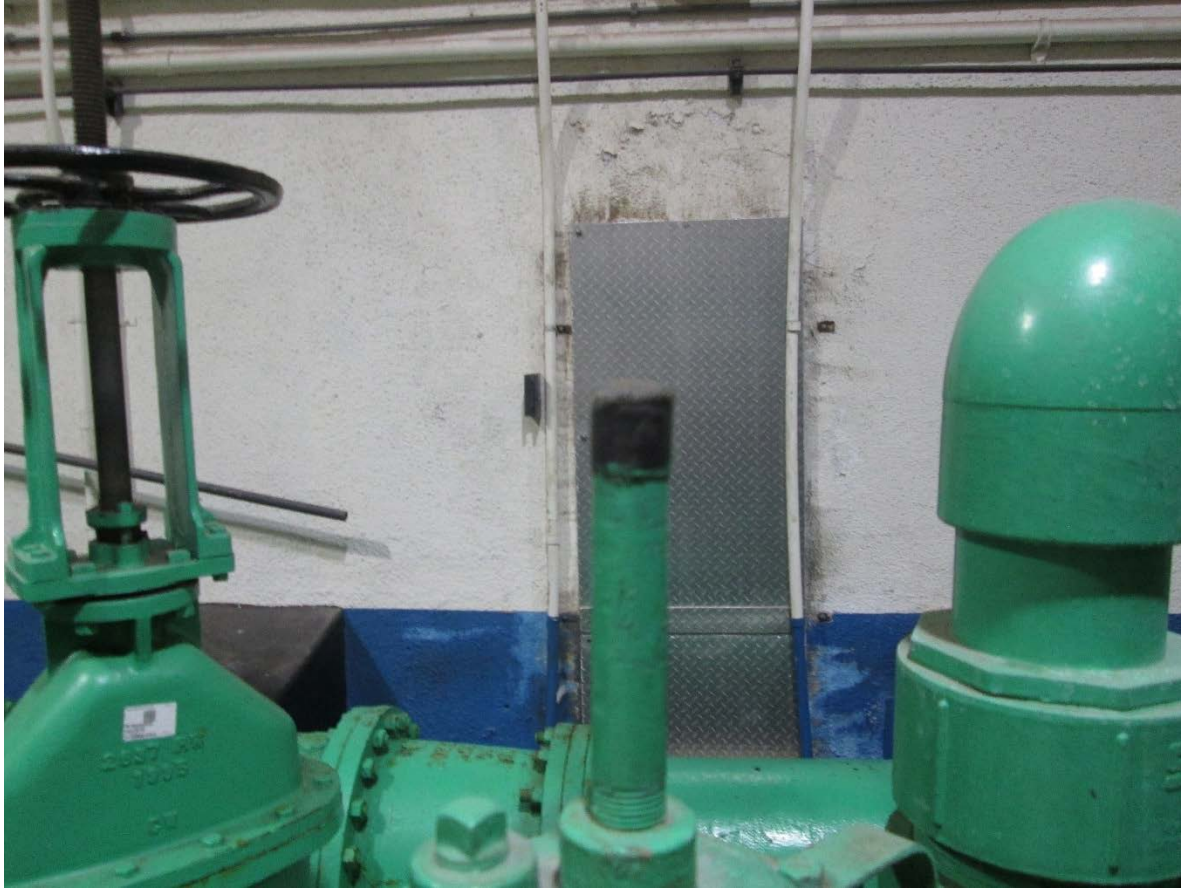
Red Hill Shaft: an ARV on the discharge pipe is pointed up and should be pointed down.

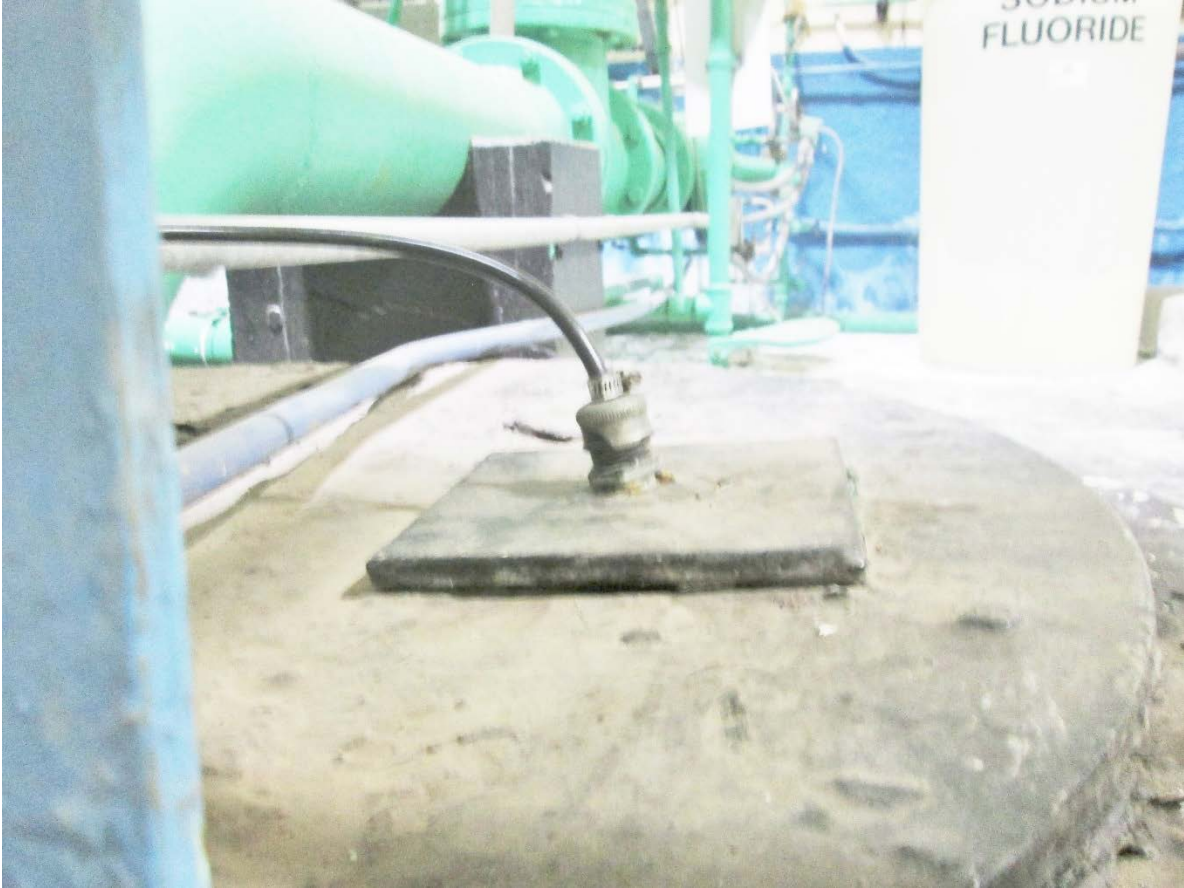
Red Hill Shaft: square baseplate on MP4's baseplate has a gap and should be sealed.

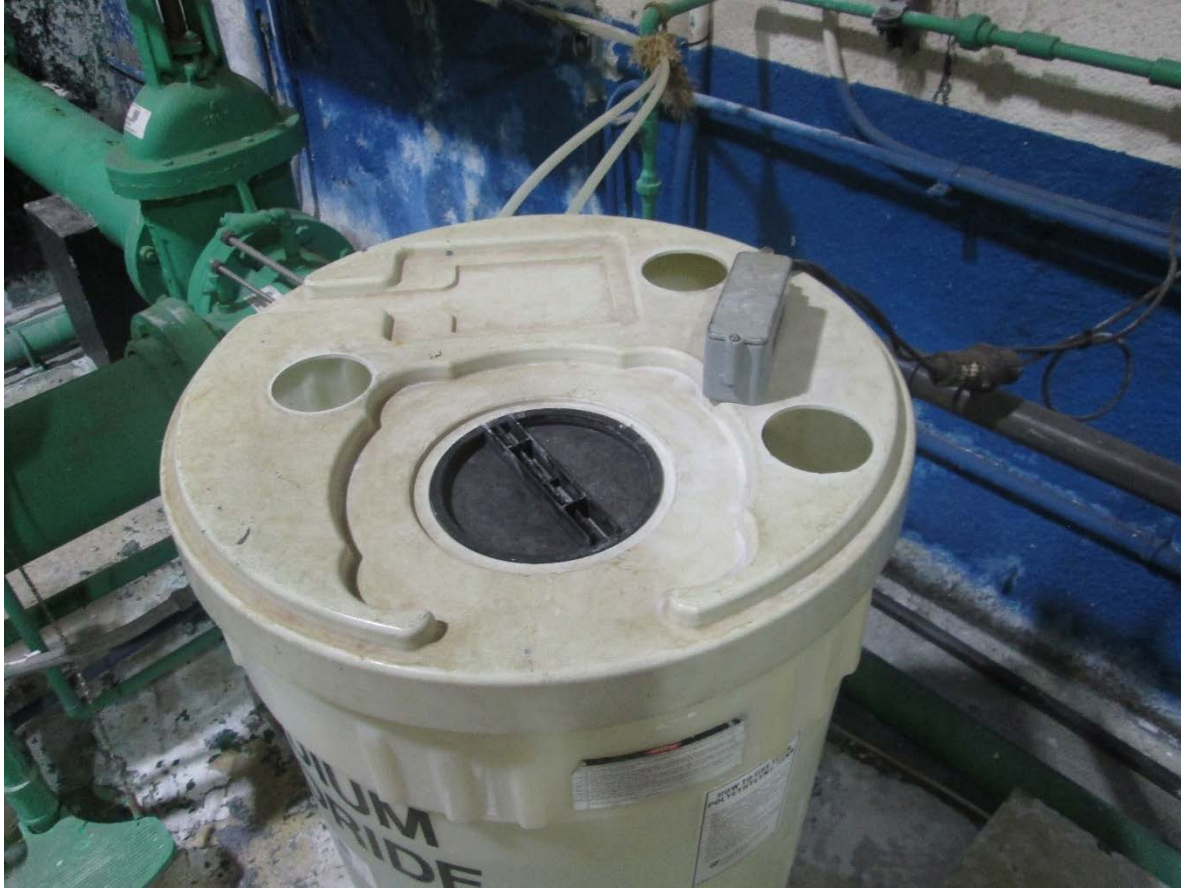
One fluoride mix tank has open holes on the cover – significant deficiency

Red Hill Shaft: the sodium fluoride container has open holes on top and should be sealed.

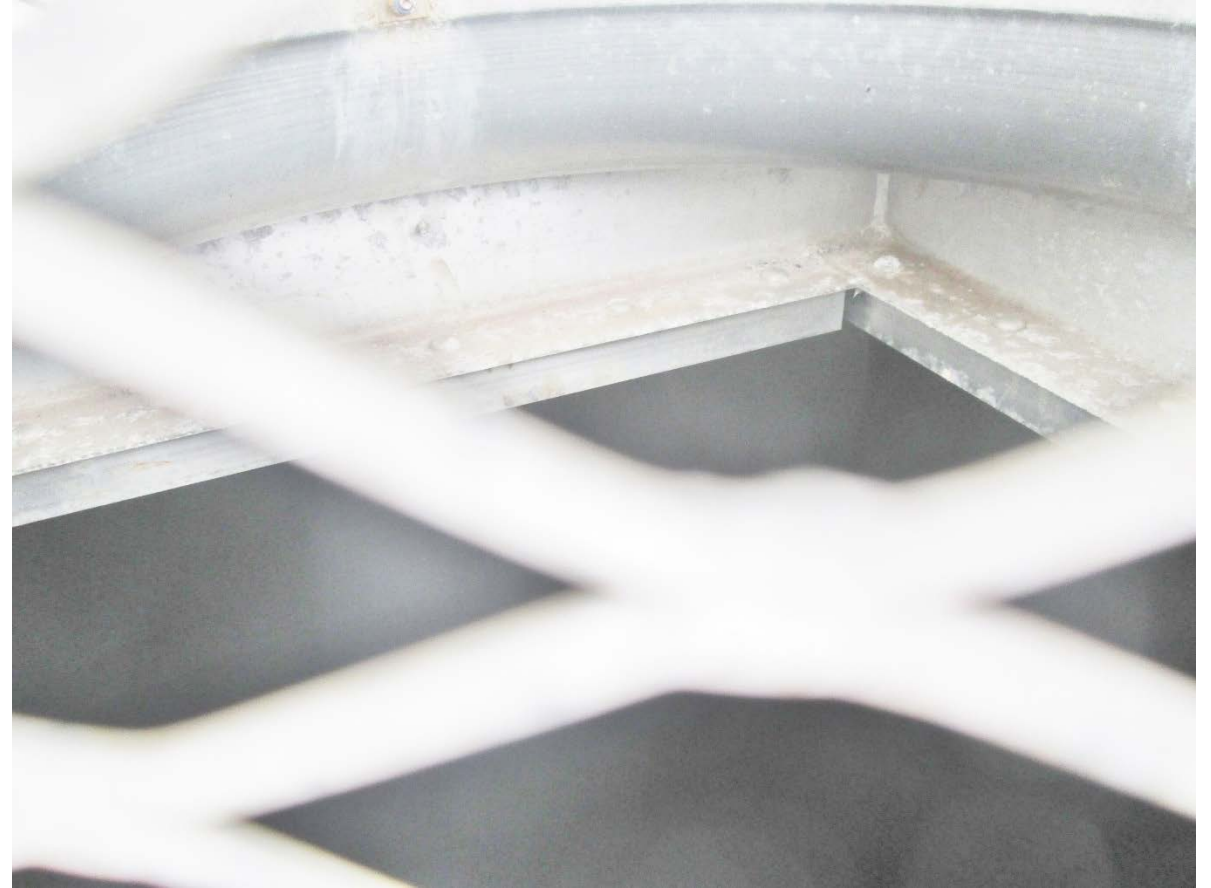
Red Hill Tank: an insect screen is missing from the vent.

Hi! I've added a photo to item 9. There is a black "plastic plug" in place at the center of the top of the vent on the Red Hill Tank, that can be seen in the added photo. This may have been hard to make out on the wide view photo of the vent top. Thank you!

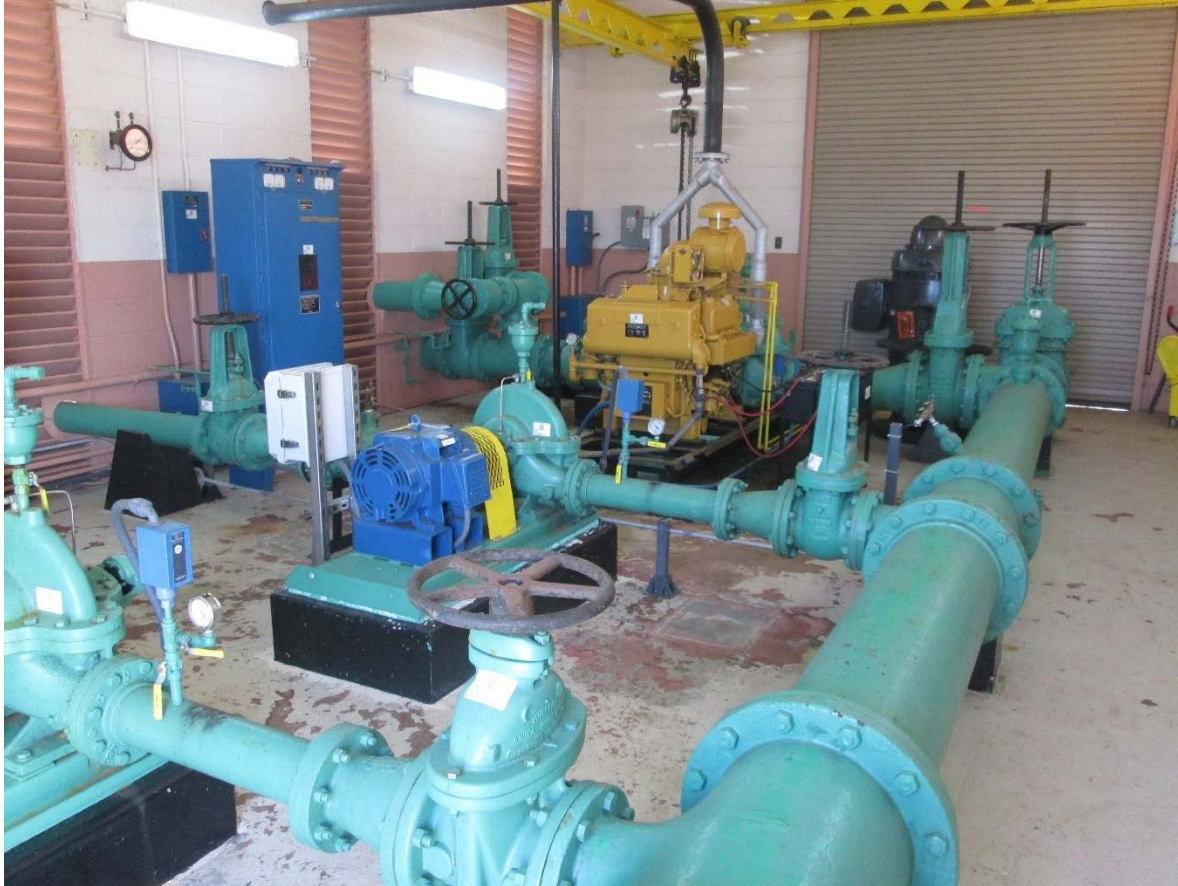
Manana Booster Pump Station: ARV pointing sideways and should be pointed down.

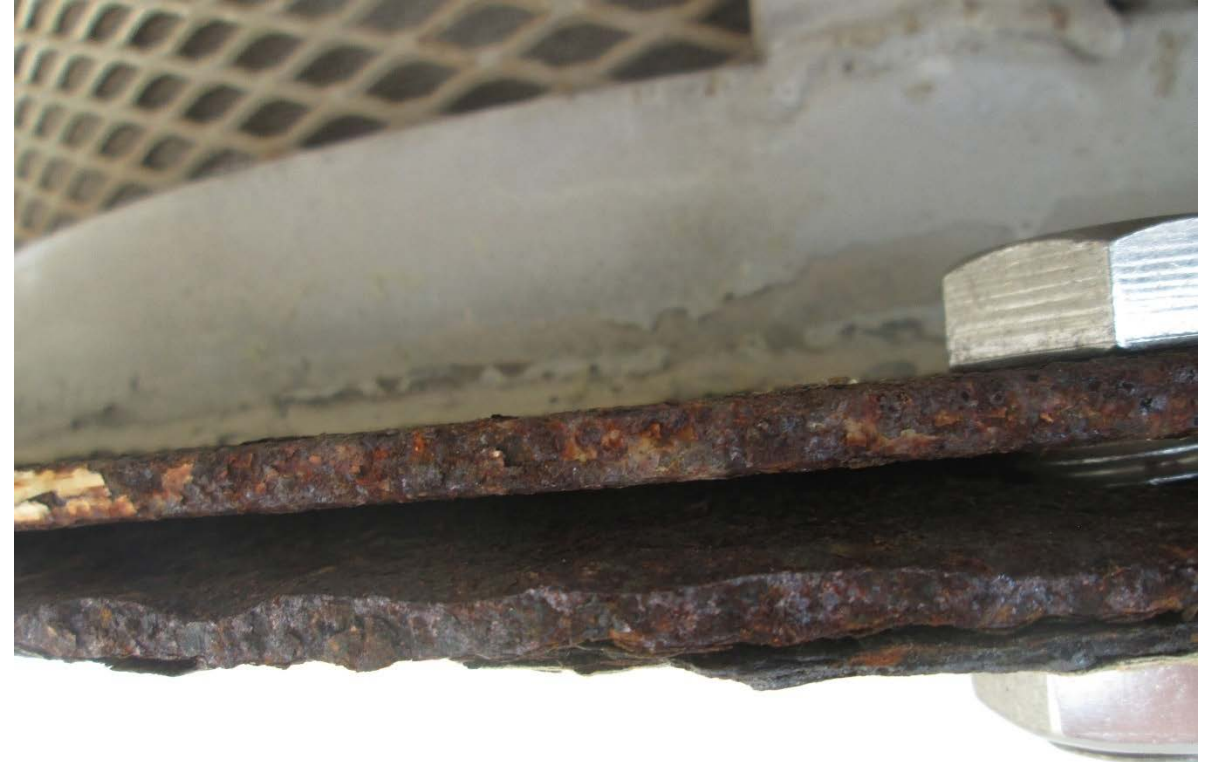
Halawa S-1 Tank: there are gaps between the flanges of the vent screen and the pedestal (daylight was seen through this gap)

Hi! I've updated the photos for items 6 and 9. The original photo for item 6 showed a vent from Tank S-2, instead of Tank S-1. Additional photos were added to item 9 to show that the vent was indeed from the Red Hill Tank. Please let me know if you have any additional questions or concerns. Thank you!
