TANK S-1
API-653 In-Service Inspection
September 15, 2020

Subject: In-service (External) API 653 inspection including Ultrasonic Thickness (UTT) Survey on Tank #S-1, located in Honolulu, Hawaii.

Tank ID: S-1
Built By: Pittsburgh Des Moines Inc.
Year Built: 1996
Product: Potable Water
Product SPG: 1.00
Capacity: 125,000 Bbls.
Size: 165' Diameter x 40' Height

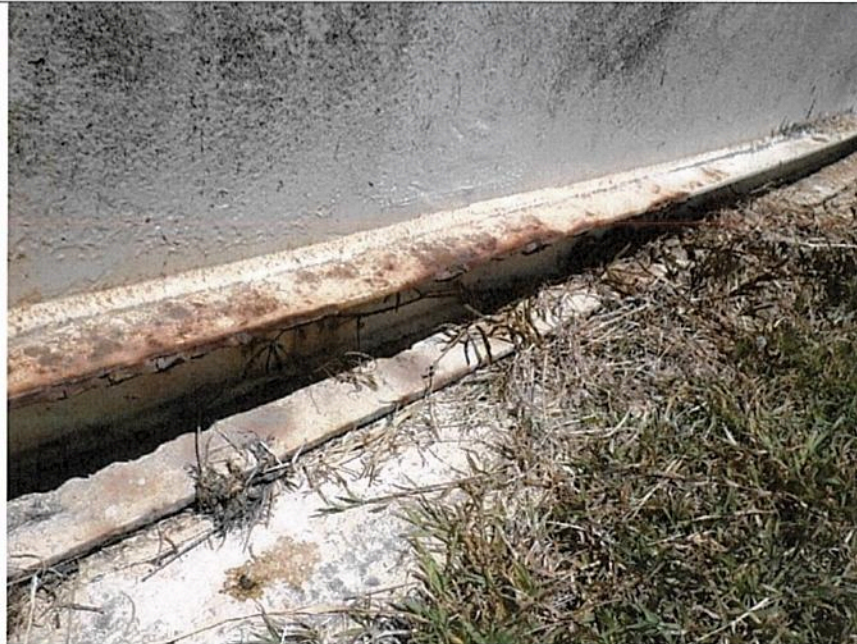
Projection Plate (typical)

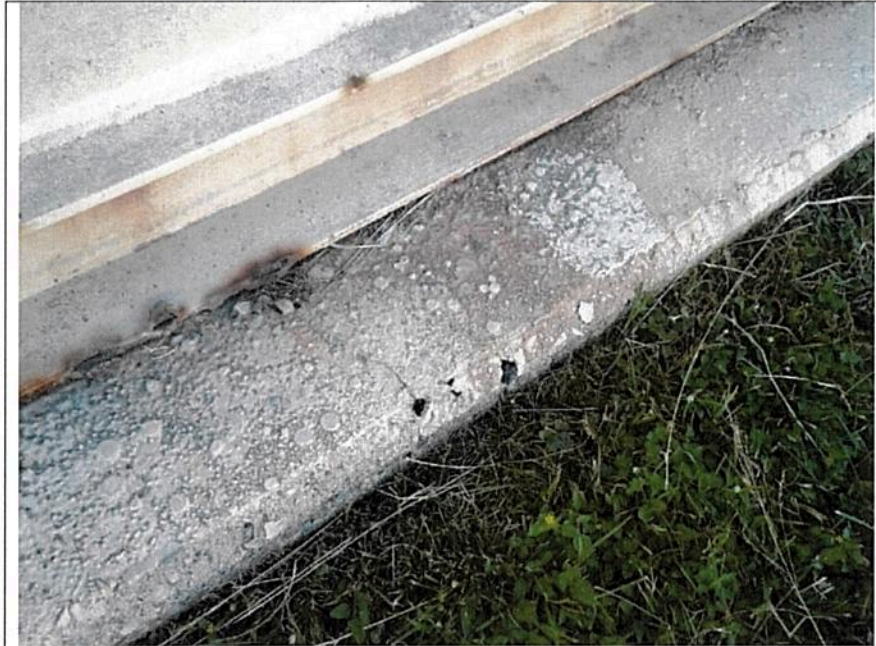
Concrete shrink cracking

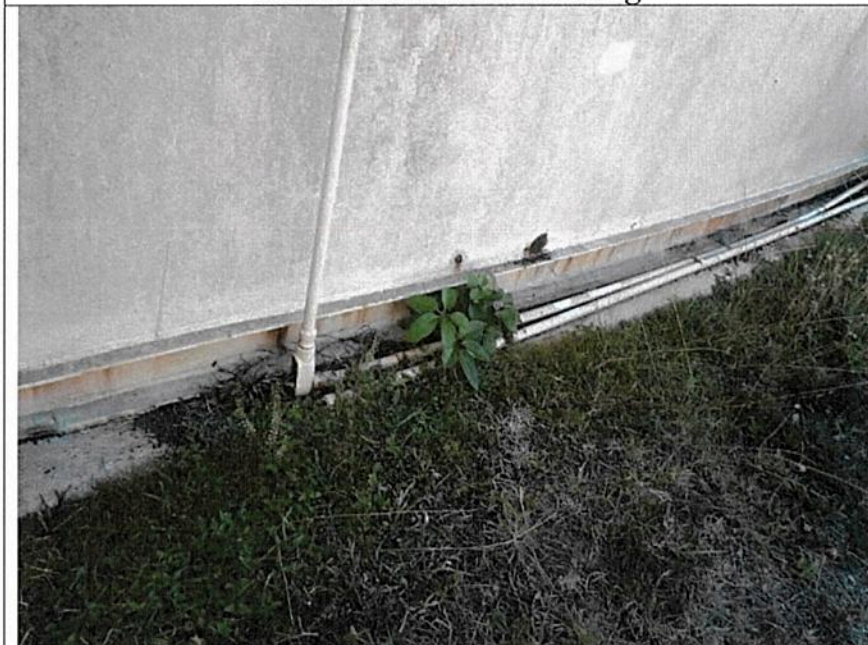
Vegetation around tank base (typical)

1. Mechanically clean and recoat the scattered areas of active localized corrosion found scattered across the tank shell and projection plate on both the top and bottom side, using an approved coating procedure and specification by NAVFAC.
2. Remove the vegetation found around the base of the tank.

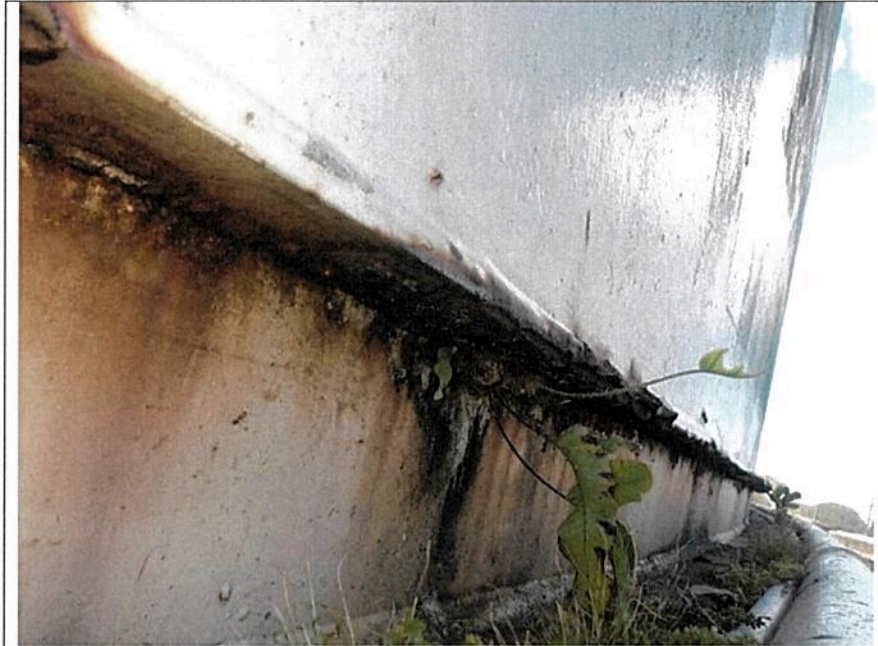
Corrosion on projection plate underside

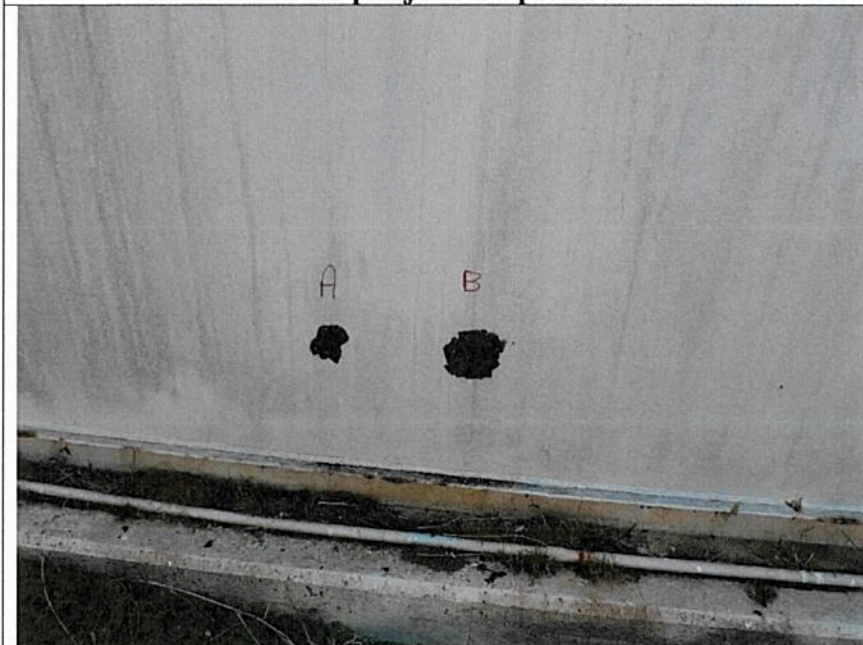
Shell corrosion

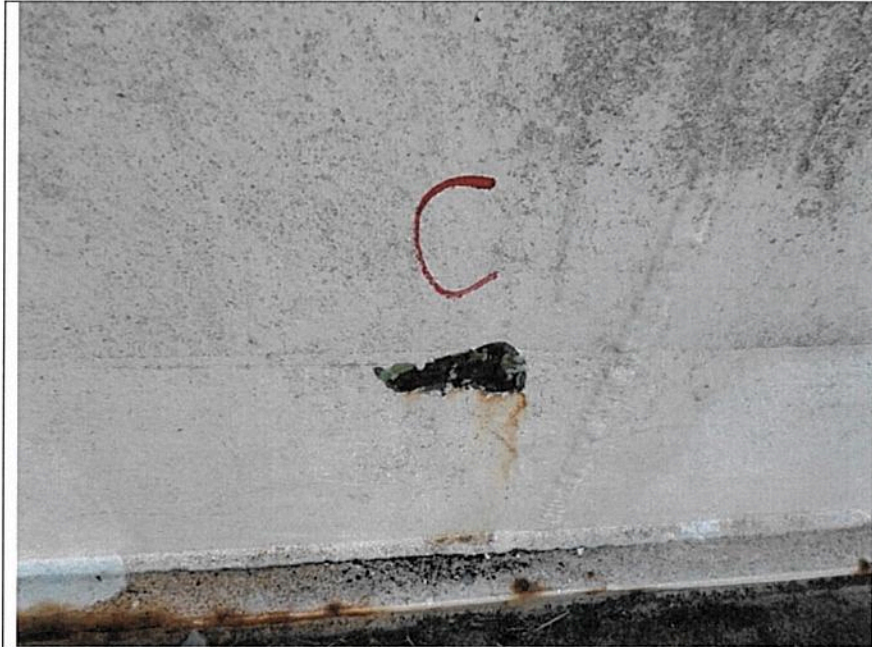
Shell corrosion

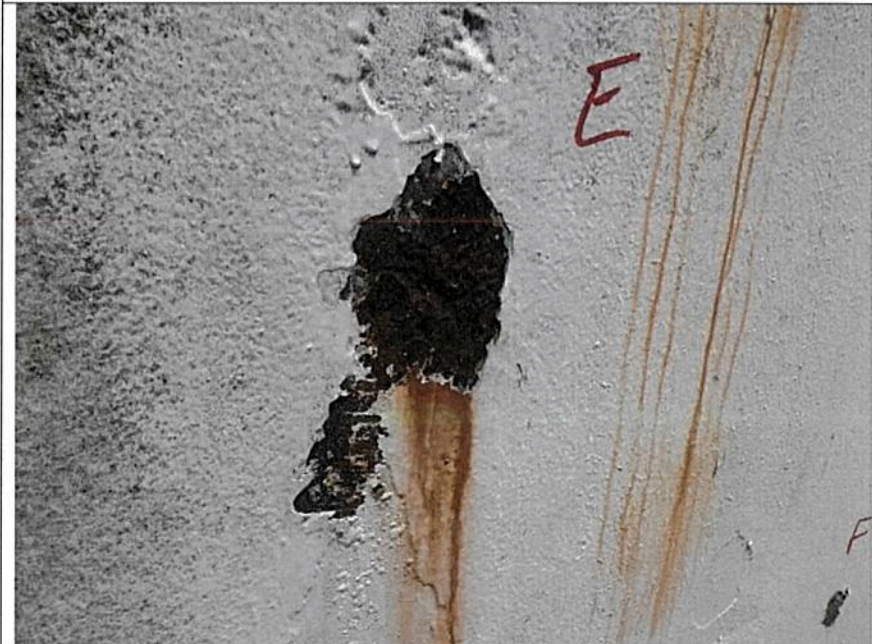
Shell corrosion

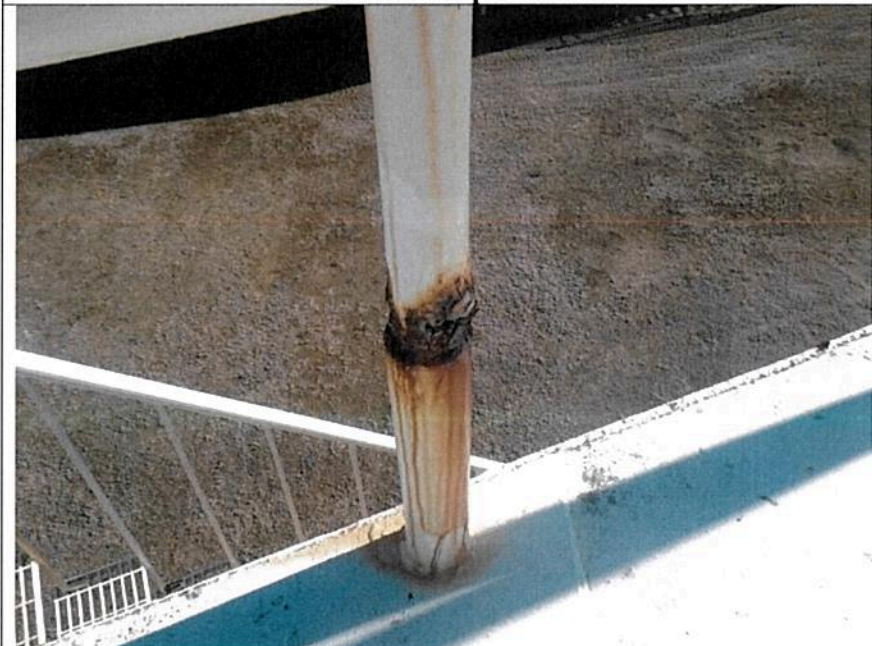
The stairway access to the roof was fully coated with several areas of discoloration found due to active corrosion. The roof access platform was a diamond plate base with light coating failure and active corrosion found around the edge of the plate.

Corrosion at roof access

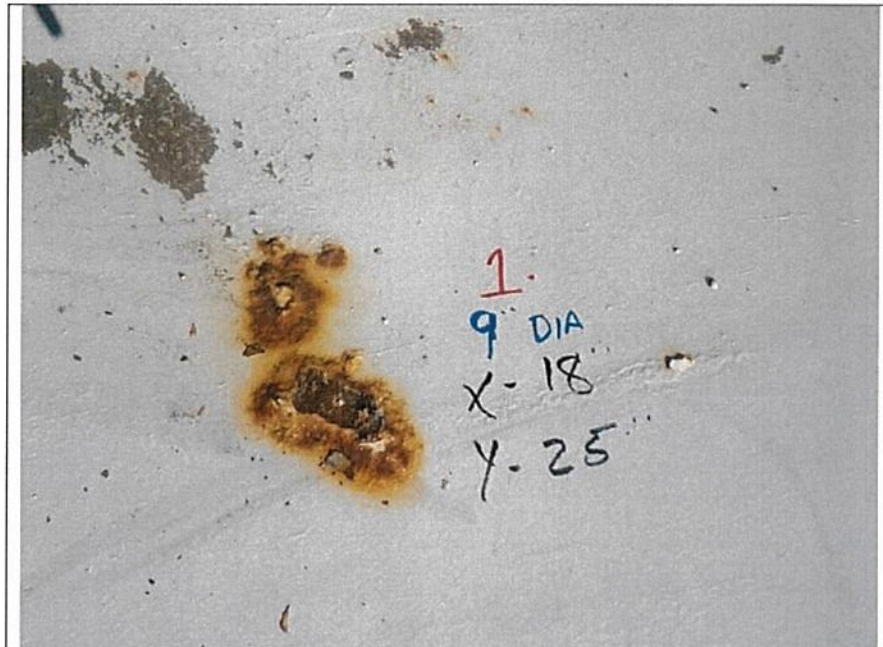
Area #1: 9" diameter area of corrosion

1. Corrosion Area #1: Install a 12" diameter lap patch over the active corrosion.
2. Corrosion Area #2: Install a 10" diameter lap patch over the active corrosion.
3. Replace the eight (8) anode bases that were identified with mechanical or corrosion deficiencies that were identified on the attached roof drawing.
4. Replace the corroded conduit coupling attached on the southwest side of the tank roof in-kind.
5. Perform weld build-up on the one (1) area of external corrosion on the peripheral edge that was identified on the south side of the tank roof.
6. Mechanically clean and recoat the scattered coating failure with active corrosion present on the tank roof and roof vent nozzle, using an approved coating procedure and specification by NAVFAC.

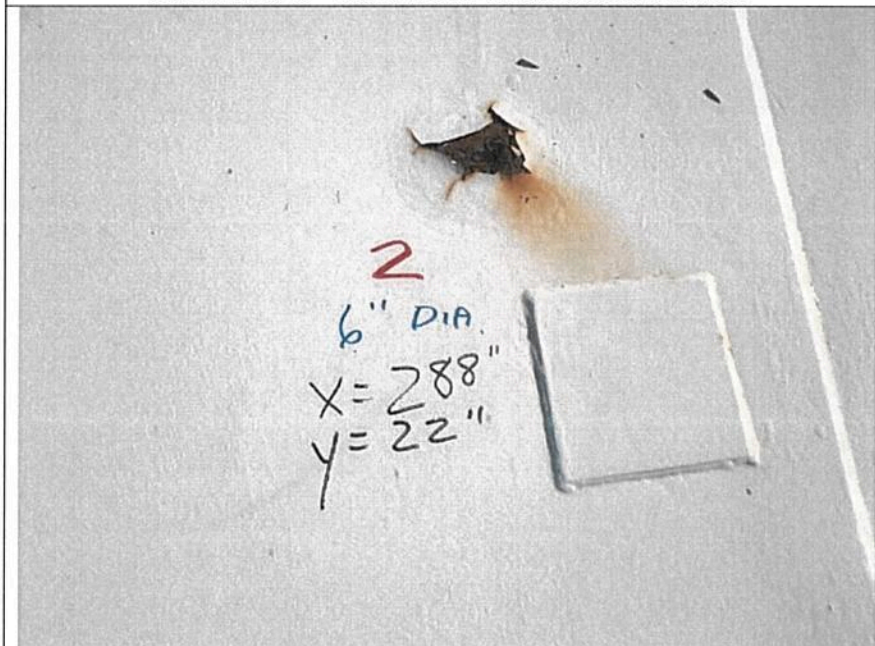
Area #2: 6" diameter area of corrosion

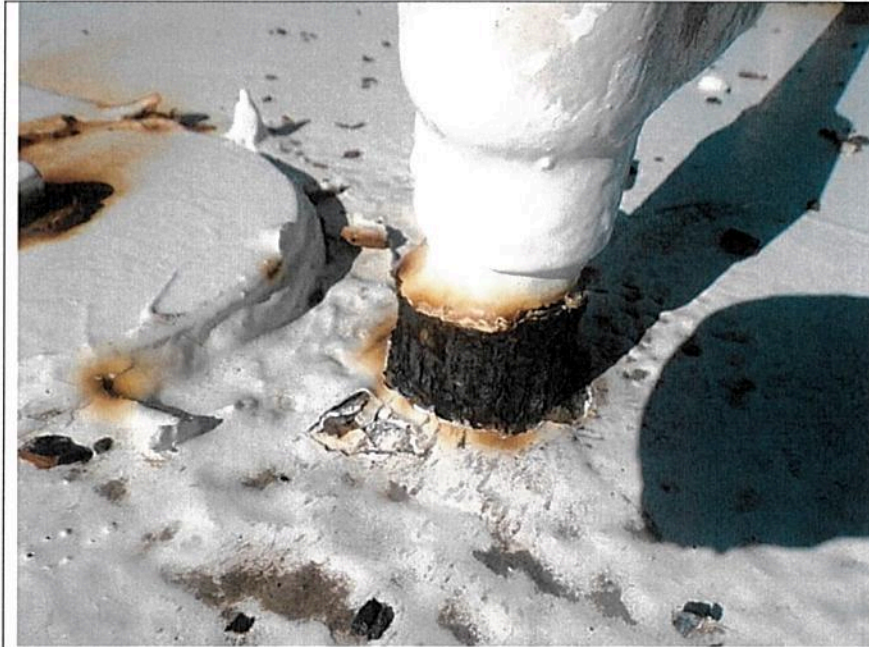
Corrosion at coupling attached to tank roof

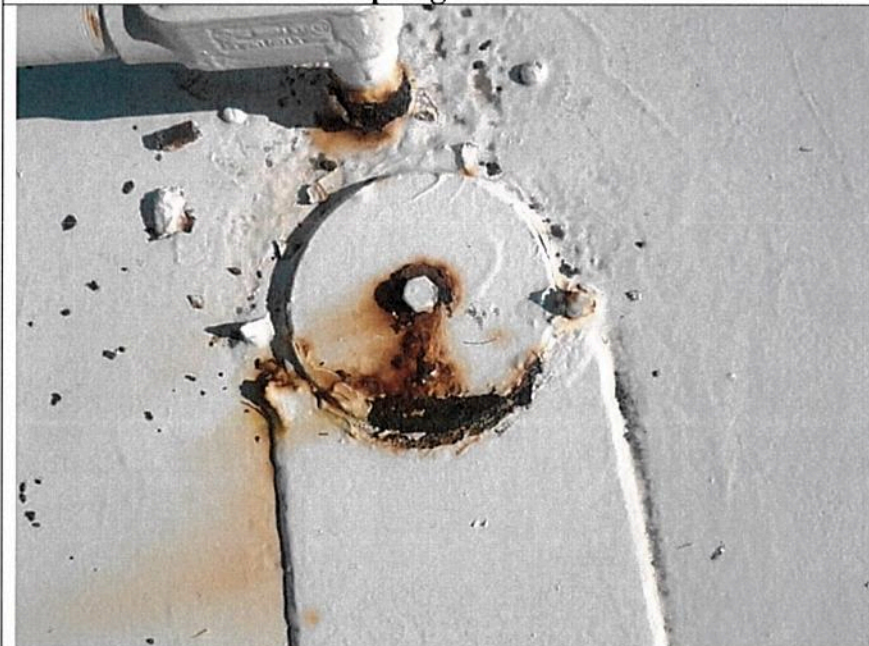
Corrosion at anode base

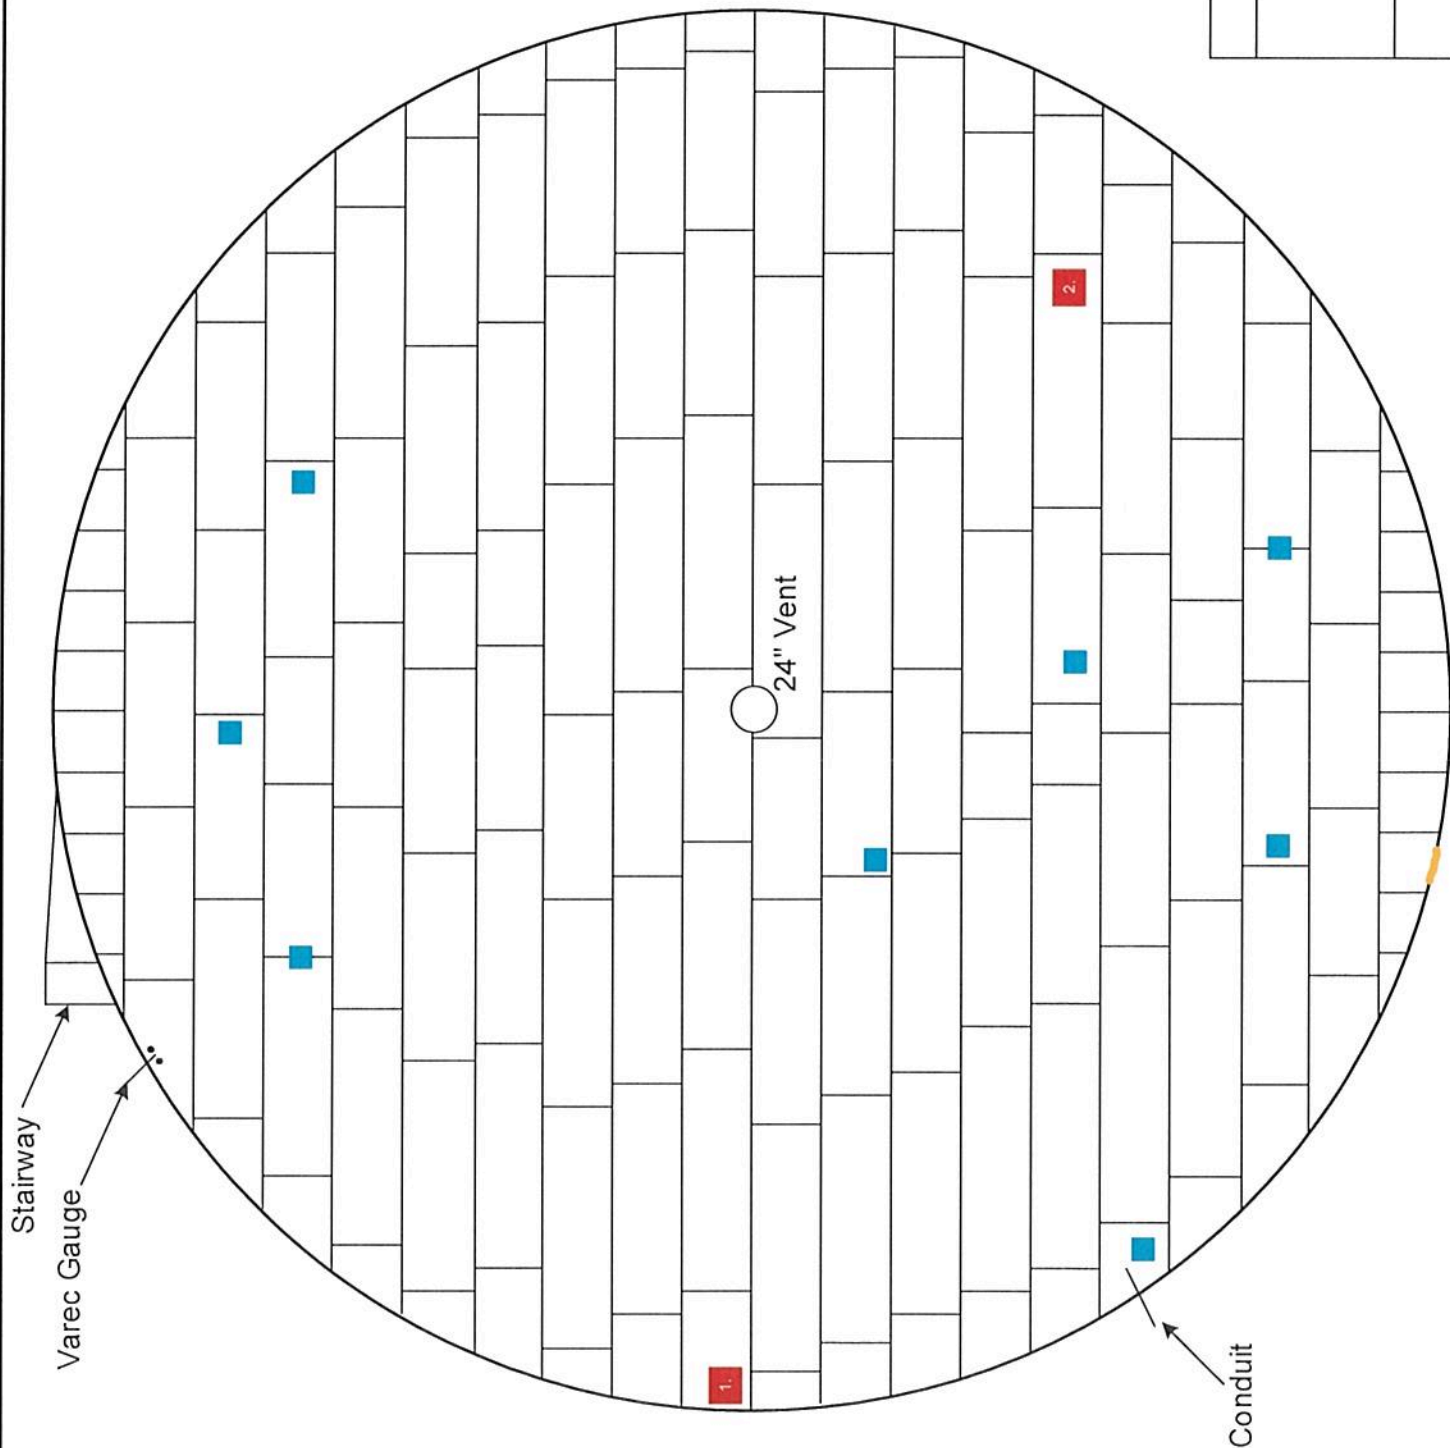
Tank S-1
NAVFAC Honolulu, HI
Tank Roof Plate Layout

- = WBU Peripheral Edge
- = Replace Anode Base
- = Patch Repair Area
