**TANK S-2  
API-653 In-Service Inspection  
September 15, 2020**

**Subject:** In-service (External) API 653 inspection including Ultrasonic Thickness (UTT) Survey on Tank #S-2, located in Honolulu, Hawaii.

Tank ID: S-2  
Built By: Morse Construction Group  
Year Built: 1996  
Product: Potable Water  
Product SPG: 1.00  
Capacity: 125,000 Bbls.  
Size: 165' Diameter x 40' Height

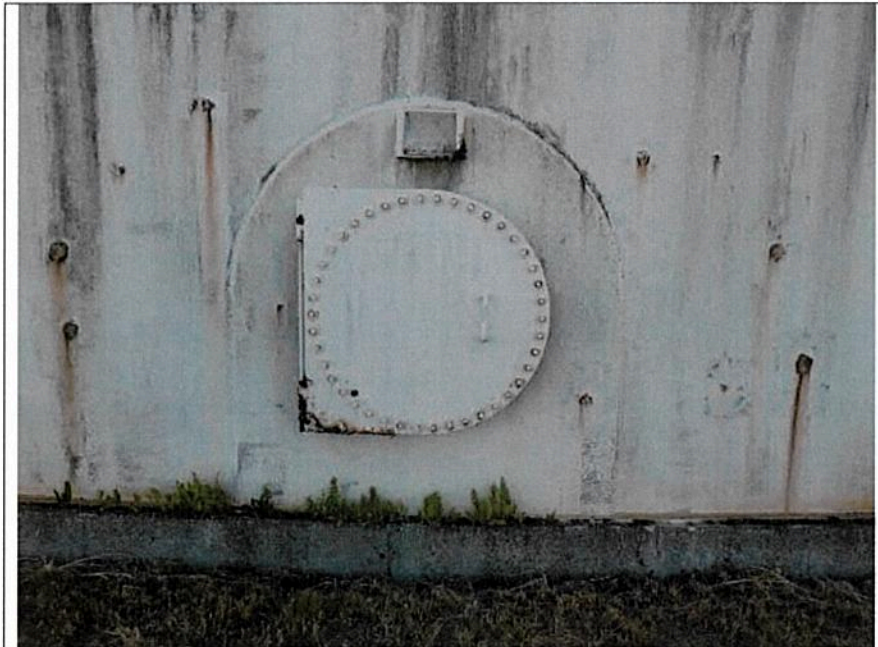
**Manway N1 with Data Plate**

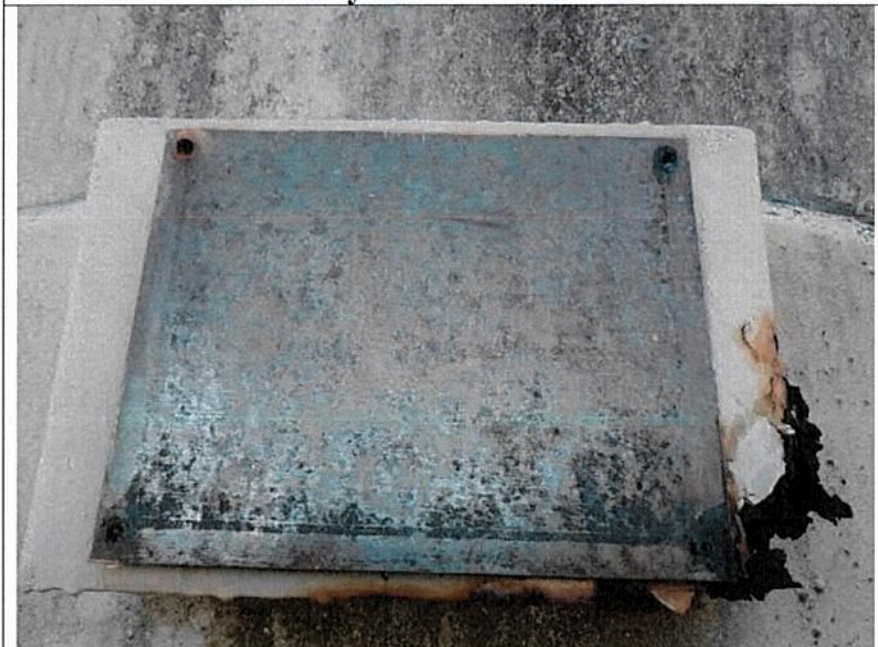
**Tank Data Plate**

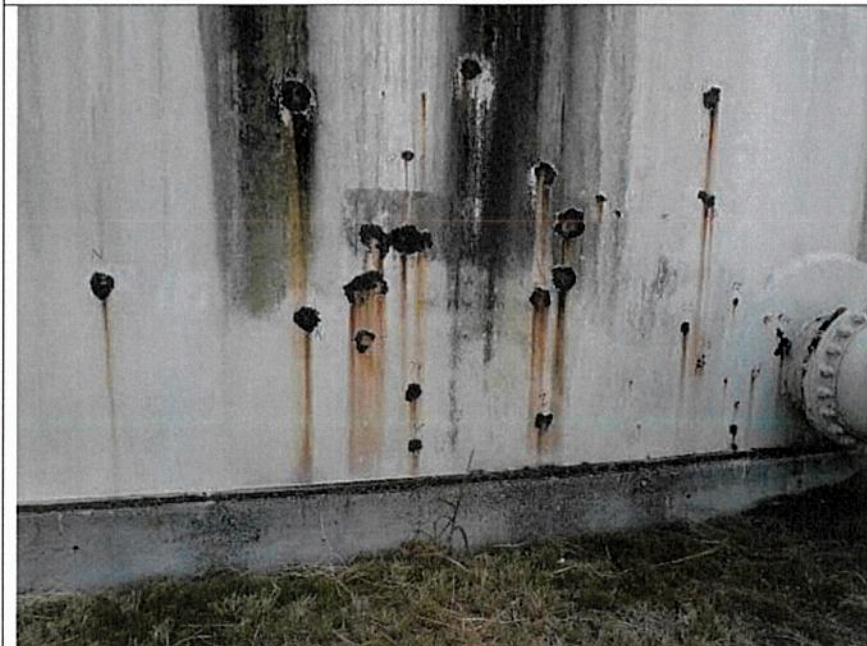
The tank shell was a five-course double butt-welded designed tank where the shell plates were staggered to the right. Discoloring of the tank coating was noted around the entire shell due to micro bacterial growth on the external surfaces. Thirty-two (32) areas of moderate active corrosion were found on the first course of the tank shell that were evaluated using a hammer, scraper, and pit gauge revealing localized corrosion. The active corrosion found on the first shell course measured less than 0.250" deep in all locations. The areas of corrosion were measured in varying sizes with several measuring larger than 12" in diameter. The nominal thickness of the first shell course was 1.262". No other significant external corrosion was found on the shell plates on the first shell course or other visible shell plates or their associated connection welds. The external surfaces of the shell were fully coated with several areas of light coating failure present revealing active corrosion on the tank shell plates. The tank does not have any active rim vents or overflows. No reinforcement plates were installed between the tank shell and external attachment bracket connections for the piping and conduit extending up the tank shell. The tank's associated data plate was illegible with the markings worn away.

**Localized corrosion on first shell course**

1. Mechanically clean and recoat the scattered areas of active localized corrosion found scattered across the tank shell and projection plate, using an approved coating procedure and specification by NAVFAC.
2. Install a sealant between the projection plate and the tank foundation.
3. Perform weld build-up on the underside of the 24" Fill/Suction nozzle to restore the nozzle to full thickness. An approved P1 to P1 welding procedure should be followed using low hydrogen electrodes, followed by non-destructive testing in accordance with API 653 for nozzle repairs.
4. Remove the vegetation found around the base of the tank.

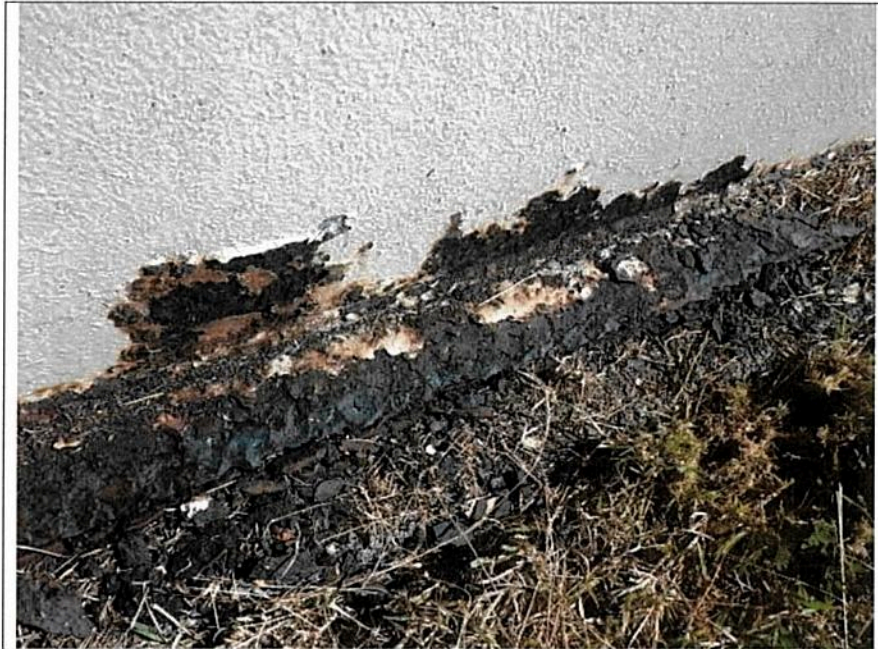
Tank S-2 had a projection plate that extended 3" past the chime weld of the tank shell. The projection plate had thickness readings taken measuring at 0.250" thick. Severe corrosion in the form of knifing and thinning was noted on the east side of the tank near the eastern manway nozzle. Moderate coating failure and active corrosion was also present scattered randomly around the tank projection plate in the form of knifing and thinning. No sealant between the foundation and tank bottom was found.

**Corrosion on projection plate and chime area**

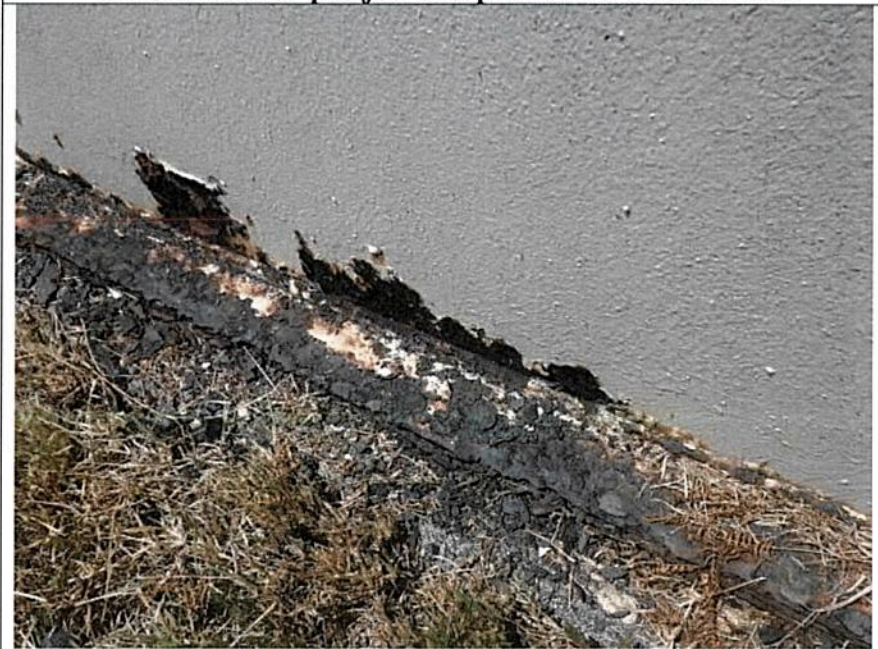
**Corrosion on projection plate with knifing noted**

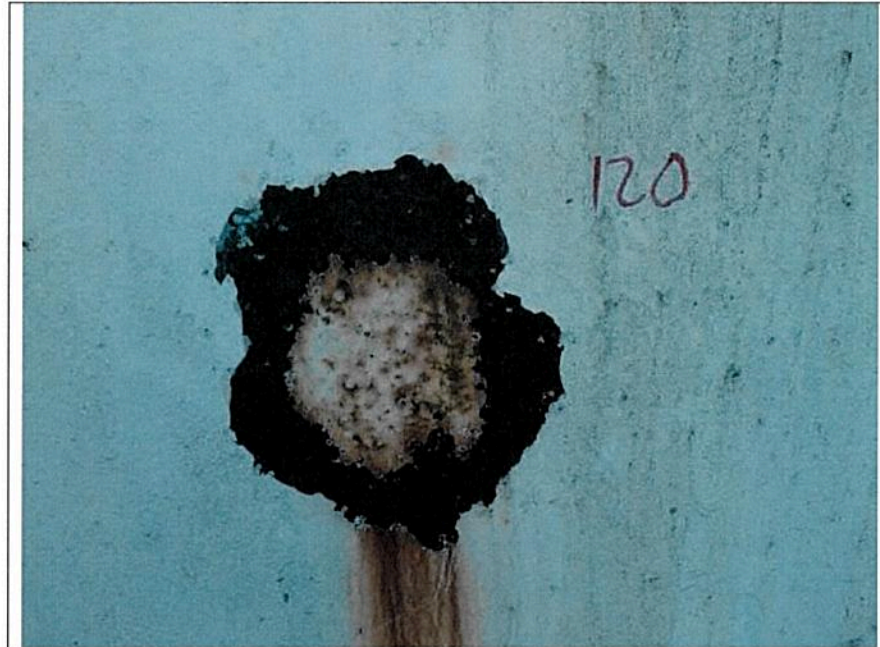
**Localized shell corrosion**

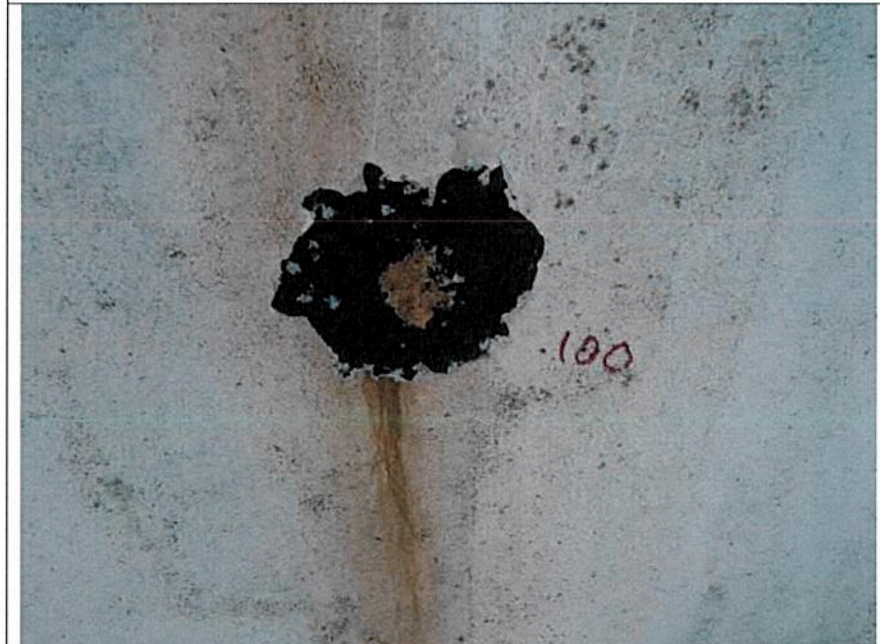
**Localized shell corrosion**

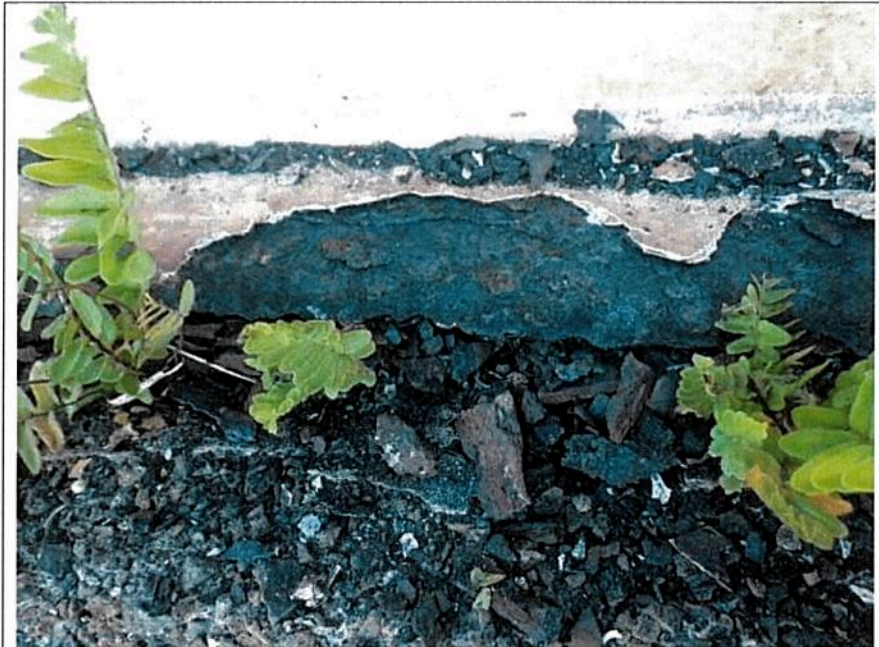
**Knifing of the projection plate and vegetation growth**

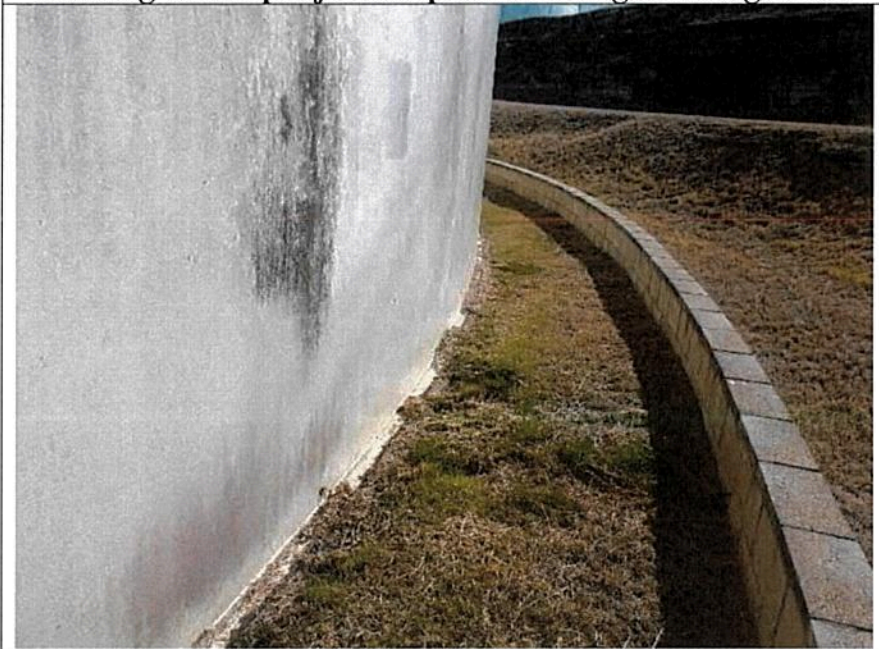
Tank S-2 was located inside of a controlled fenced area. The nearest tank (S-1) was approximately 100' to the south. A 3' high brick retaining wall was constructed at the base of the tank on the east side. A large hatch on the north side of the tank was found at the base of the tank near the overflow nozzle piping. Fencing with a lockable gate was constructed around the stairway access to the roof of the tank. Vegetation growth was noted around the base of the tank covering the projection plate in several areas.

**Vegetation growth along east side of tank projection plate**

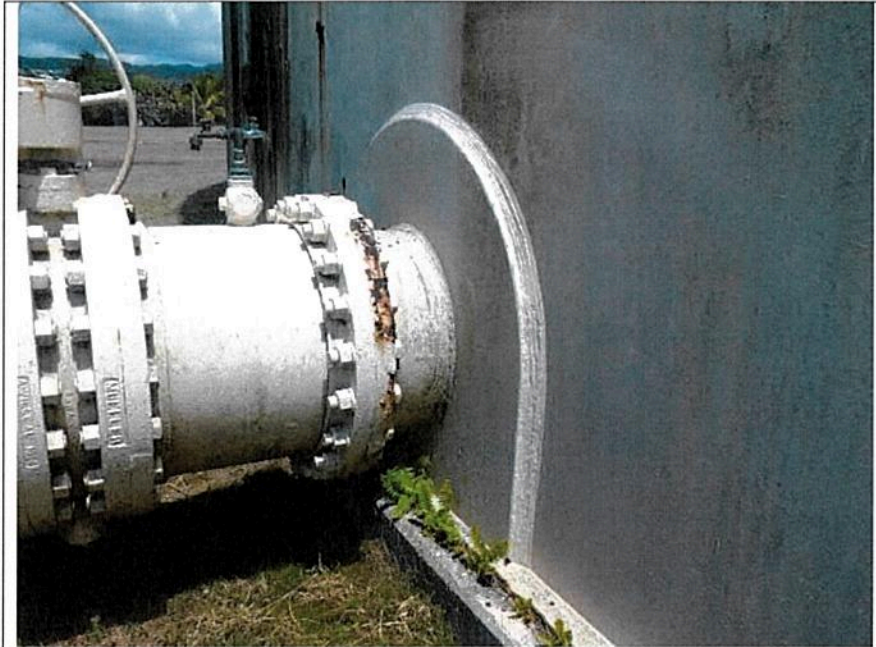
**Fill/Suction nozzle**

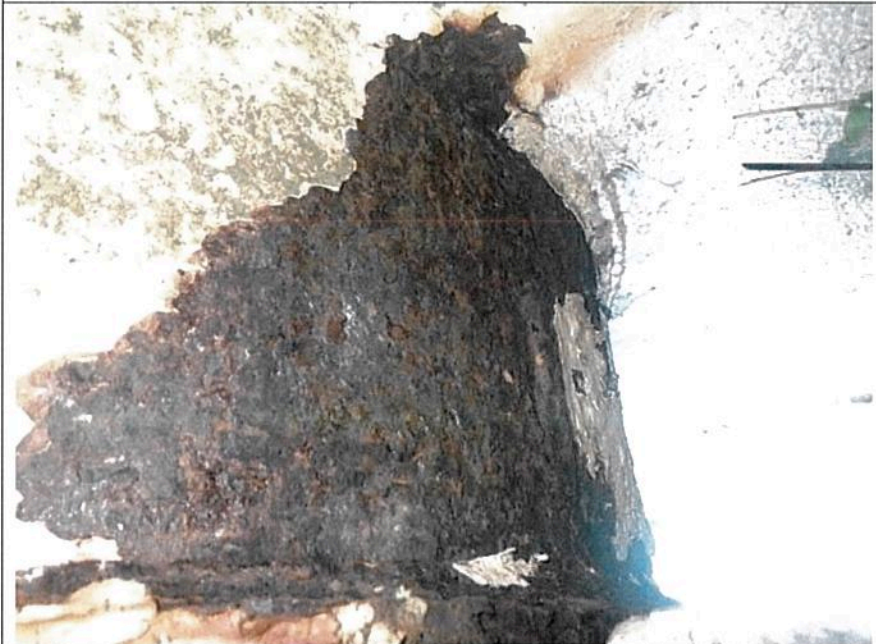
Coating failure and severe active corrosion was noted underneath the Fill/Suction nozzle on the west side of the tank shell.

The Tank has two (2) 30" manways found on the Southwest and Northeast sides of the first shell course. The 24" fill/suction line was found on the west side of the first shell course with moderate active corrosion found on the underside of the nozzle measuring up to 0.250" deep with scaling still present after hand scraping. Light isolated corrosion was observed scattered on the external portions of the tank nozzle bores, flanges, and associated hardware. A low-level alarm 1" nozzle on the North side of the shell was not seal welded to its first isolation valve. The nozzle to shell and nozzle to repad connection welds were found intact and secure with no preferential corrosion noted. A 24" overflow nozzle was found on the North side of the tank shell near the upper section of the fifth shell course. All associated nozzle reinforcing plates were found tombstoned to the tank bottom.

**Underside corrosion of the Fill/Suction Nozzle**

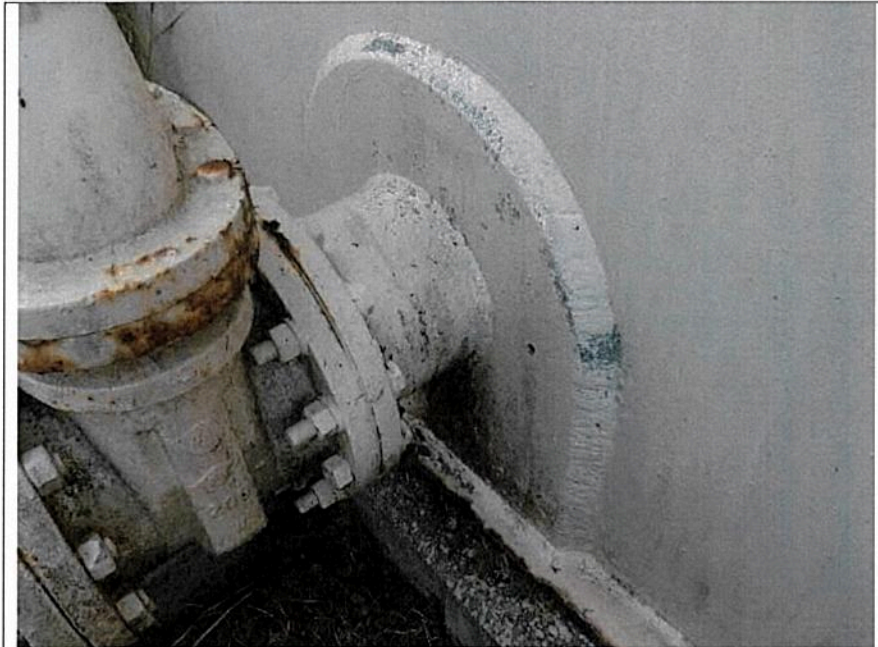
**10" Nozzle**

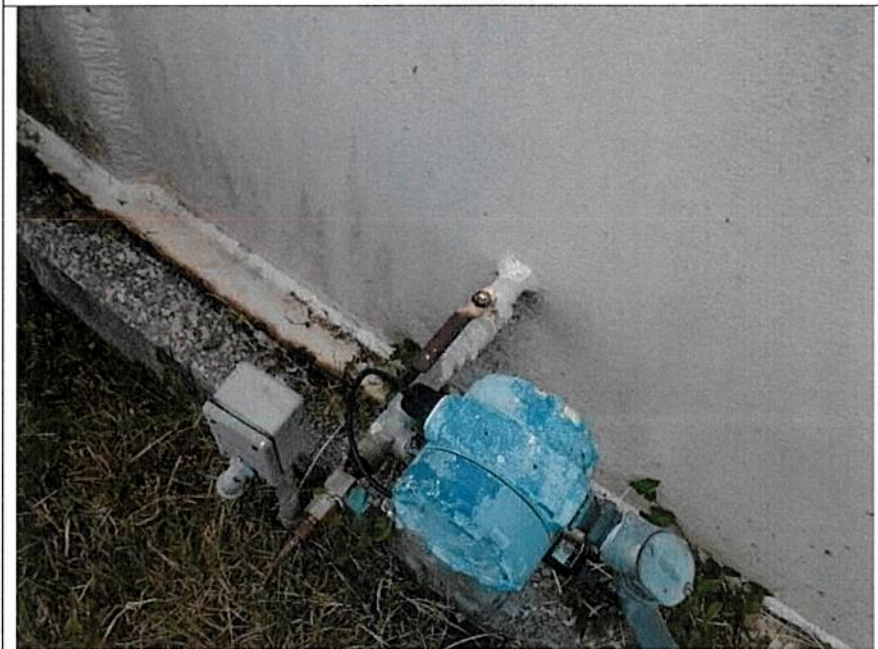
**1" nozzle without seal weld to block valve**

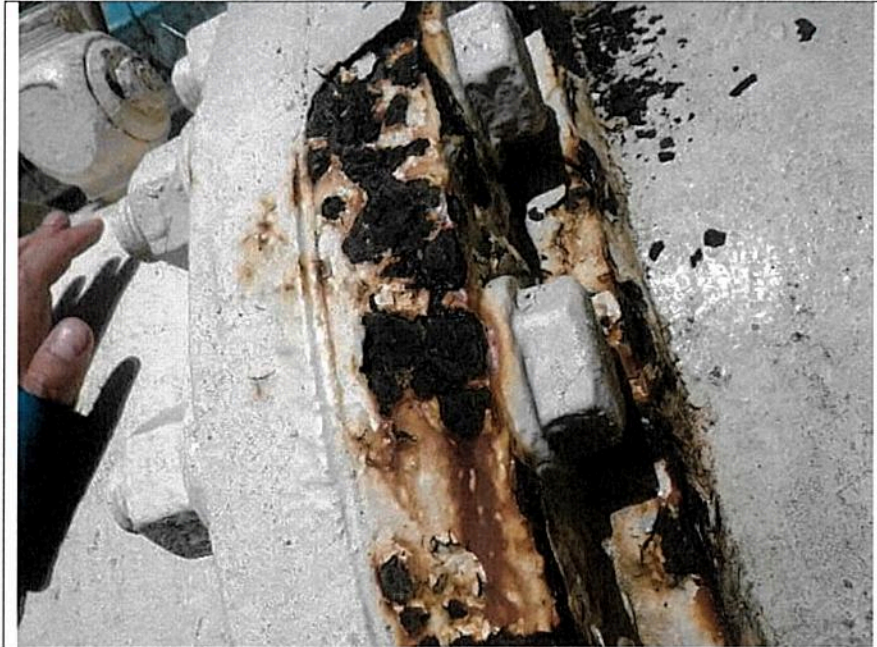
**Flange corrosion on nozzle (typical)**

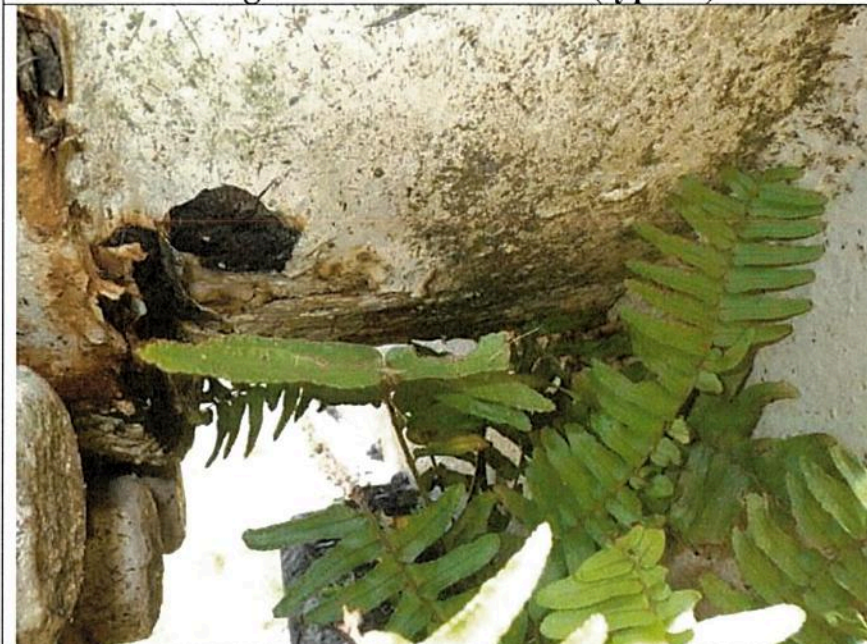
**Vegetation growth around tank (typical)**

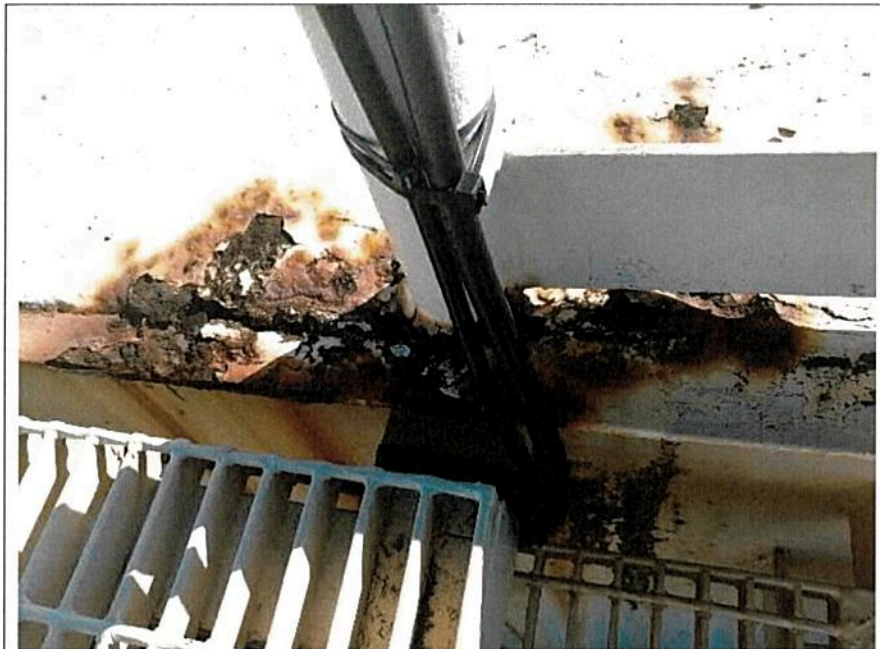
**Corrosion at handrail support of tank roof**

6. Mechanically clean and recoat the scattered coating failure with active corrosion present on the tank roof and roof vent nozzle, using an approved coating procedure and specification by NAVFAC.

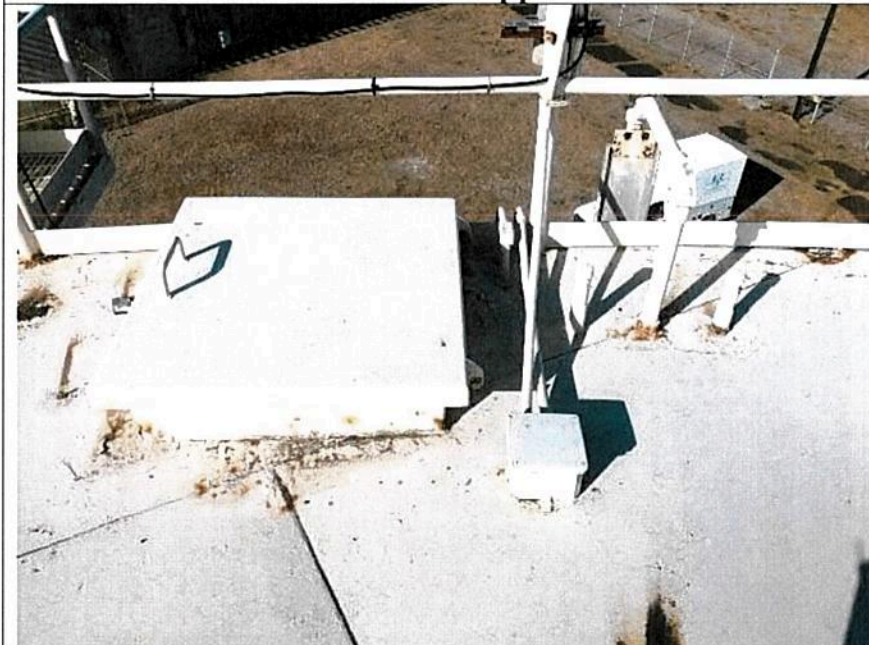
**Roof access hatch and visible board gauge.**

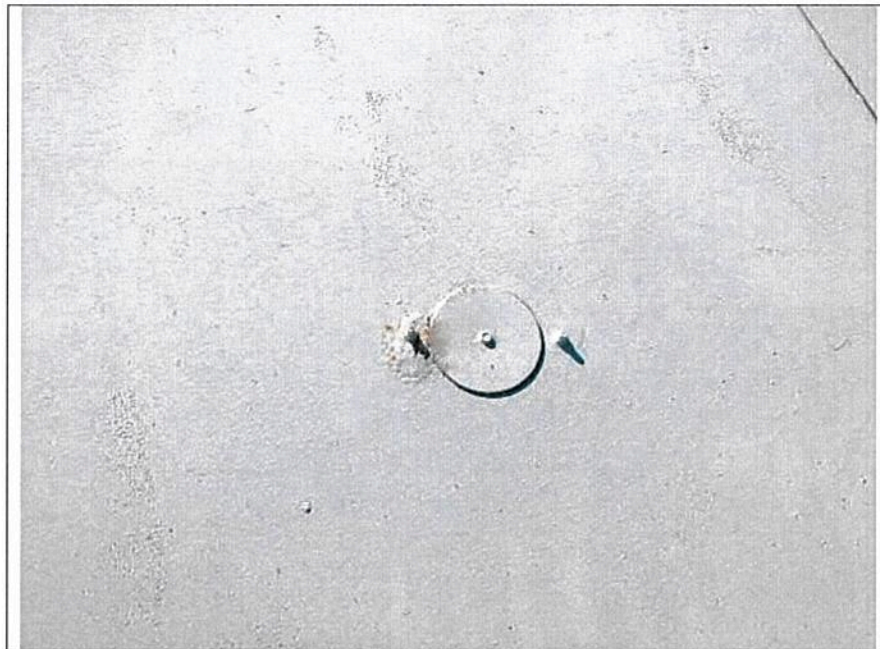
**Roof anode base on tank roof**

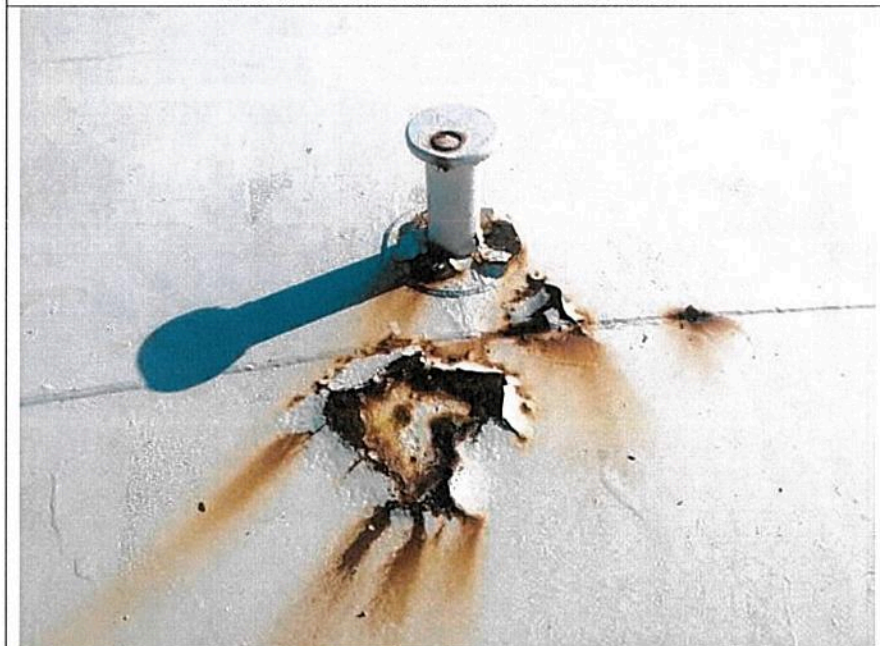
severe corrosion to the hatch nozzle as well as the roof connection weld and adjacent roof plates; the area was identified as Corrosion Area #31 and written to be removed and lap patched. The scaffold ring in the center of the tank roof has severe active corrosion on its associated reinforcing plate, creating a loss of profile.

**Scaffold ring with corrosion at reinforcing plate**

5. Install a new reinforcing plate underneath the scaffolding ring at the center of the tank roof.

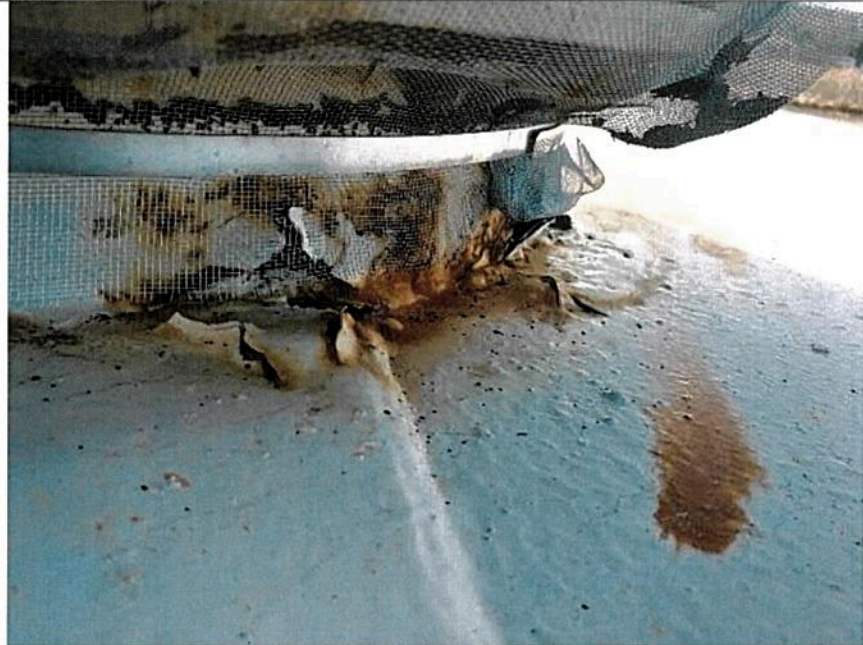
**24" roof vent nozzle with corrosion on nozzle bore and attached mesh screen**

4. Remove and replace the two (2) 24" roof vents and replace with new atmospheric vents. The associated nozzle flanges may need to be replaced as well due to corrosion that was unable to be adequately inspected due to the make-up of the current roof vent and associated vent screens covering the nozzles.

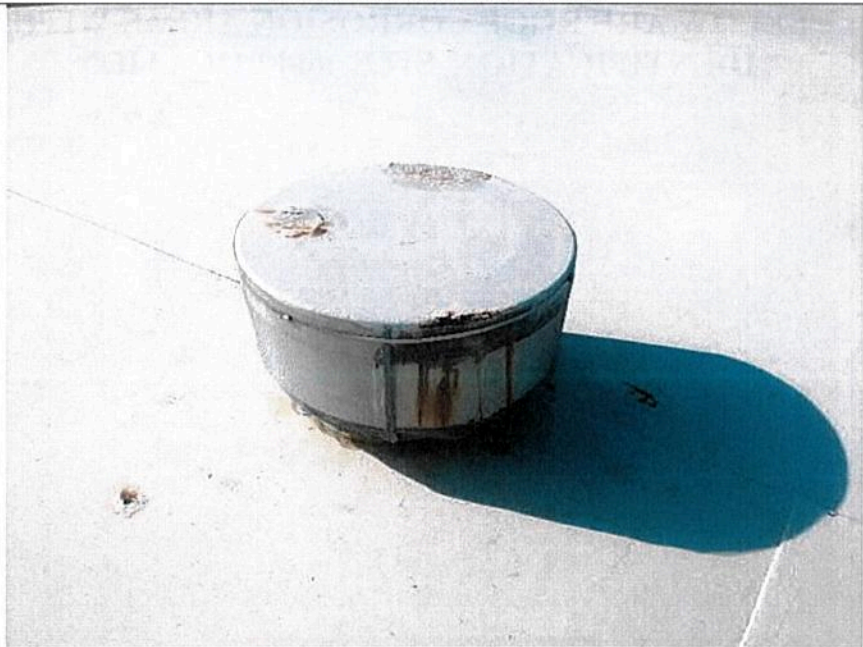
**24" roof vent**

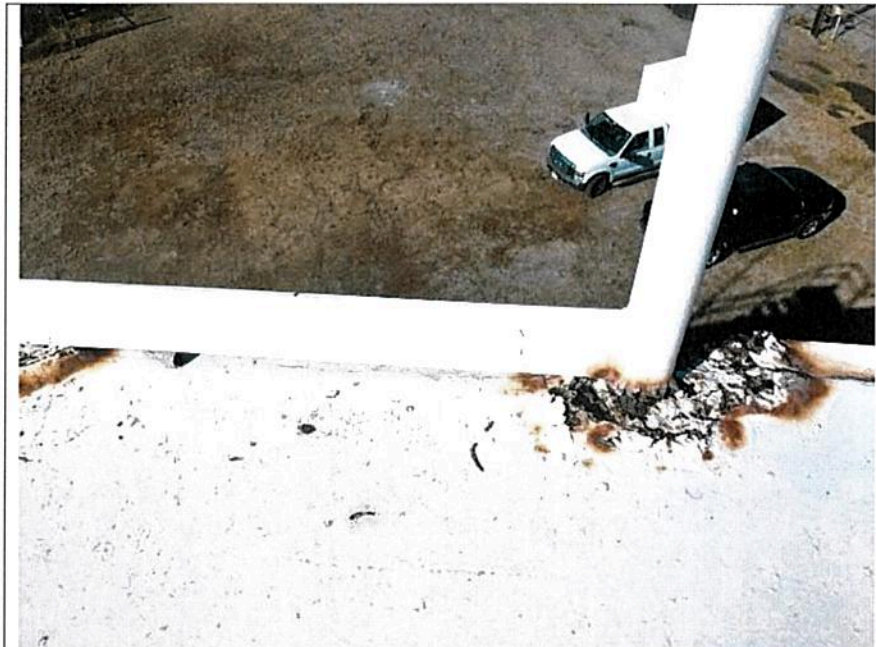
**Corrosion at handrail support at peripheral edge of roof**
