Reducing Lead in Schools

Testing School Drinking Water for Lead

EPA REGION 8

Testing of School Drinking Water for Lead

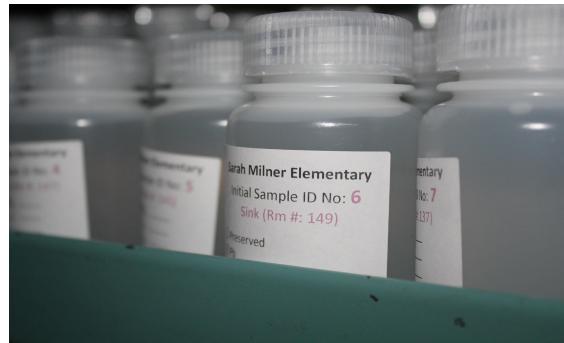
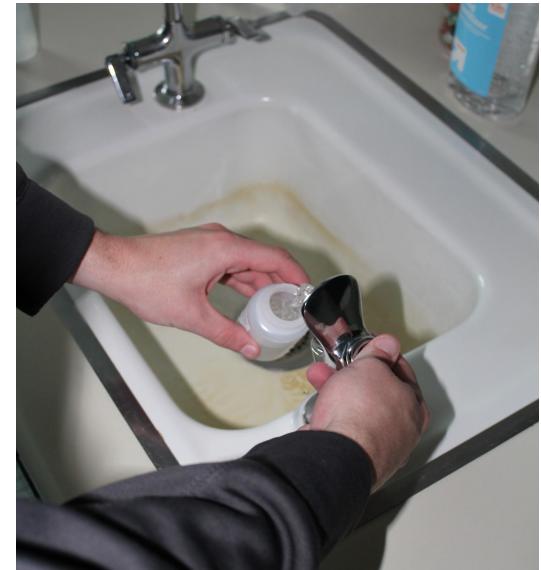
Building ID: 122				Sampling	
Time	Sample ID	Room	Room Type	Sample Type	Location
7:49	32	161	Classroom	N	Sink
7:49	33	161	Classroom	N	Bubbler
OFF	34	160	Classroom	N	Sink
OFF	35	160	Classroom	N	Bubbler
7:55	36	A12	Classroom	N	Sink
7:55	37	A12	Classroom	N	Bubbler
7:57	38	A13	Classroom	N	Sink
7:57	39	A13	Classroom	N	Bubbler
8:07	40	A16	Classroom	N	Sink
8:00	41	A16	Classroom	N	Bubbler
8:02	42	A8	Girls Bathroom	S	Left sink
8:02	43	A8	Girls Bathroom	S	Right sink
8:04	44	A5	Boys Bathroom	S	Left sink
8:04	45	A5	Boys Bathroom	S	Right sink
8:04	46	A17	Classroom	S	Sink
47	A17	Classroom		S	Bubbler
48	A20	Classroom		S	Sink
49	A20	Classroom		S	Bubbler
50	A21	Classroom		S	Sink
51	A21	Classroom		N	Right sink
52	A42	Boys Bathroom		N	Left sink
	A42	Boys Bathroom		N	Sink

- ❖ Conducted from March to December 2018
- ❖ Collected first draw and 30 sec flush samples (hand sinks, drinking fountains, and bottle fillers)
- ❖ Analysis by City of Loveland WQL
- ❖ One week turnaround on samples
- ❖ Action threshold of 15 ppb for remediation

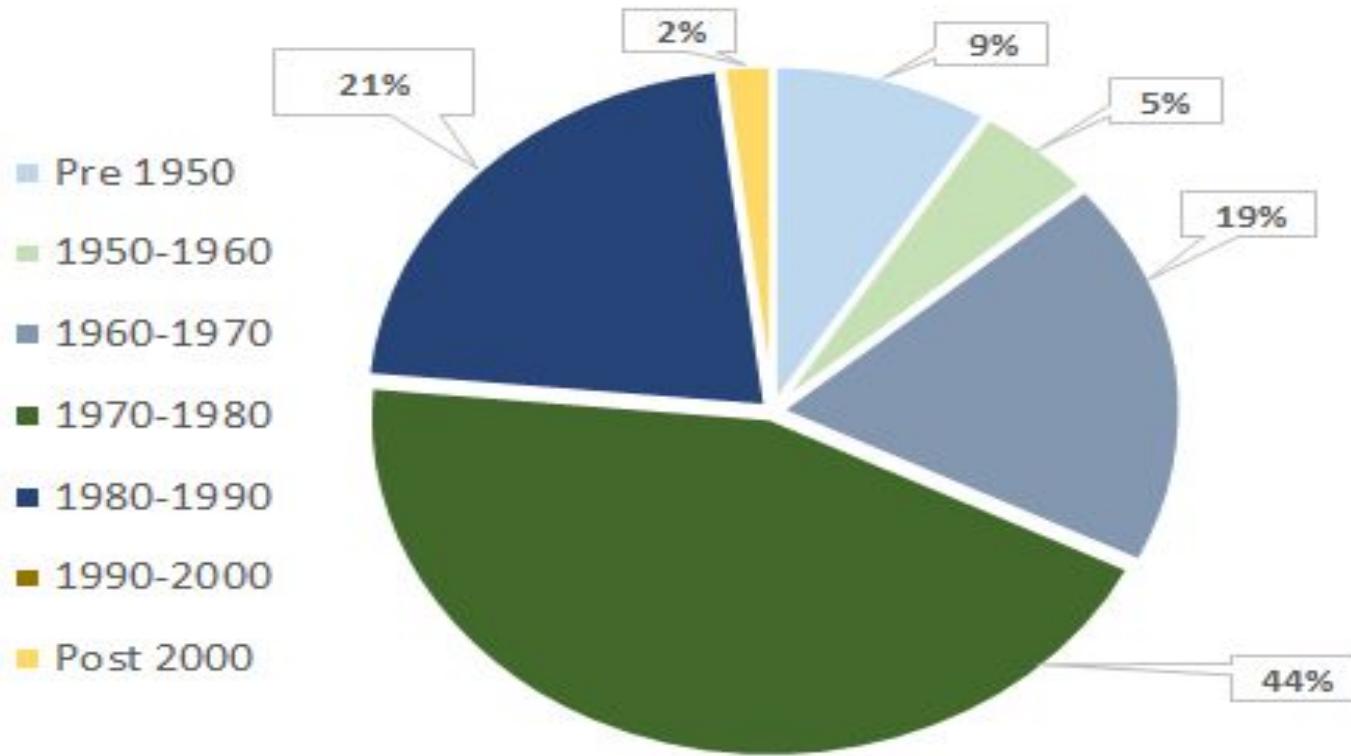
Percentage of Samples >15.00 ppb By Year Built

Note: % is based on 102 total samples from 34 TSD locations
