Re: Stream Mitigation Measures Work Plan – Complete Package  
NSRC East Palestine, OH Derailment

# **Sediment Mitigation Measures Work Plan – Modified**

**East Palestine Train Derailment  
Columbiana County, Ohio**

**Prepared in response to USEPA’s Administrative Order pursuant to  
Section 311 of the Clean Water Act – Docket No. CWA-1321-5-24-001**

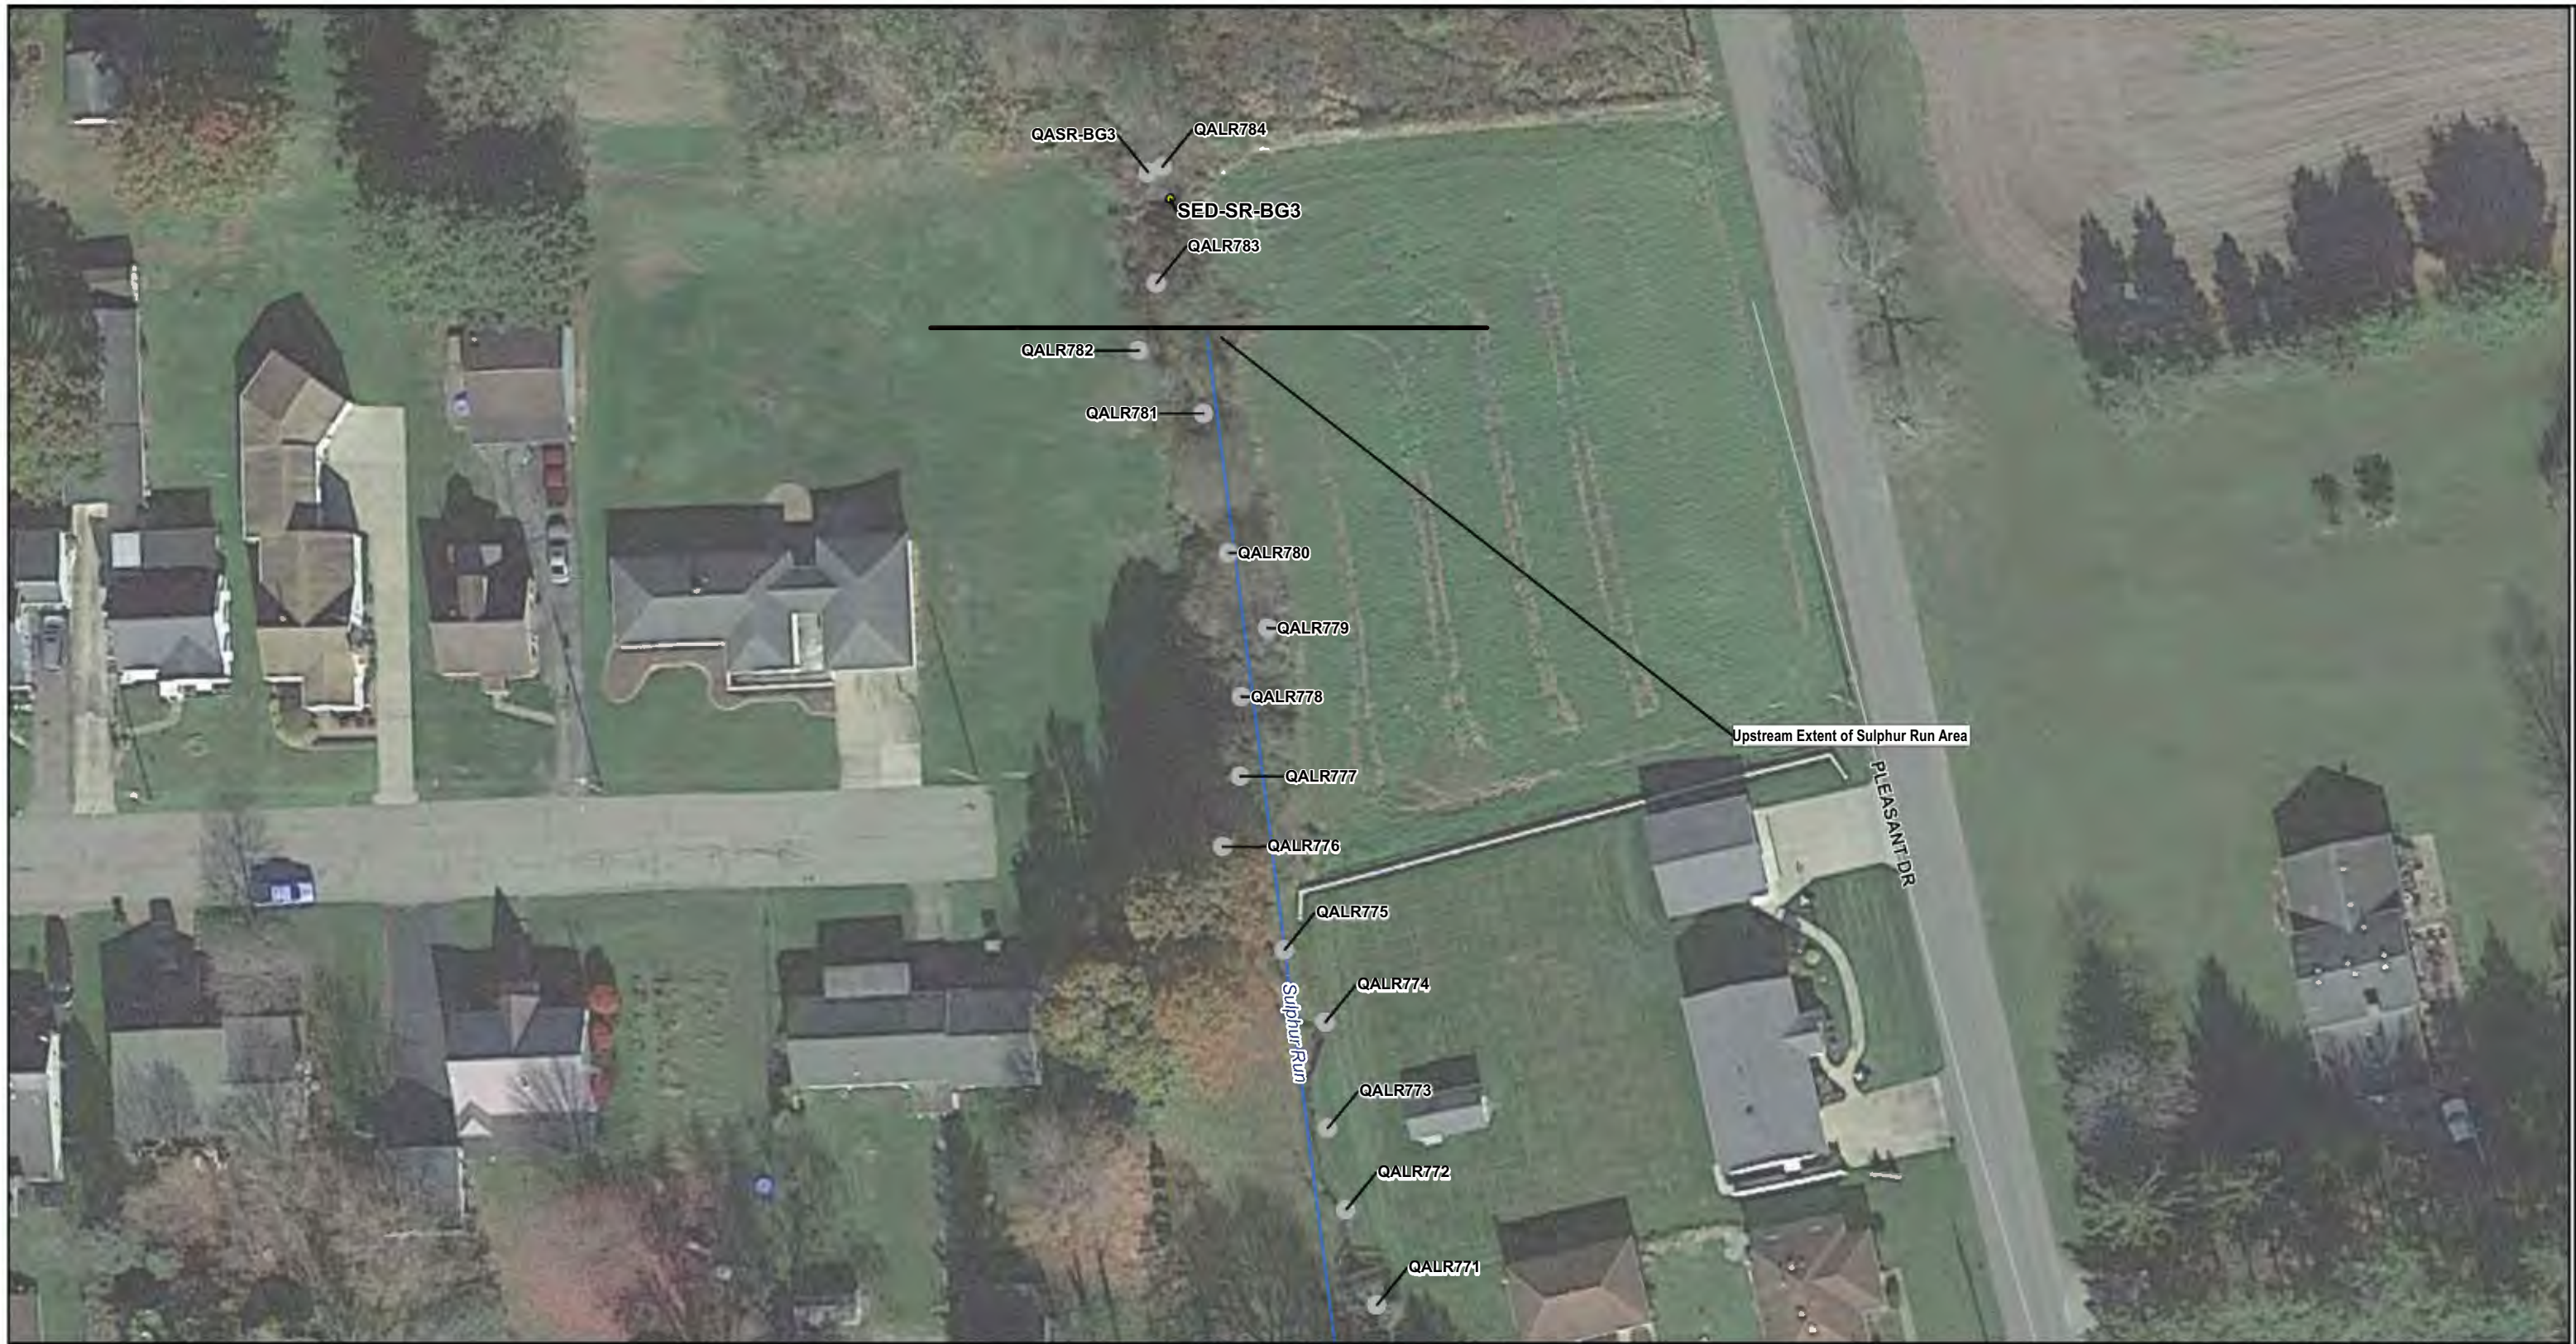
- See Figures 5 through 10 for visual detail of the areas for sediment mitigation. Figures 2-4 present data in the upstream portion of the Sulphur Run area (upstream of the railroad crossing) for reference.

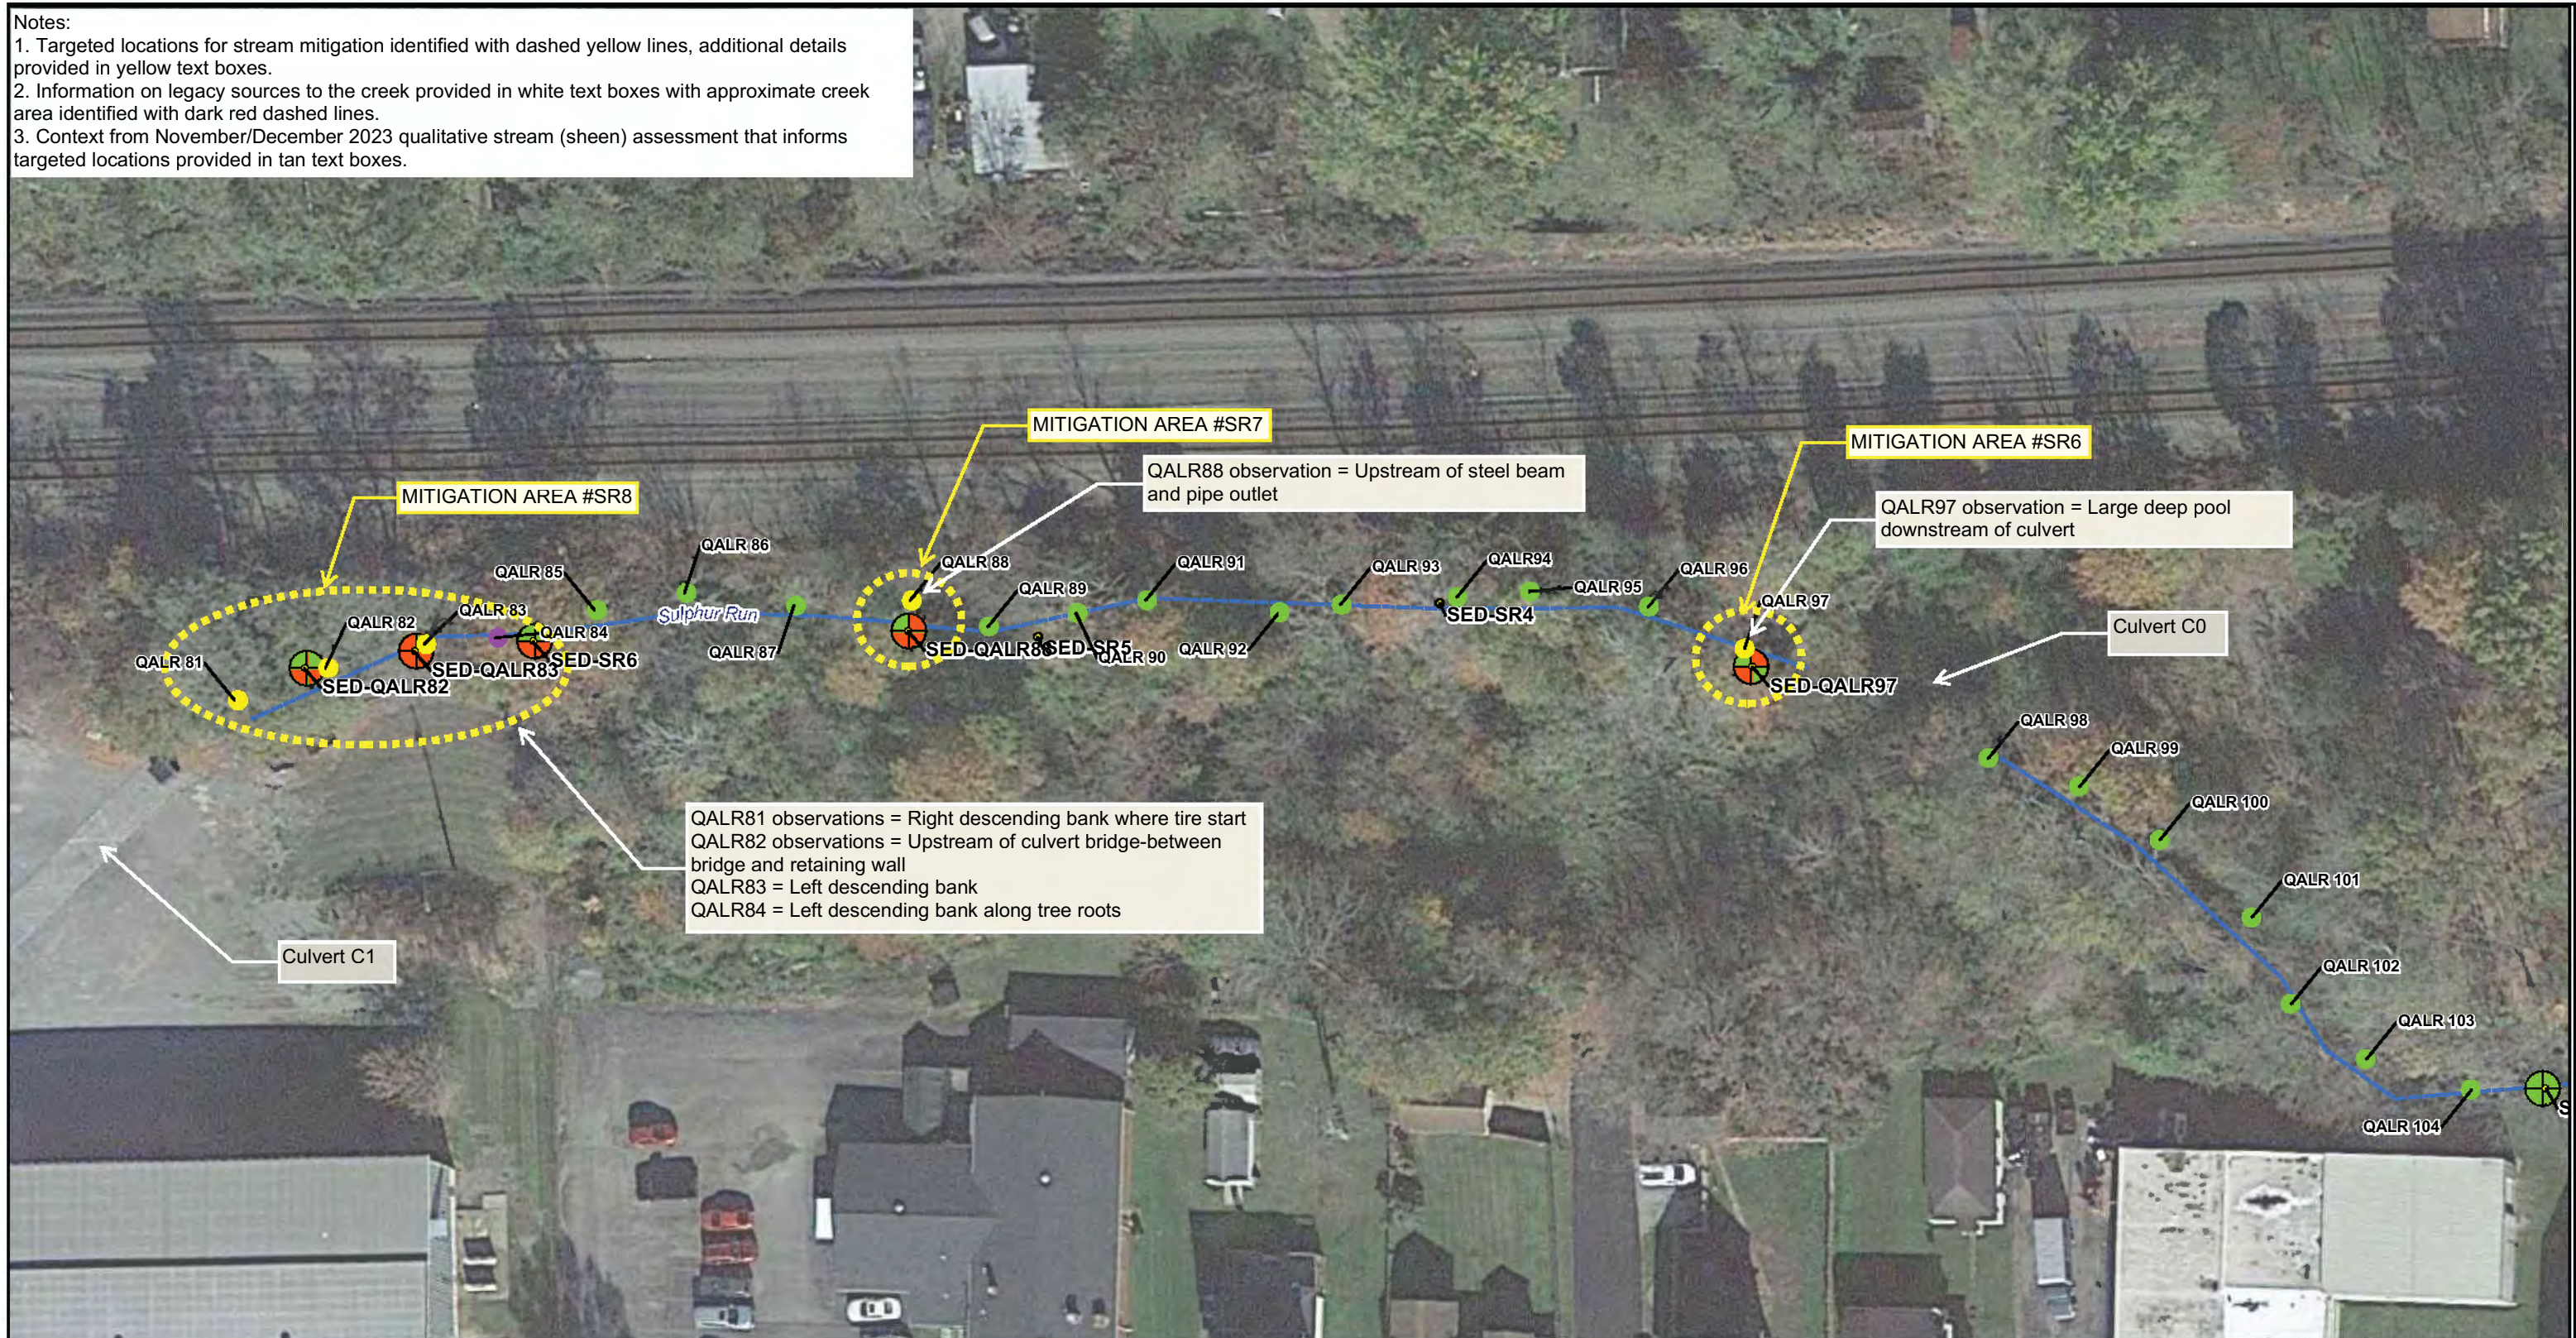
Areas within both Sulphur Run and Leslie Run requiring mitigation are shown on Figure 1. Areas of the affected streams that have observed sheen scores of 2 and 3 from the Qualitative Sheen Assessment and chemical exceedances in sediment of human health screening levels will be targeted. Areas of confounding sources of contamination in Sulphur Run are depicted in Figures 5 & 7 by red hatches.

- Specific areas within the flow path of oil discharged during the derailment that are known to have confounding sources of contamination will be addressed. These areas include the portion of the creek adjacent to the former Leake Oil gas station (see Figure 5) and areas with an unknown black product/liquid unrelated to the derailment that surfaced during air knifing activities in March 2023 (see Figure 7).

- In Sulphur Run from its confluence with Leslie Run to 1,000 feet upstream beyond the confluence with the Unnamed Tributary of Sulphur Run (located just north of the railroad tracks), which is commonly called the North Ditch (see Figure 5 for the upstream demarcation).
- In Leslie Run from its confluence with Bull Run to 1,000 feet upstream beyond the confluence with Sulphur Run (see Figure 16 for the downstream demarcation / start of the qualitative re-assessment).

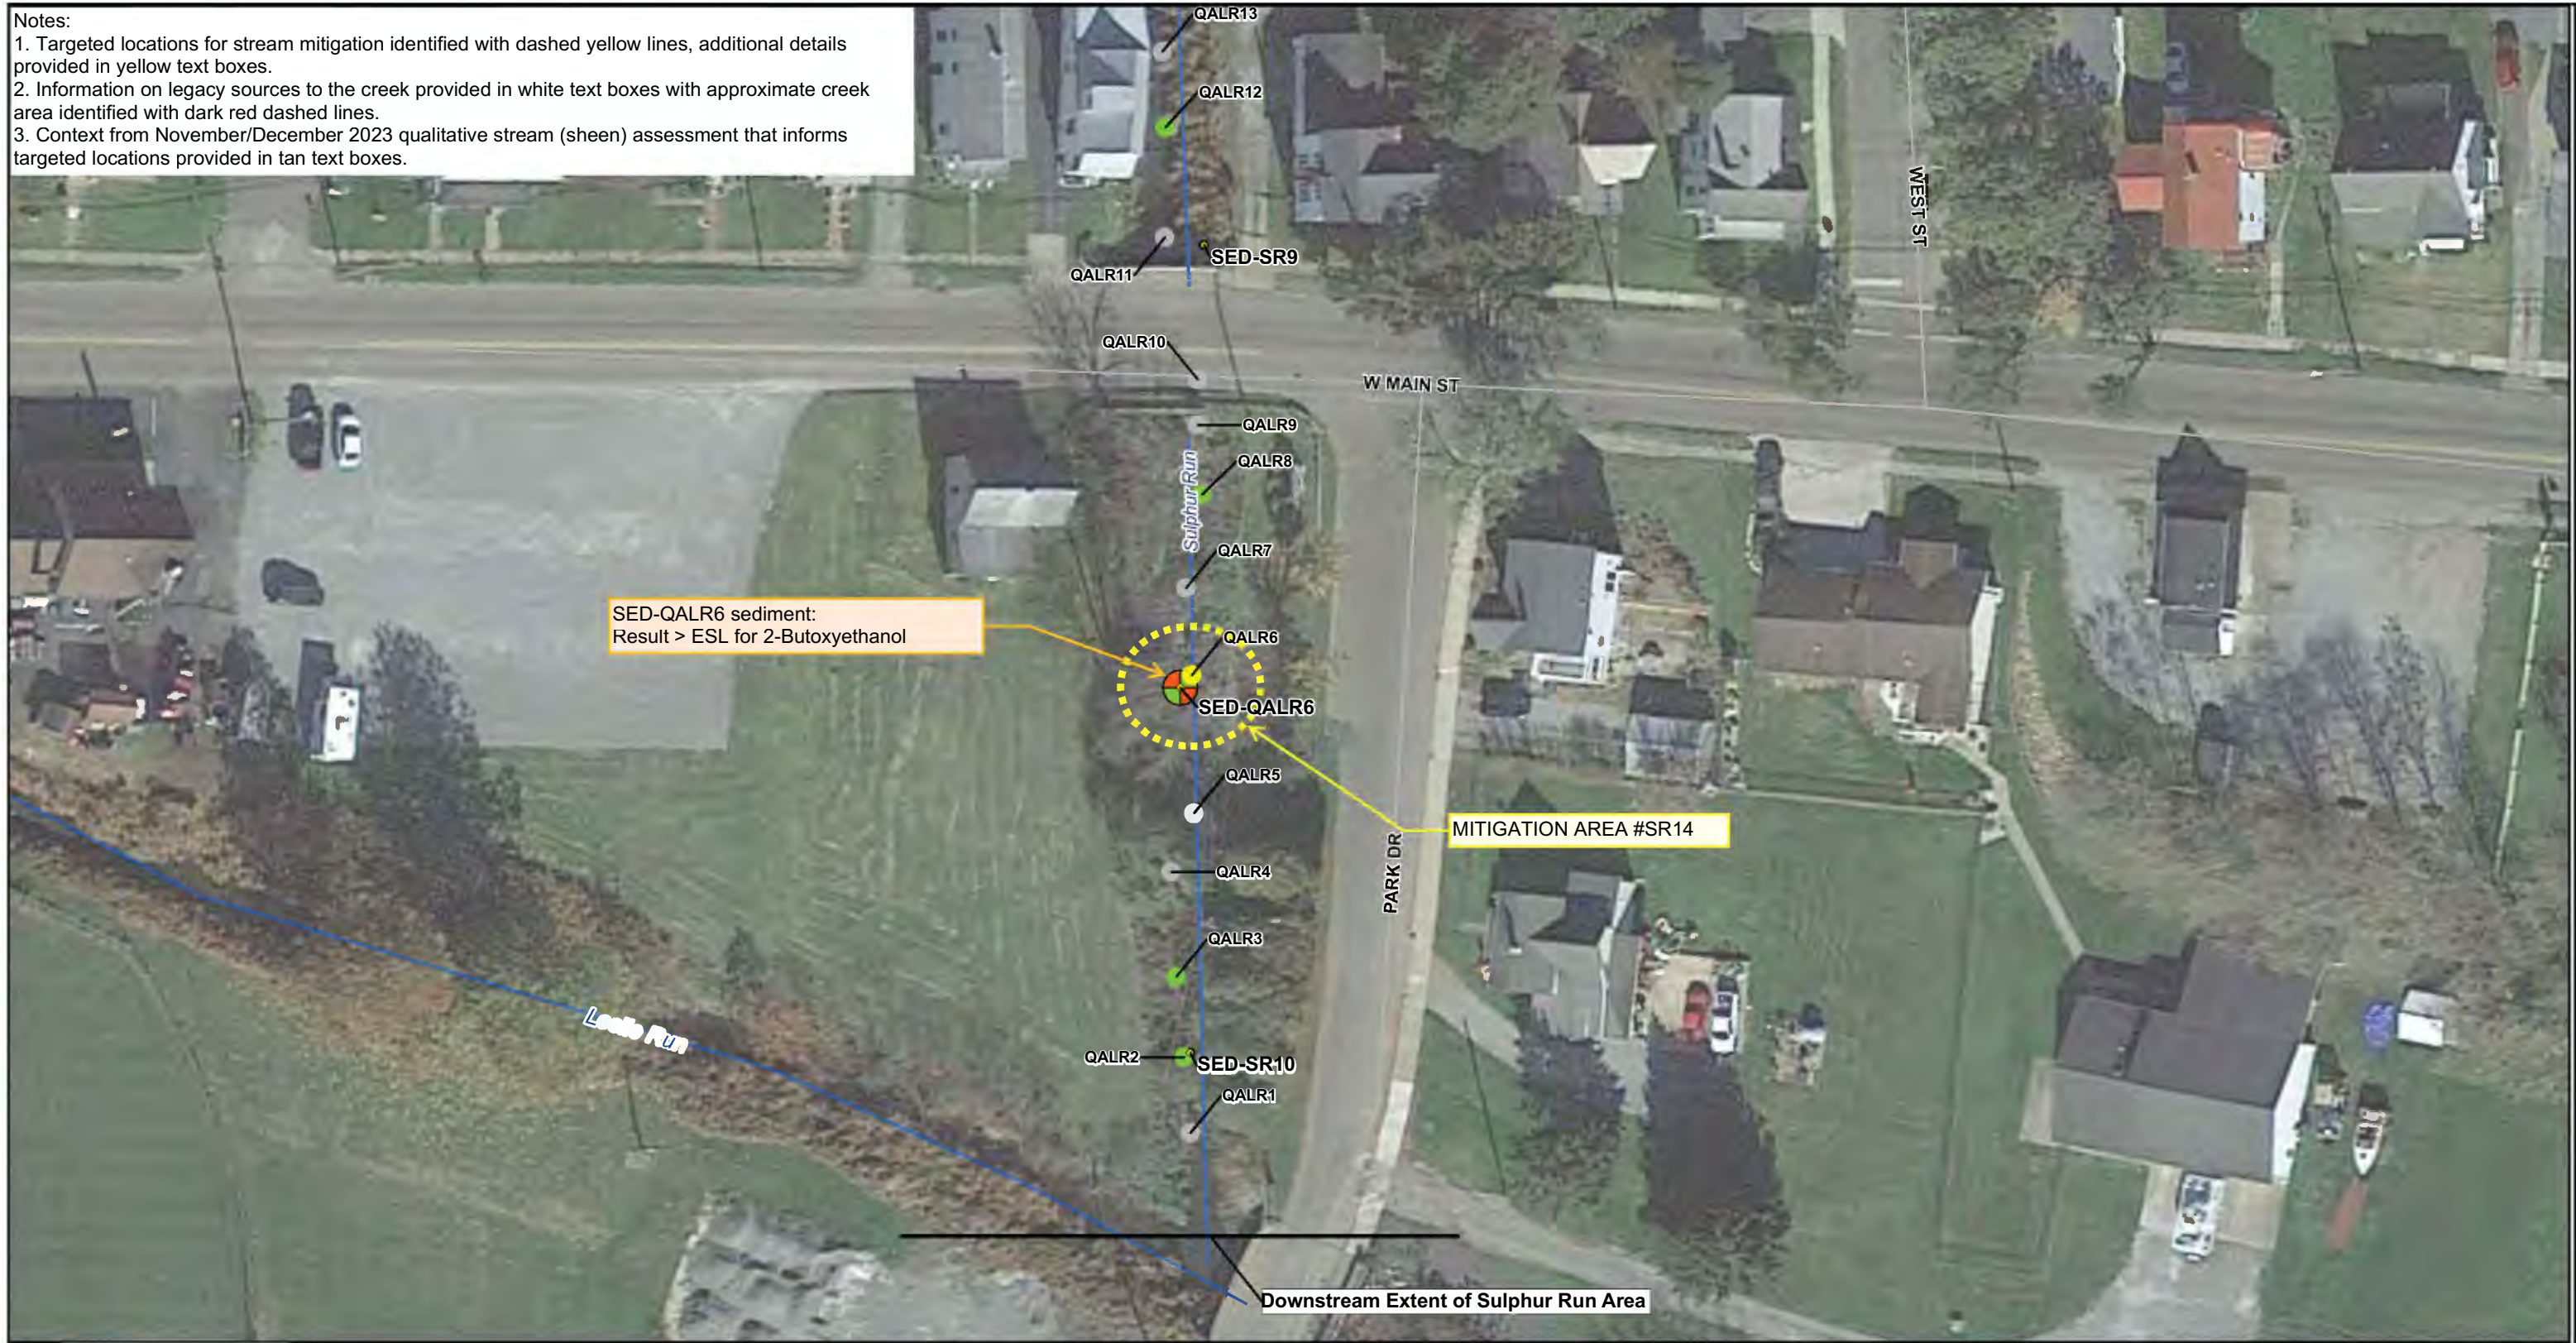
NORFOLK SOUTHERN EAST PALESTINE, OHIO	
<b>SULPHUR RUN - DETAIL 9</b>	
	FIGURE <b>10</b>

SED-QALR6 sediment:  
 Result > ESL for 2-Butoxyethanol

MITIGATION AREA #SR14

Downstream Extent of Sulphur Run Area

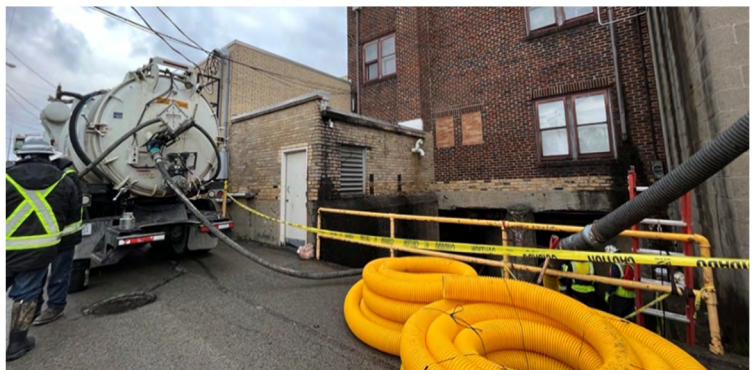
Vacuum extraction with culvert entry, which is the current practice, has been evaluated and the proposed approach for going forward has been modified. This modification consists of installing a stream diversion for flow around the immediate work area utilizing a foam-constructed curb – similar to those used for secondary containment berms. This foam diversion is easily relocatable and avoids having to carry-in sandbags for stream diversion. At the downstream end of the work area within the culvert, absorbents will be installed to provide sheen containment. Once these work area controls are in place, vacuum extraction of sediments may be performed using a 4-inch diameter vacuum hose. The hose is attached to a vacuum truck and can extend as far as 400 feet while remaining effective at removing sediment. Removed sediment and water is then collected in the vacuum truck and transported to a dewatering roll-off container in preparation for disposal.

*Image 1 – Photo showing vacuum truck and cleaning hose extending into culvert.*

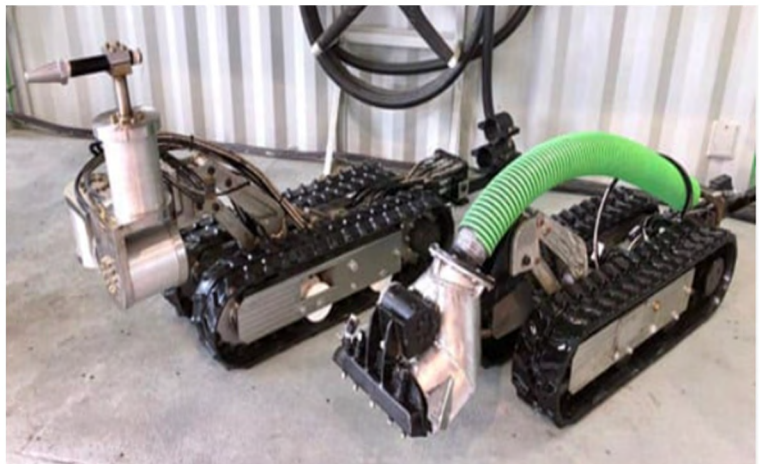
The limitations of the robotic vacuum include unit availability, limited travel distance, limitations on the debris it can remove, and maneuverability around obstructions or into tight corners. As noted above, this option would still require workers to enter the culvert to visually confirm that cleaning has been completed, capture any missed areas, remove stuck robot, and setup and remove diversions and containment. These activities would require approximately the same amount of time workers are in the culvert as vacuum extraction with culvert entry. Reduction of worker time in the culvert will not be significant as there is a minimal amount of sediment to be removed, but the time for the robot to remove that sediment will be much longer than a worker due to nature of using robotics. Ingress and egress are also more challenging than typical vacuum extraction in that the robot would likely have to be lifted into stream as the bank may be challenging to maneuver.

*Image 2 – Photo showing robotic vacuum equipment.*

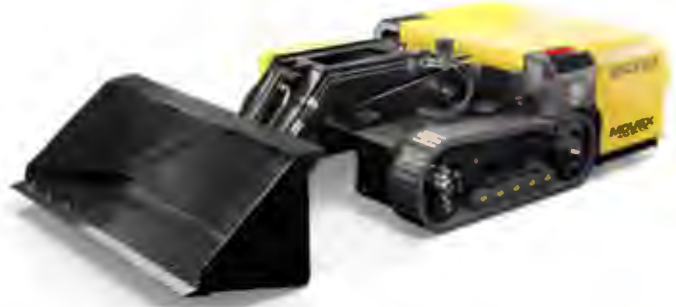
The limitations for this option include ingress and egress from the stream, as the equipment would have to be lifted down into the stream. The equipment will not be effective at removing sediment from the culvert corrugations, has a limited travel distance of 300 feet, and potential to damage the culvert. Workers would also have to enter the culvert to install diversions and containment or a bypass to facilitate a safe water level for operation and enter the culvert to remove any obstructions not removeable by the loader. This would require similar or more time spent in the culvert by workers in support of this option compared to vacuum extraction with culvert entry. In addition, removing the sediment from the culvert with the loader would take longer than vacuuming it out due to the need to load the bucket, travel time in and out of the culvert, and limited amount of sediment to be removed.

**Image 3 – Photo showing battery operated loader.**

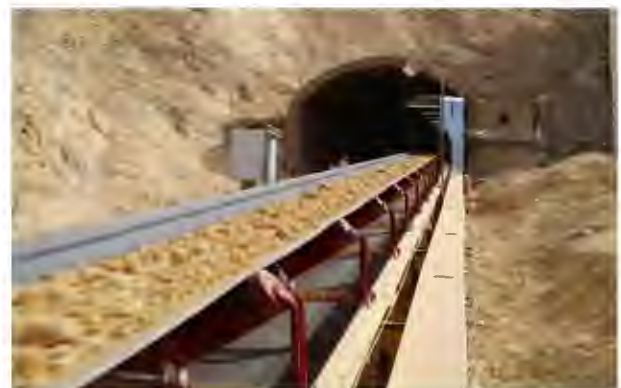
This option still requires workers to enter the culvert to install and load the conveyor belt and install bypass and containment controls. The equipment would have to stay in place for the duration of the work. Aside from not needing this level of sediment conveyance given the limited volume of sediment anticipated to be removed, ingress and egress of the equipment would be impractical on a daily basis and it may get damaged or obstruct flow during a storm event. The labor in the culvert to set up the equipment would also be significant. Further, powering such a system must be considered and its presence may obstruct worker movement within the culvert.

**Image 4 – Photo showing a conveyor system. Temporary conveyor system fabrication may vary.**

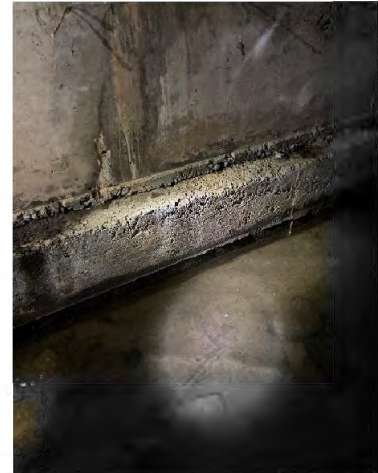
Image 3 – Scour at the Foundation

Structurally, no significant areas of concern were identified during the visual assessment of Culvert C1. Expected “wear and tear” was observed, but no damage or deformation that could lead to concerns of reduced structural performance. No signs of movement or other distress were noted. While some potential maintenance issues have been identified (scour, beam protection), these issues should not prevent remediation efforts from proceeding. However, remediation efforts should not include actions (i.e., significant material removal from bottomless sections) that may worsen these conditions.
