**Old Church Rock Mine
Eastern Abandoned Uranium Mine Region**

**Old Church Rock Mine
Removal Assessment Report**

August 25, 2023

**Submitted to
U.S. Environmental Protection Agency**

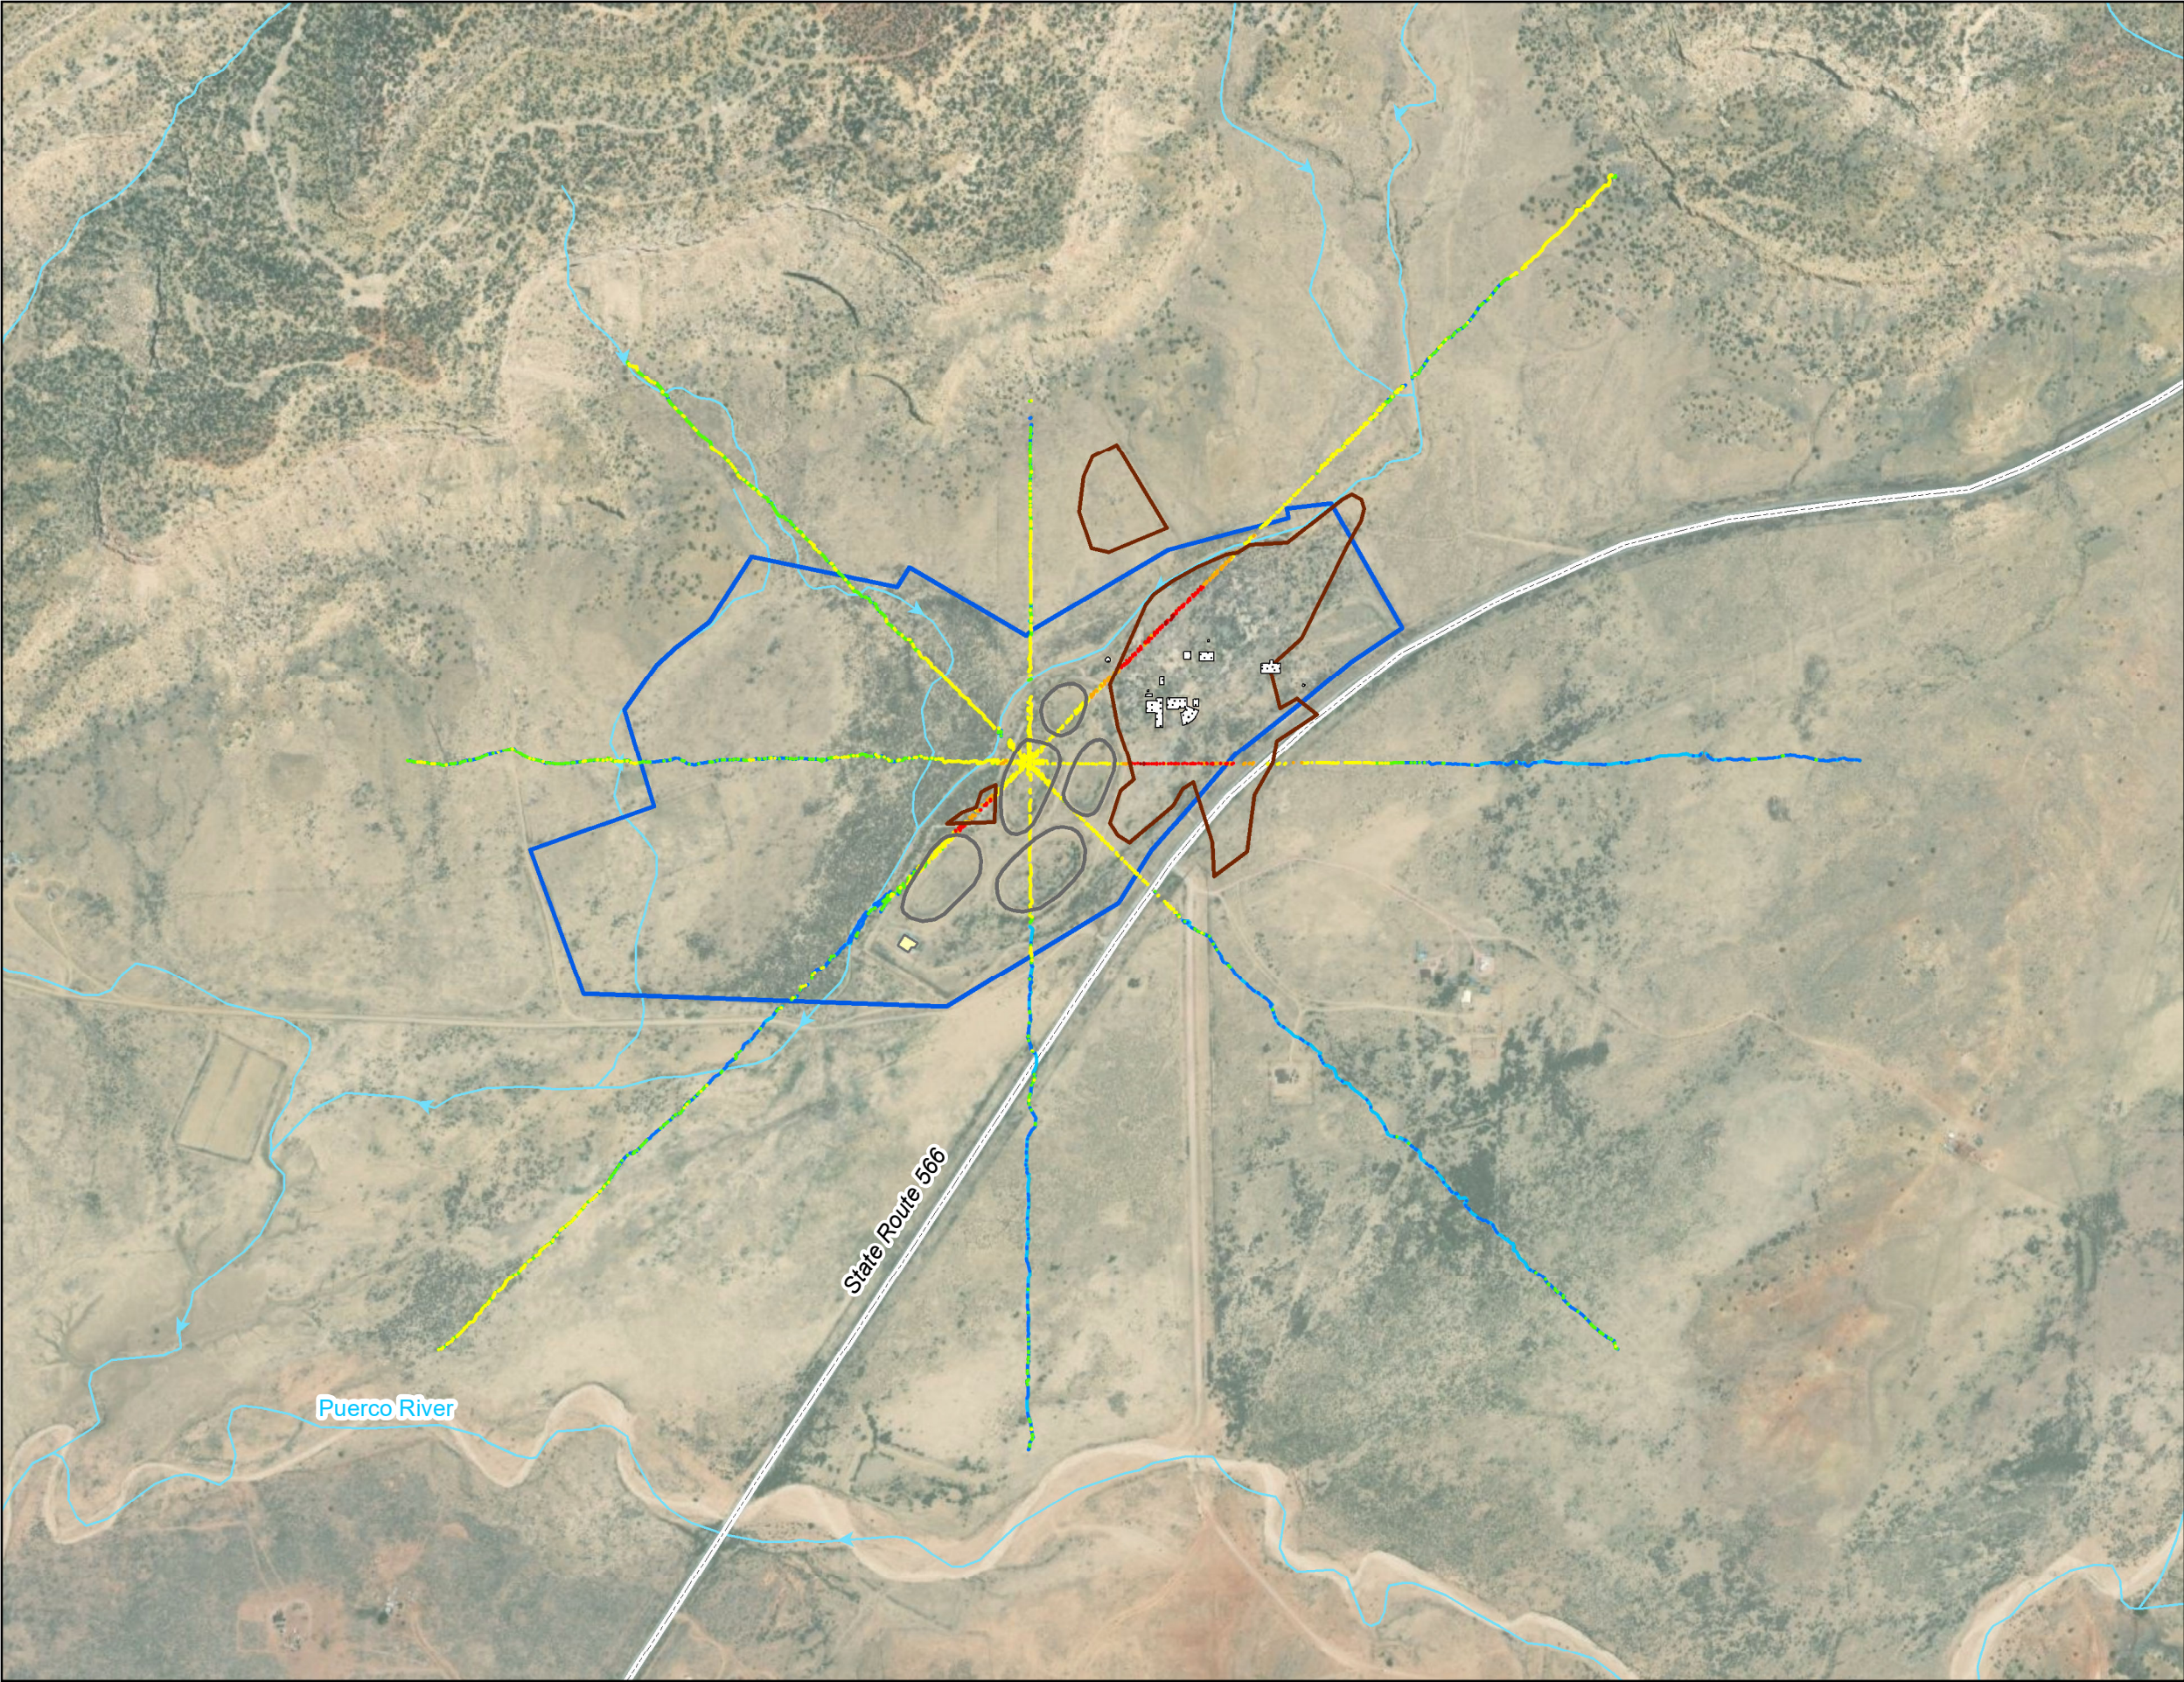
Figure 11 shows the gamma radiation survey results for the eight radial transects to assess windblown contamination at OCRM. Each radial transect extended until the gamma IL calculated from the background investigation was met or until terrain conditions halted the survey.

Except for the northern and southwestern radial transects, measurements below the gamma BTV were not achieved inside of the fenced area. The north and northeast radial transects both included segments measuring below the gamma BTV, but after a duration, the observed gamma radiation levels increased back above the gamma BTV. In both cases, the radial transect approached a geologic contact between the quaternary alluvium that dominates the OCRM area and Mancos Shale for the north radial transect and landslide deposits for the northeast radial transect.

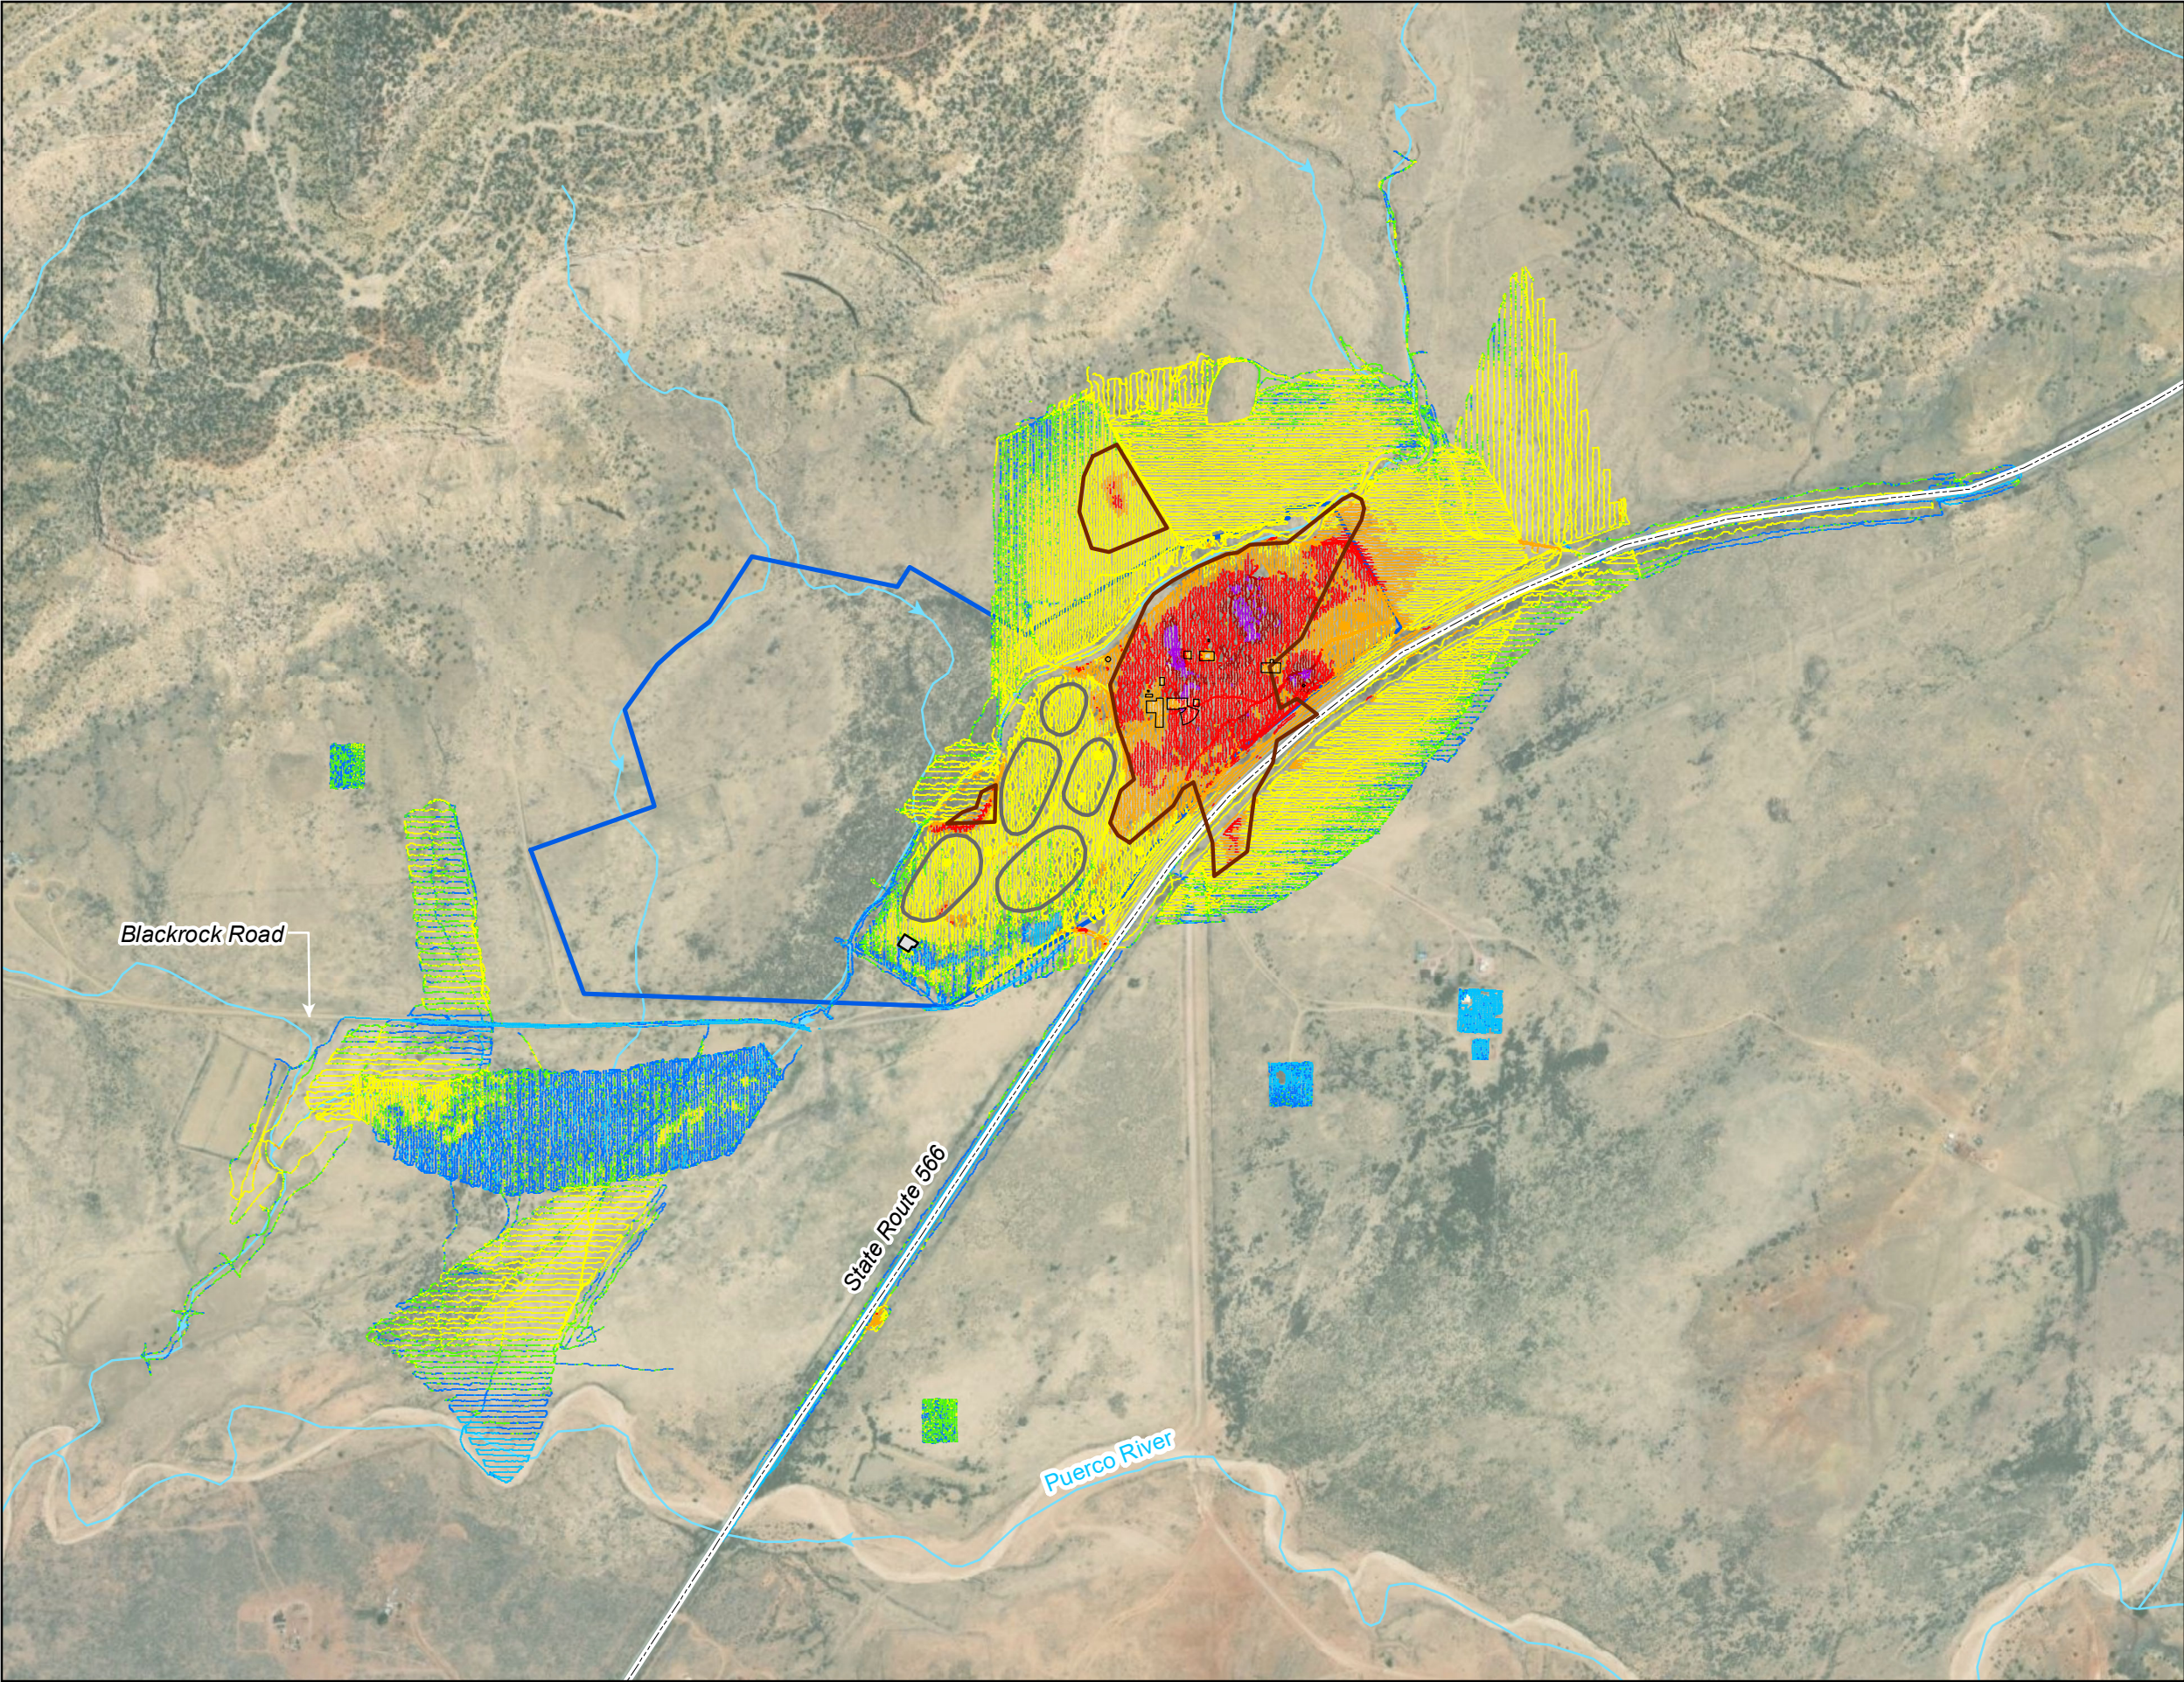
Figure 14 shows the gamma radiation survey results within the OCRM fenced area, which contained the highest gamma rates observed during the removal assessment. Contamination was largely centered around the existing concrete slabs, indicating previous mine work locations. North of the arroyo, the observed elevated gamma radiation levels identified a waste pile from previous mine work. Gamma survey results near the western fence line indicated a line of elevated gamma radiation levels. Field observations identified the area as a berm composed of mine waste with ore rock buried amongst the berm (see Photographs 4 and 5 in Section A-4 in Appendix A). The full extent of the berm, both inside and outside the fenced area, is shown on Figure 13, north-northeast of the ion-exchange building.
