TANK S-1
API-653 In-Service Inspection
September 15, 2020

Subject: In-service (External) API 653 inspection including Ultrasonic Thickness (UTT) Survey on Tank #S-1, located in Honolulu, Hawaii.

Tank ID: S-1
Built By: Pittsburgh Des Moines Inc.
Year Built: 1996
Product: Potable Water
Product SPG: 1.00
Capacity: 125,000 Bbls.
Size: 165' Diameter x 40' Height

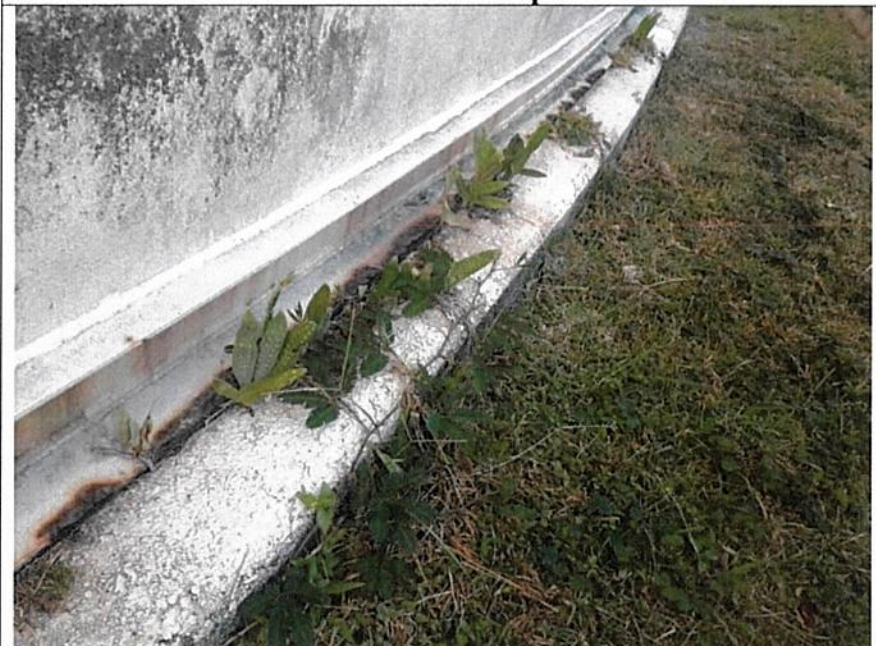
Base of tank (typical)

The tank rested on top of an elevated concrete slab. The concrete sat approximately 6" above grade. The existing concrete was found with slight cracking and spalling located randomly around the tank. Vegetation growth was noted around the base of the tank with some of the vegetation in direct contact with the tank floor. No tank grounding was associated with the tank. One leak detection port was associated with the tank; it was found dry with no obvious evidence of leakage from the tank floor.

1. Mechanically clean and recoat the scattered areas of active localized corrosion found scattered across the tank shell and projection plate on both the top and bottom side, using an approved coating procedure and specification by NAVFAC.
2. Remove the vegetation found around the base of the tank.

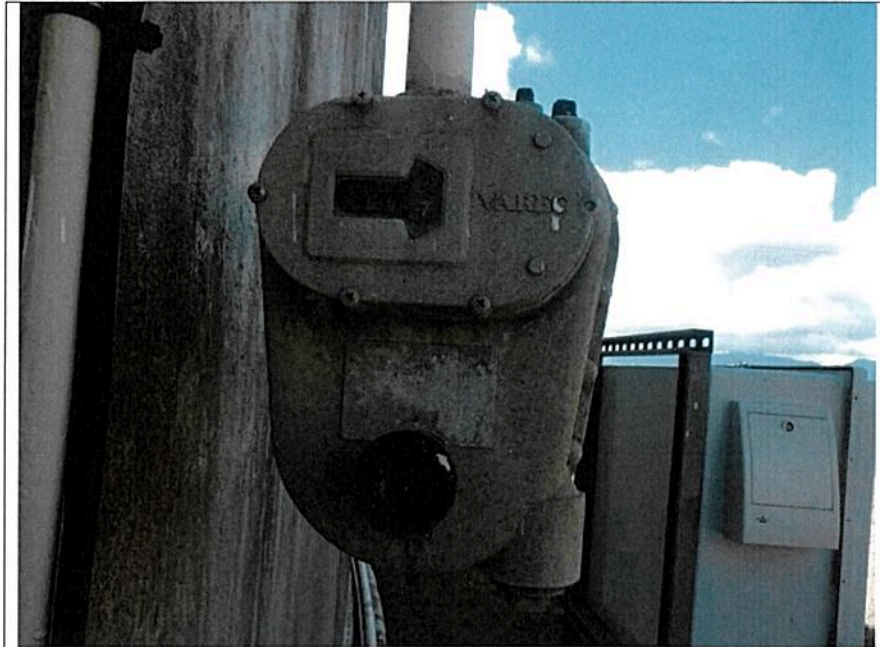
Varc gauge

The Varec-gauge was found on the west side of the tank shell. The gauge was showing a product height of 2'-7" with the bump check not being operational at the time of inspection.

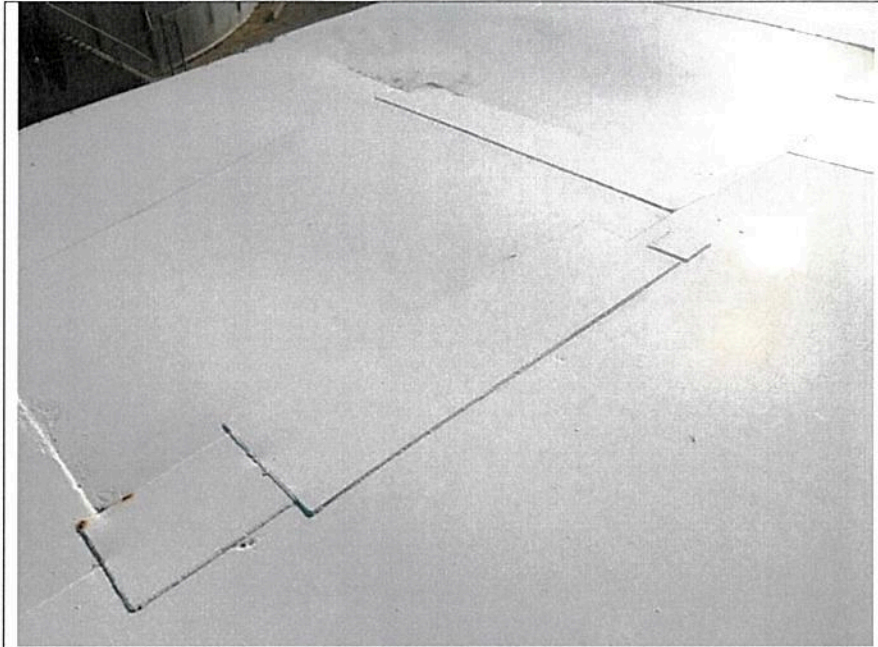
Tank roof plates

The tank roof had been recently recoated. Several areas of the tank roof were experiencing light to moderate coating failure with active corrosion present underneath. Numerous previous repairs were completed on the tank roof after severe active corrosion was identified on the previous drawing. Two (2) areas of the tank roof were identified with severe isolated corrosion and were identified on the tank roof as well as the attached drawing. The two identified areas were marked up to have lap patches installed over the active corrosion. The identified areas of significant corrosion on the tank roof were identified with X and Y coordinates with the starting location being the south west corner of each individual roof plate, and extend to the center of the corroded area. One (1) area of coating failure and moderate active corrosion was found on the southern side of the tank roof along the peripheral edge of the tank and was identified on the associated drawing. Eight of the anode beds found on the tank roof were found with missing hardware, corroded base covers, or duct tape covering the tops, indicating a need to be repaired or replaced. Several areas of isolated pitting were also noted on the tank roof that had been arrested and recoated with no discoloration or further corrosion noted. The roof has one 24" center vent with the screen intact, clear, and secured. The flange of the vent base was found with active corrosion and slight loss of profile and knifing at the edge of the flange. A single 1" coupling on the southwest side of the tank roof was discovered with severe active corrosion with loss of profile to the coupling and attachment weld to the tank roof. The toe boards of the roof access handrailing system was found in direct contact with the tank roof on the north side. Several of the vertical handrail supports were found with active severe corrosion with thru-wall indications noted.

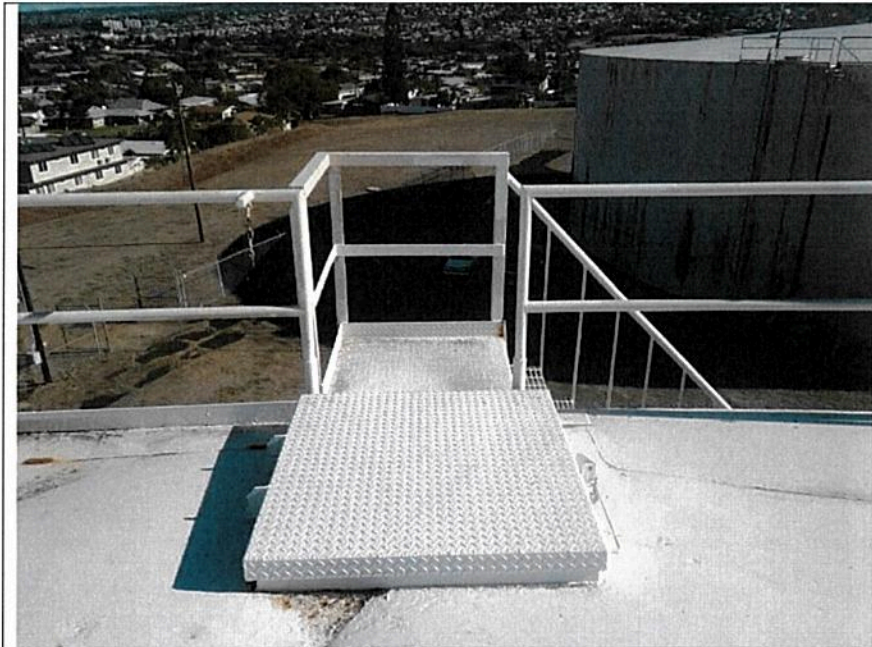
Roof access platform

The stairway access to the roof was fully coated with several areas of discoloration found due to active corrosion. The roof access platform was a diamond plate base with light coating failure and active corrosion found around the edge of the plate.
