**TANK S-2  
API-653 In-Service Inspection  
September 15, 2020**

**Subject:** In-service (External) API 653 inspection including Ultrasonic Thickness (UTT) Survey on Tank #S-2, located in Honolulu, Hawaii.

Tank ID: S-2  
Built By: Morse Construction Group  
Year Built: 1996  
Product: Potable Water  
Product SPG: 1.00  
Capacity: 125,000 Bbls.  
Size: 165' Diameter x 40' Height

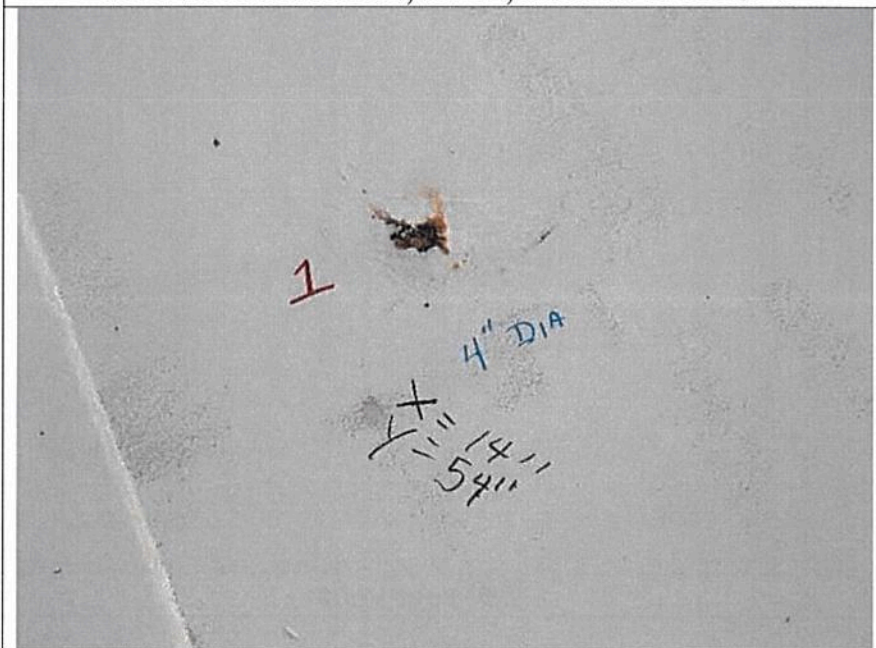
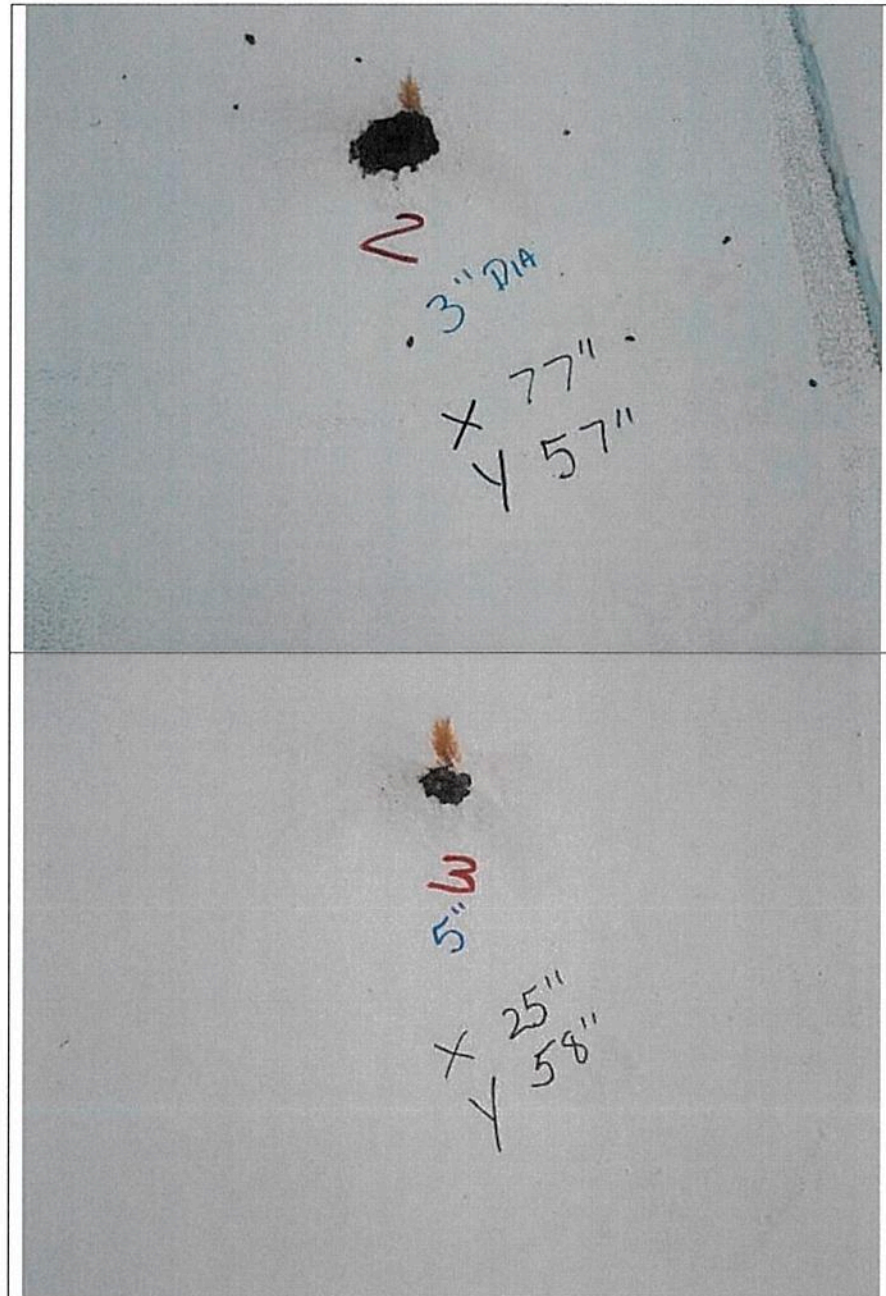
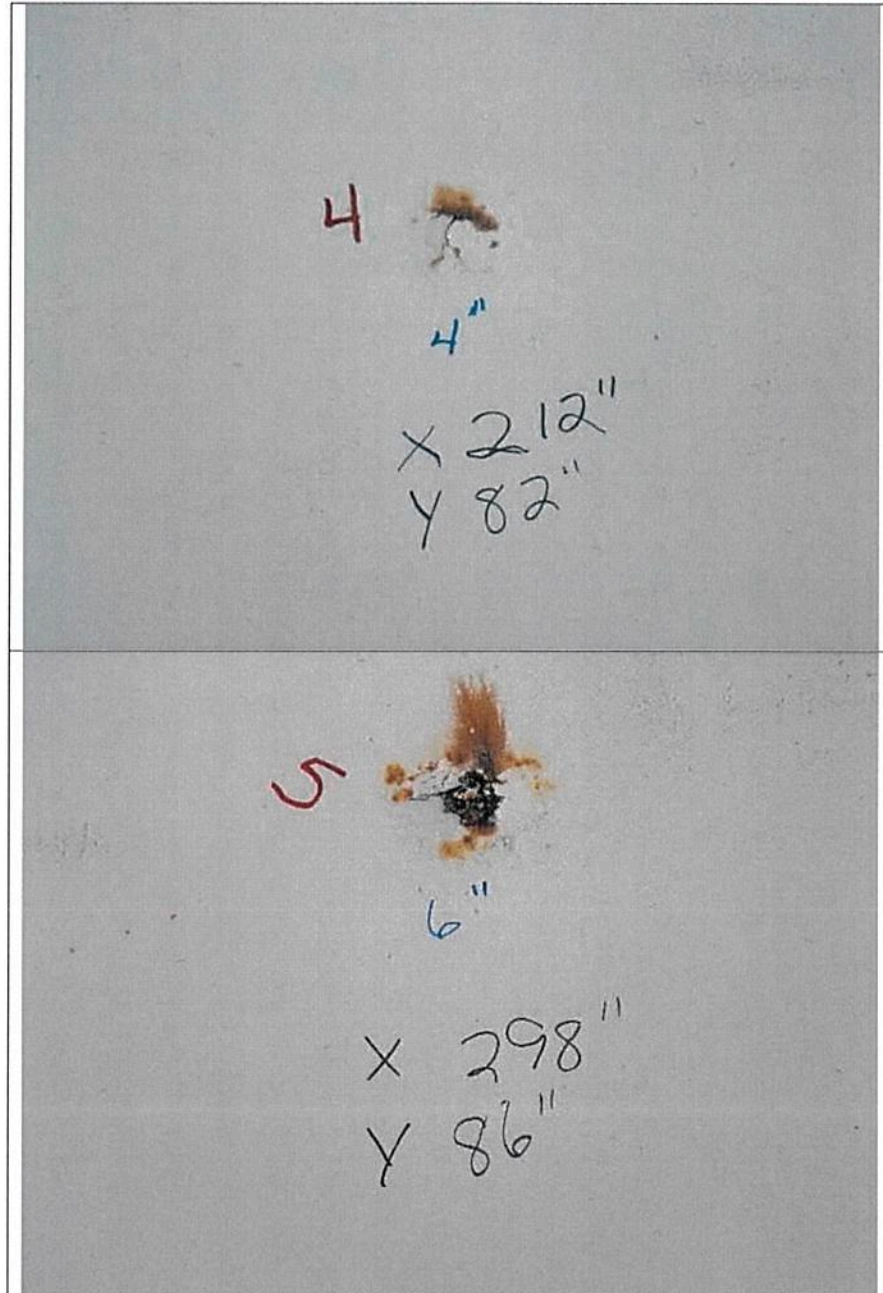
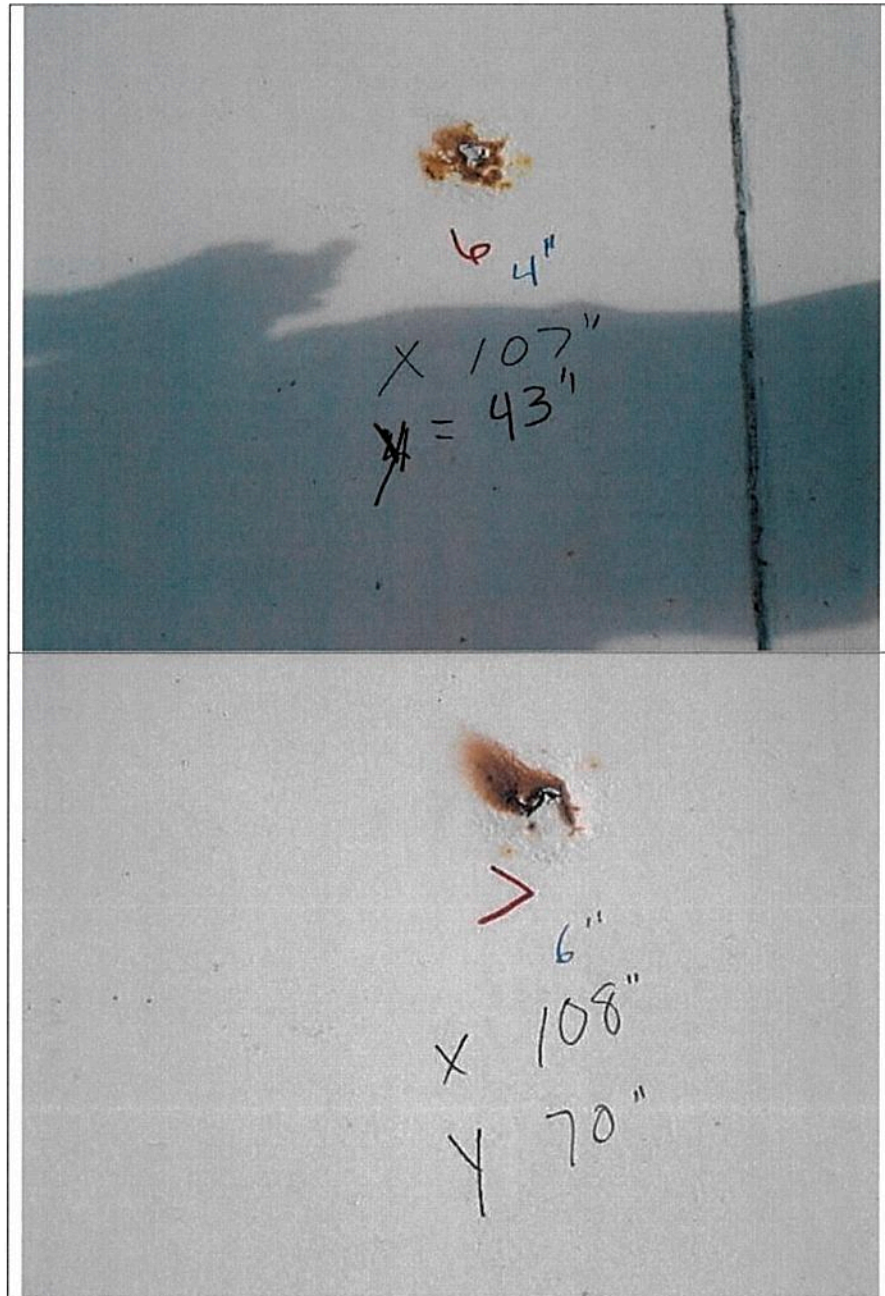
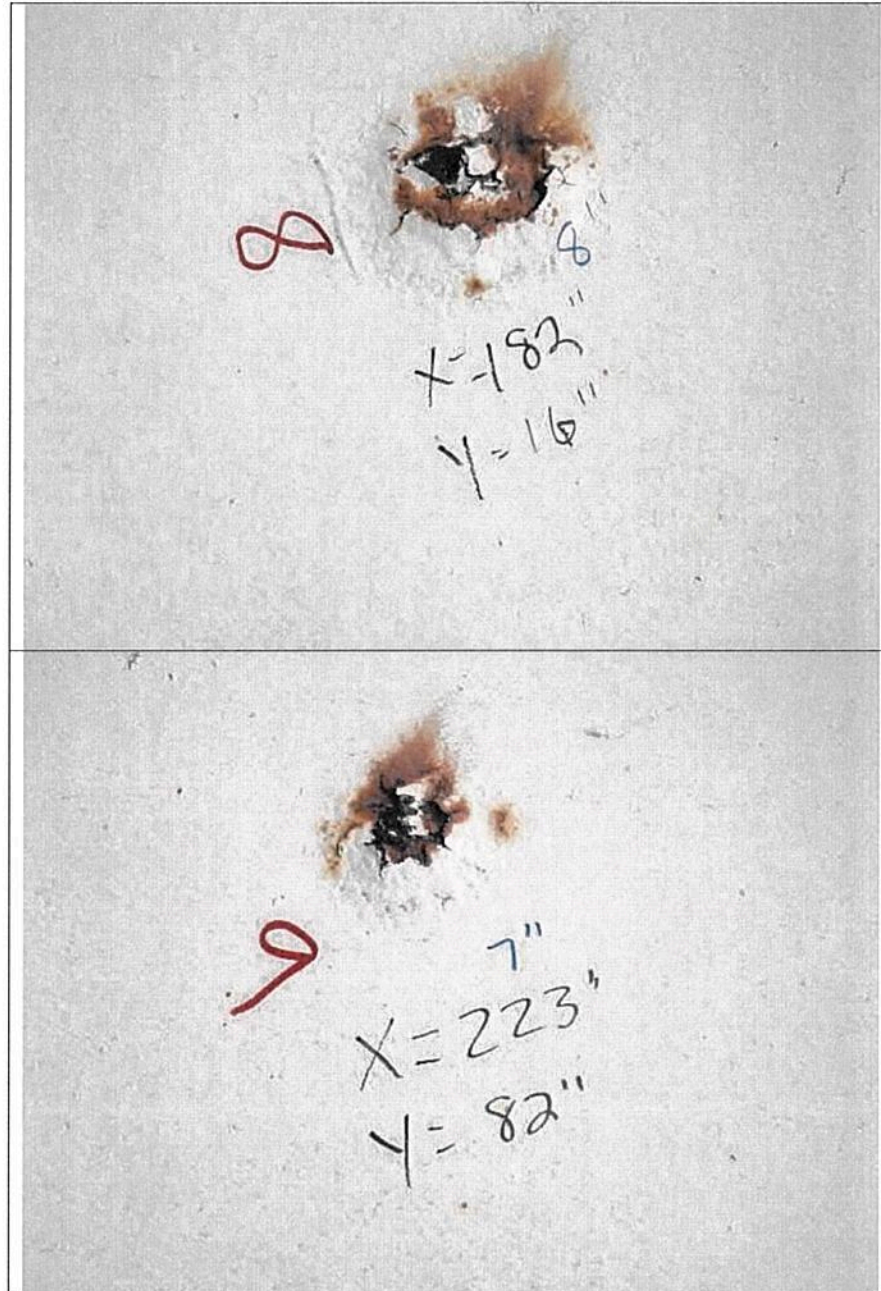
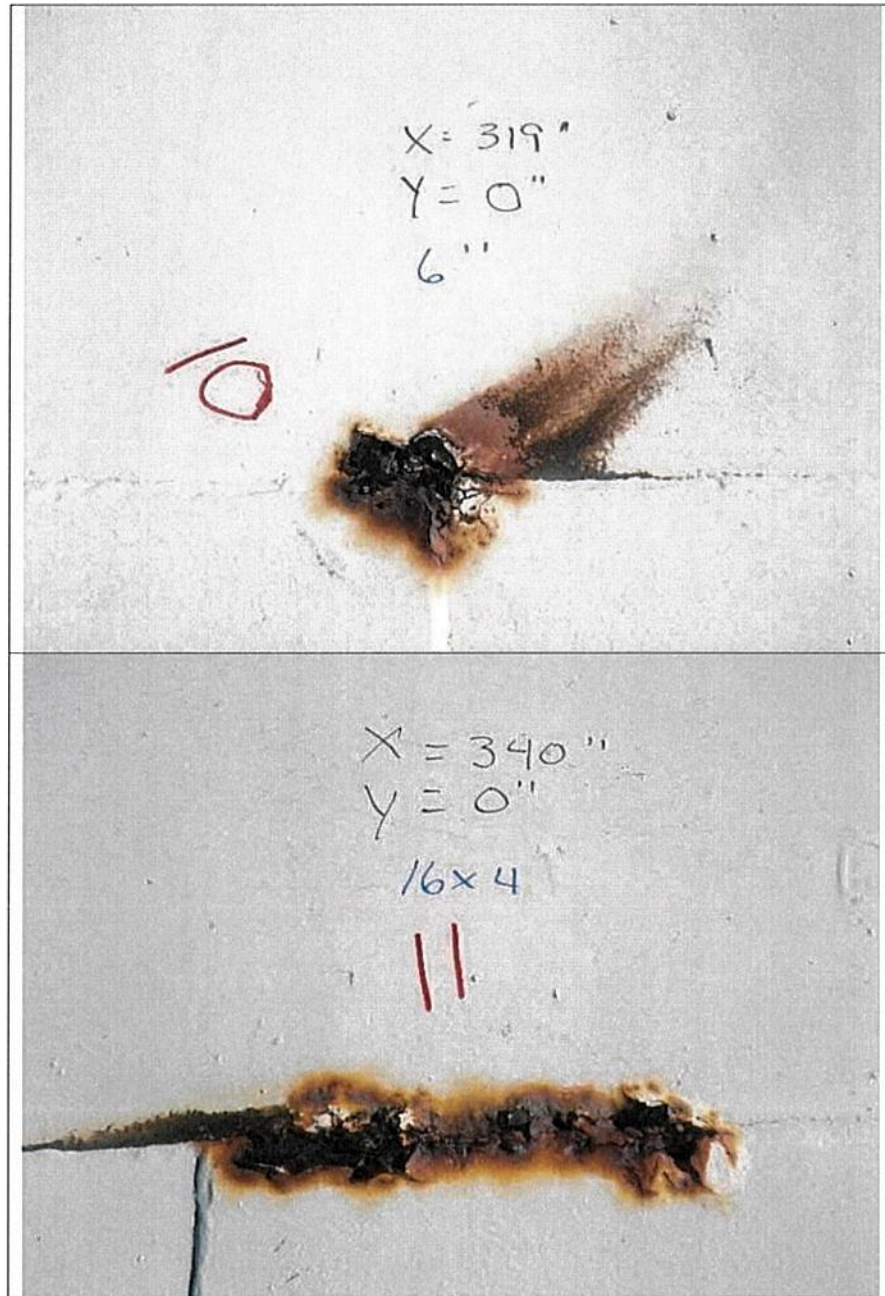
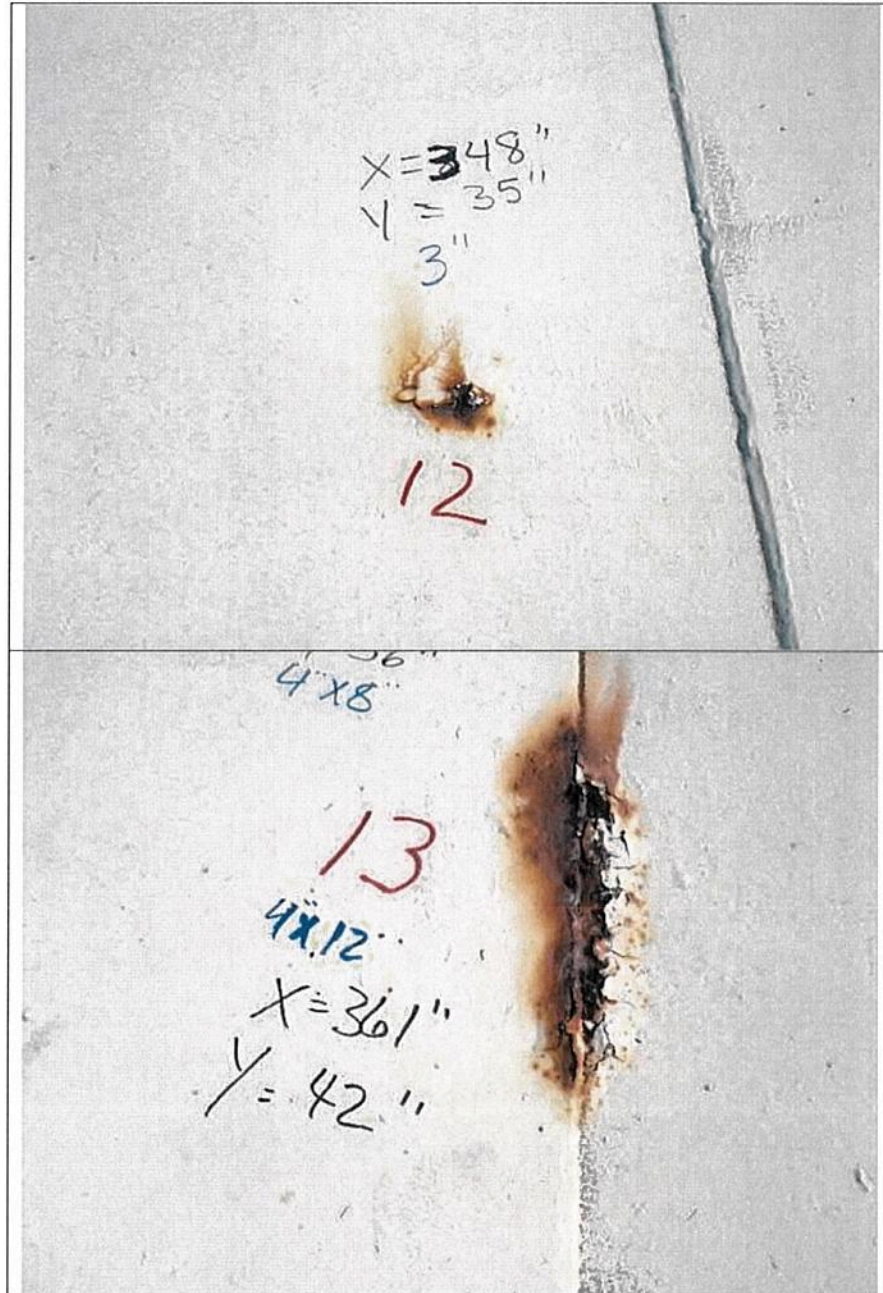
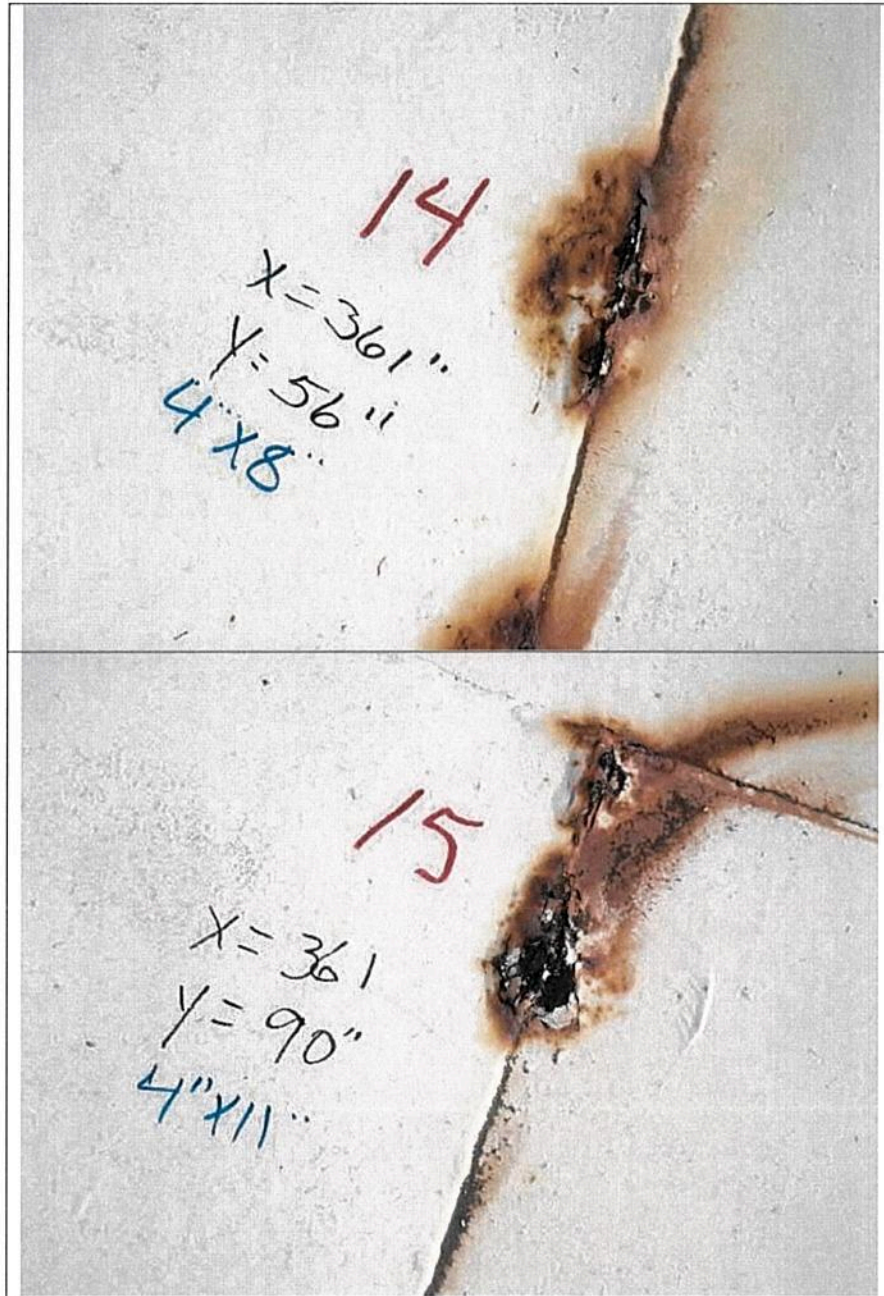
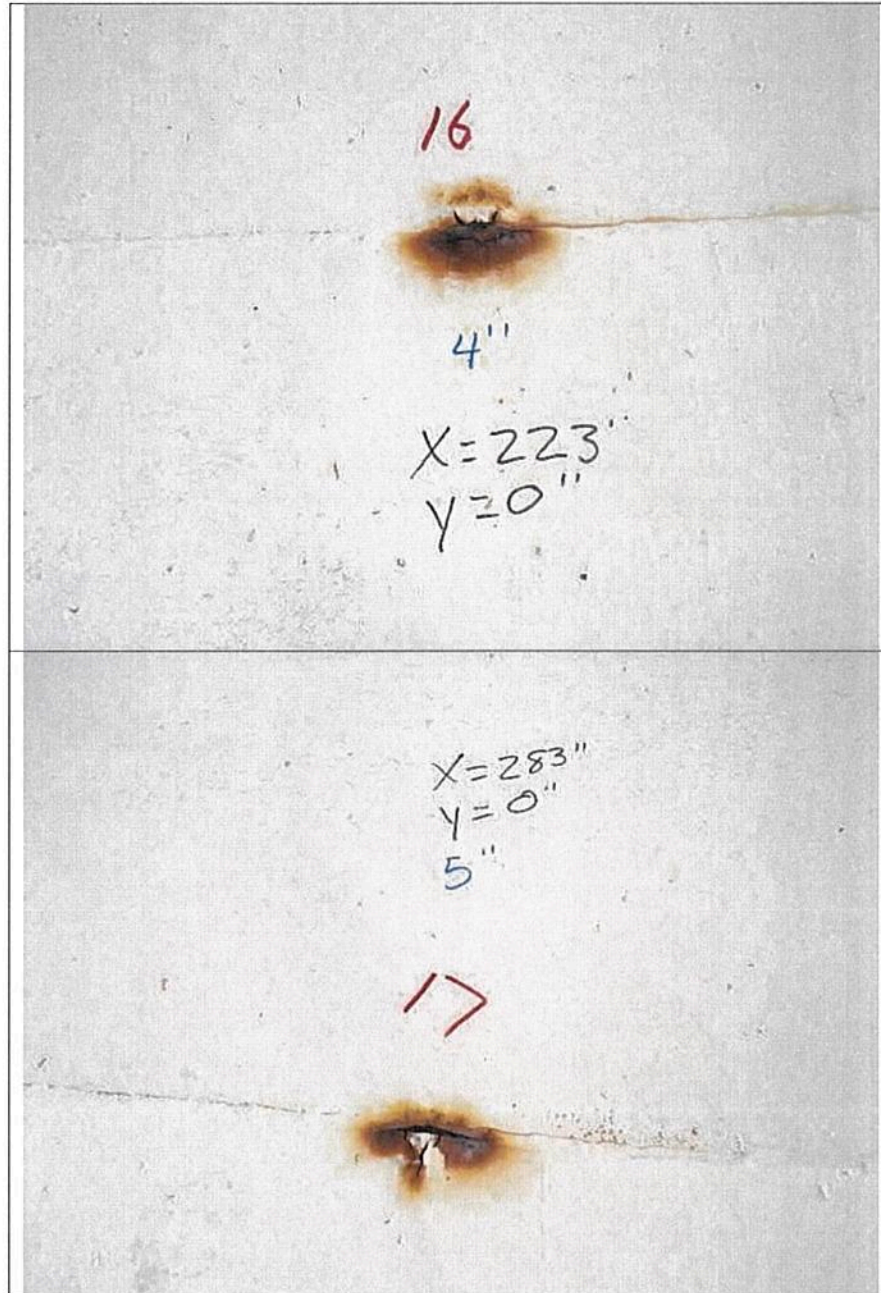
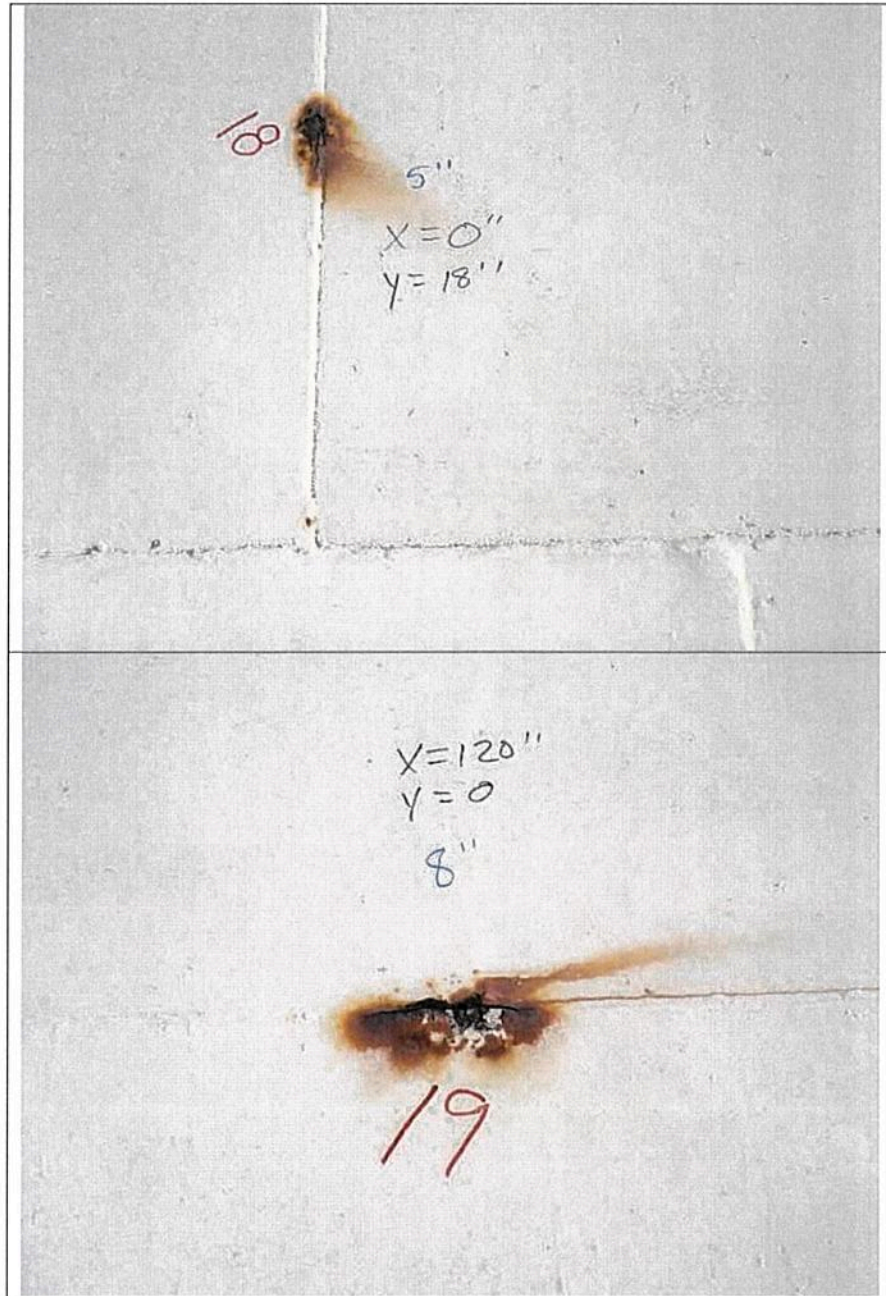
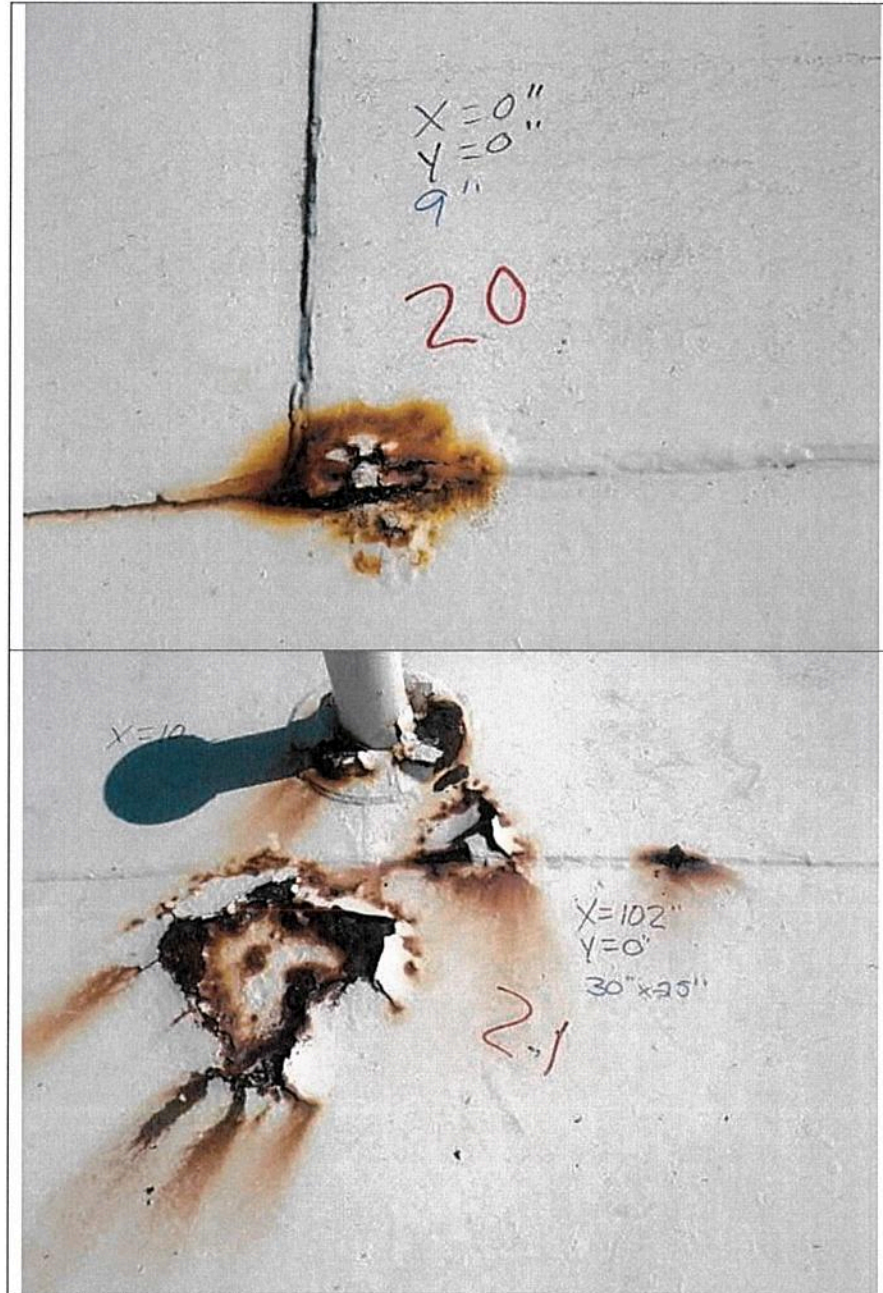
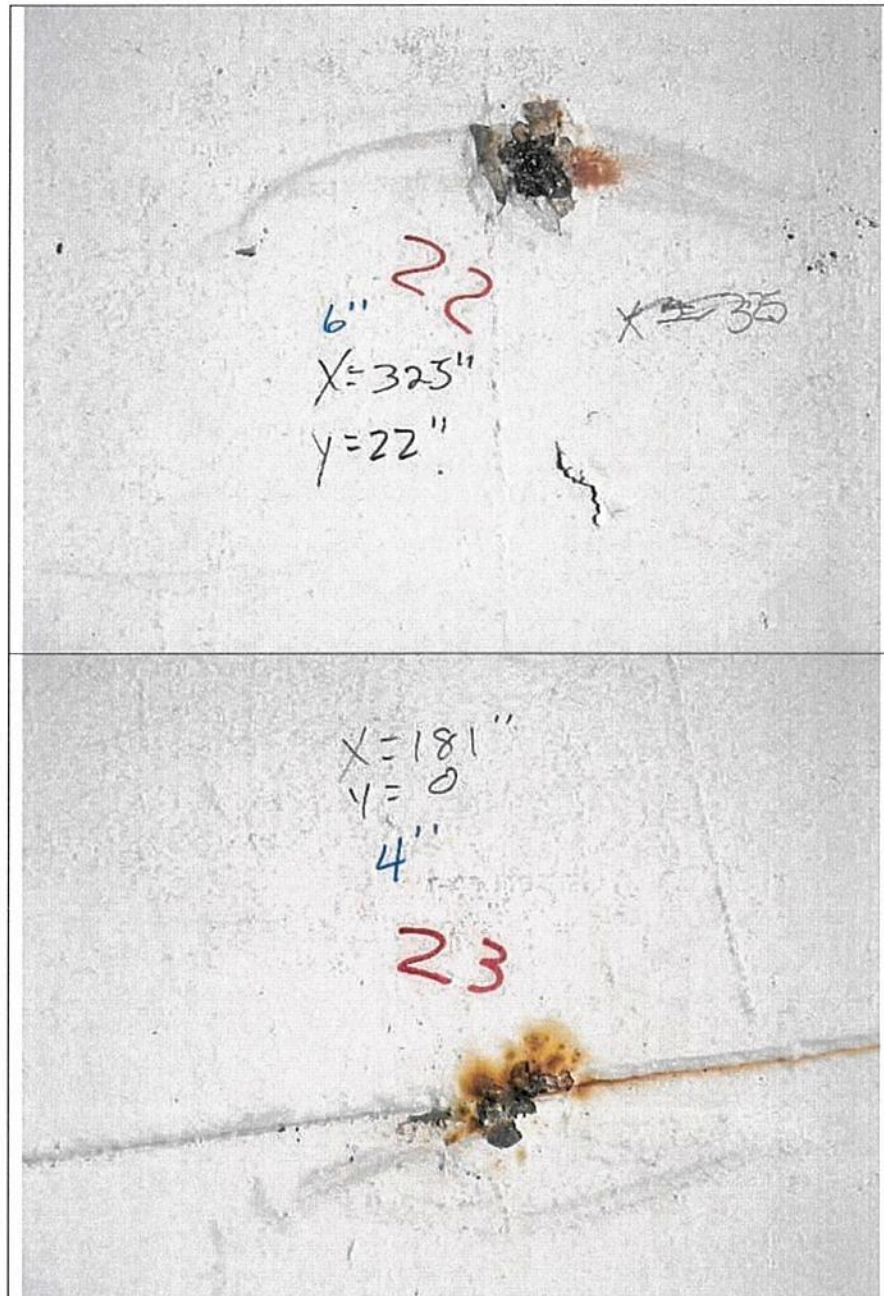
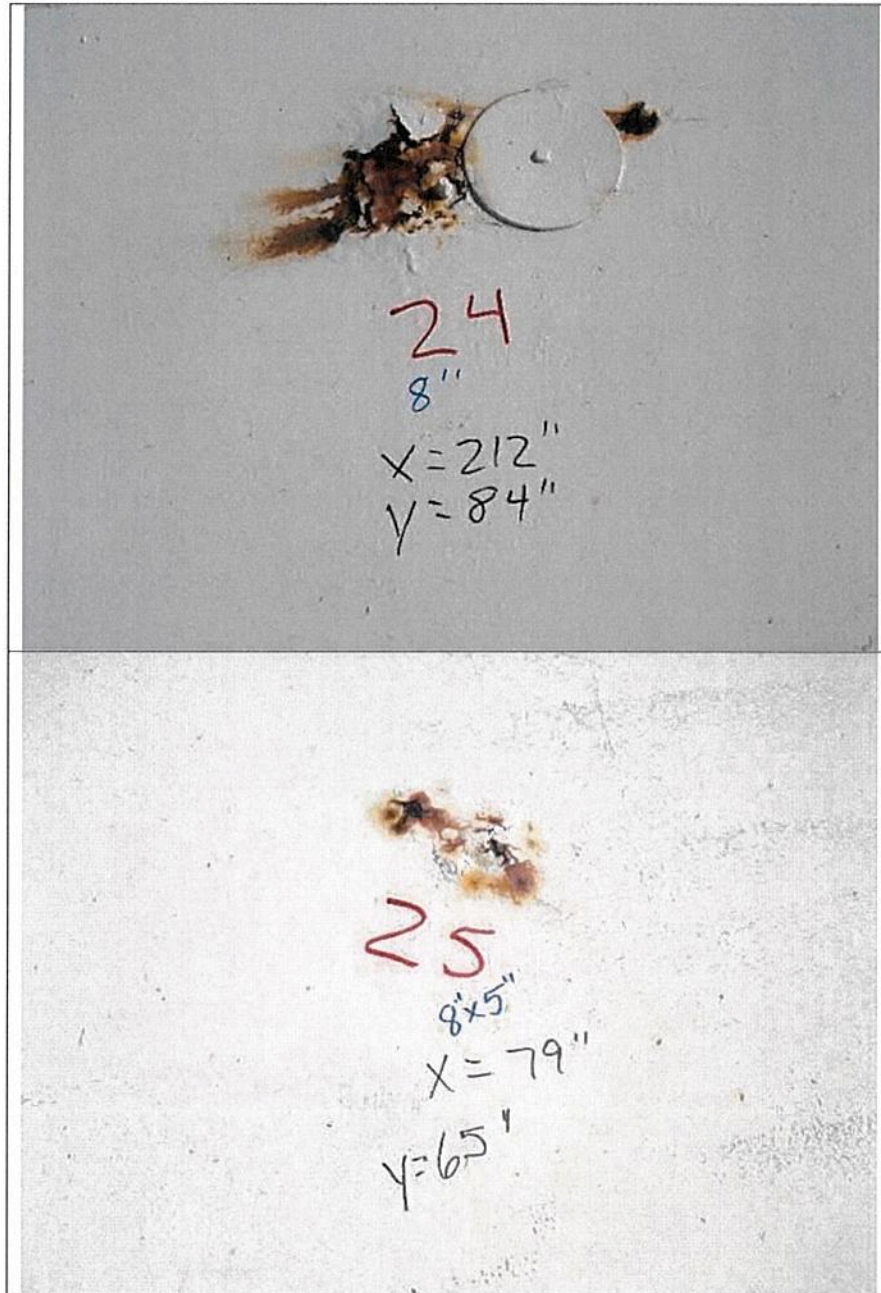
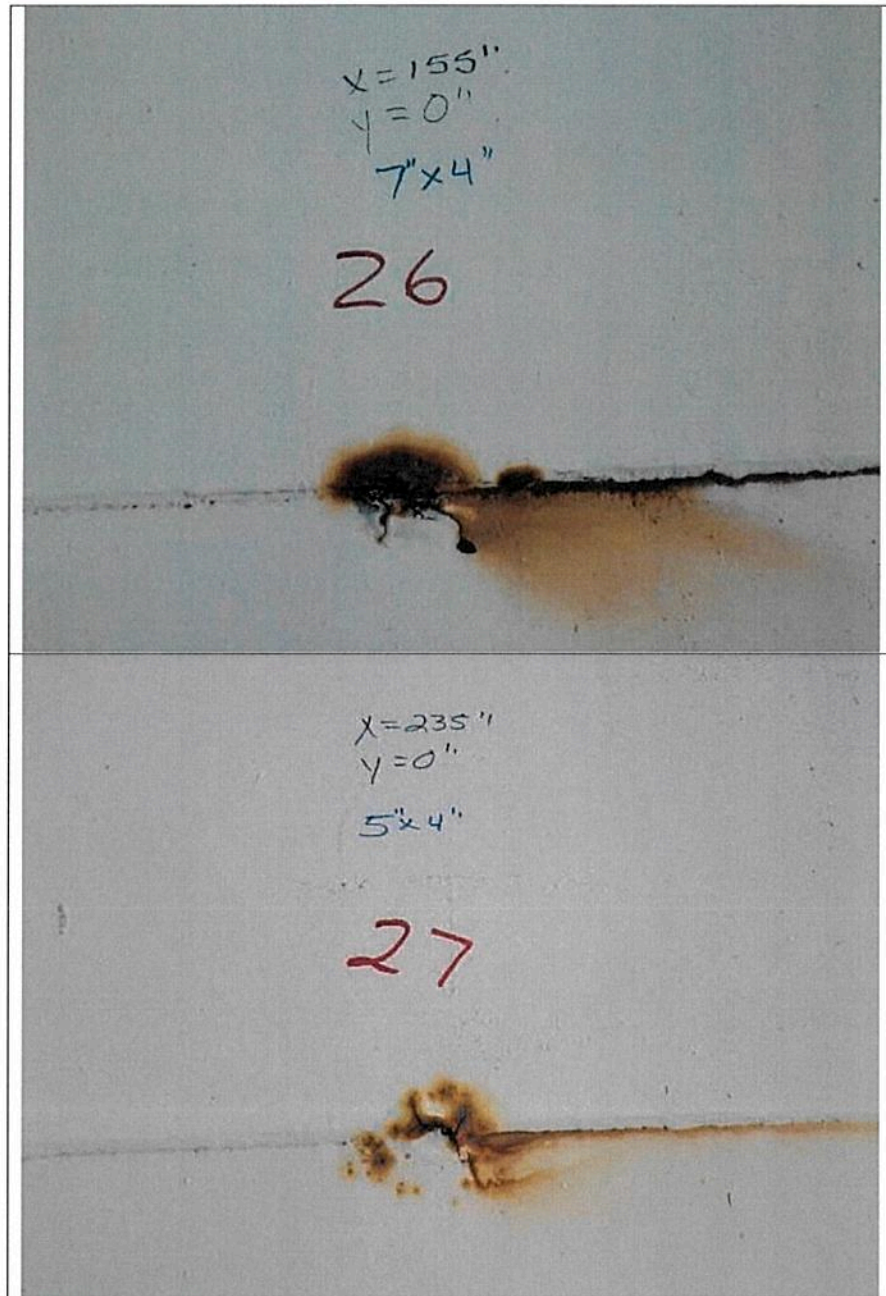
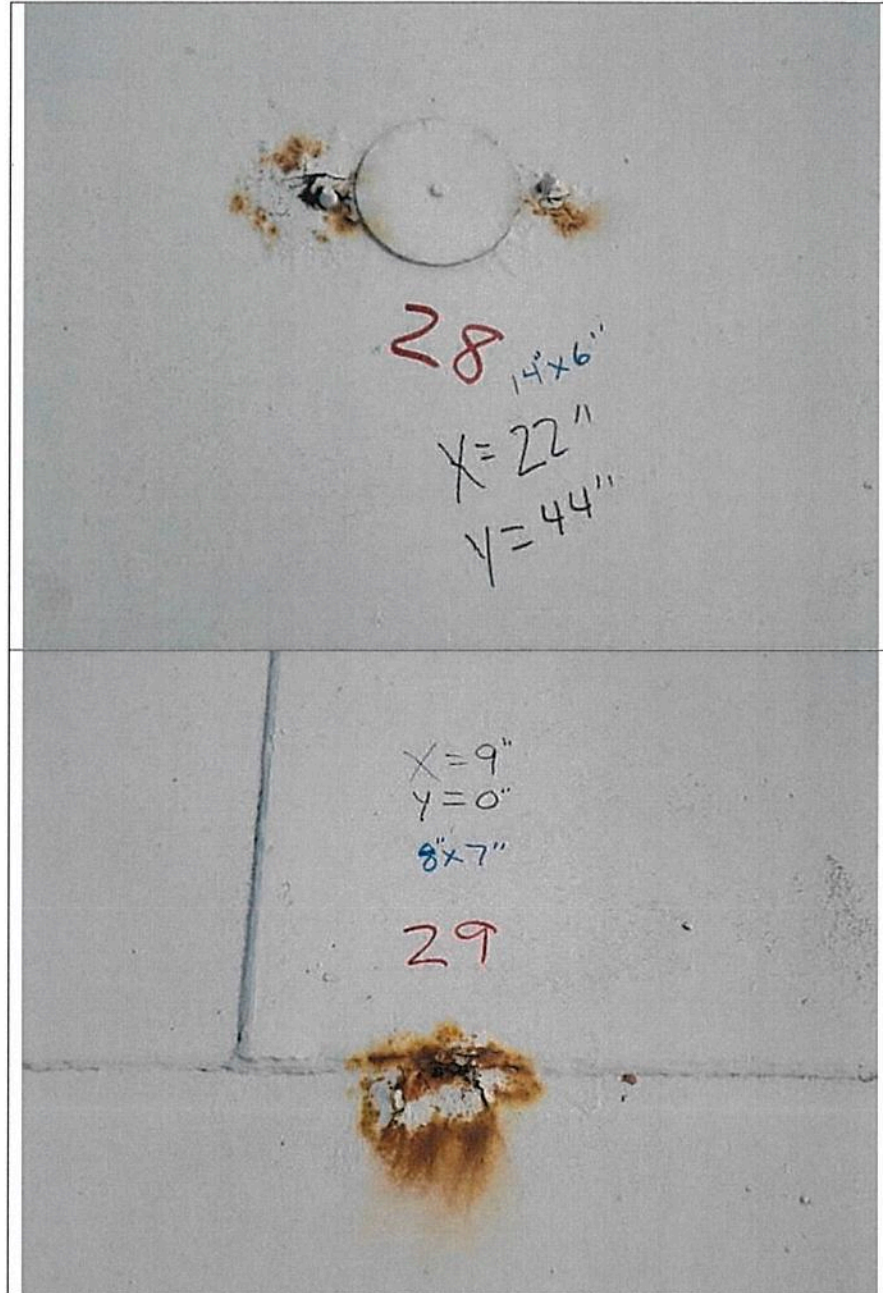
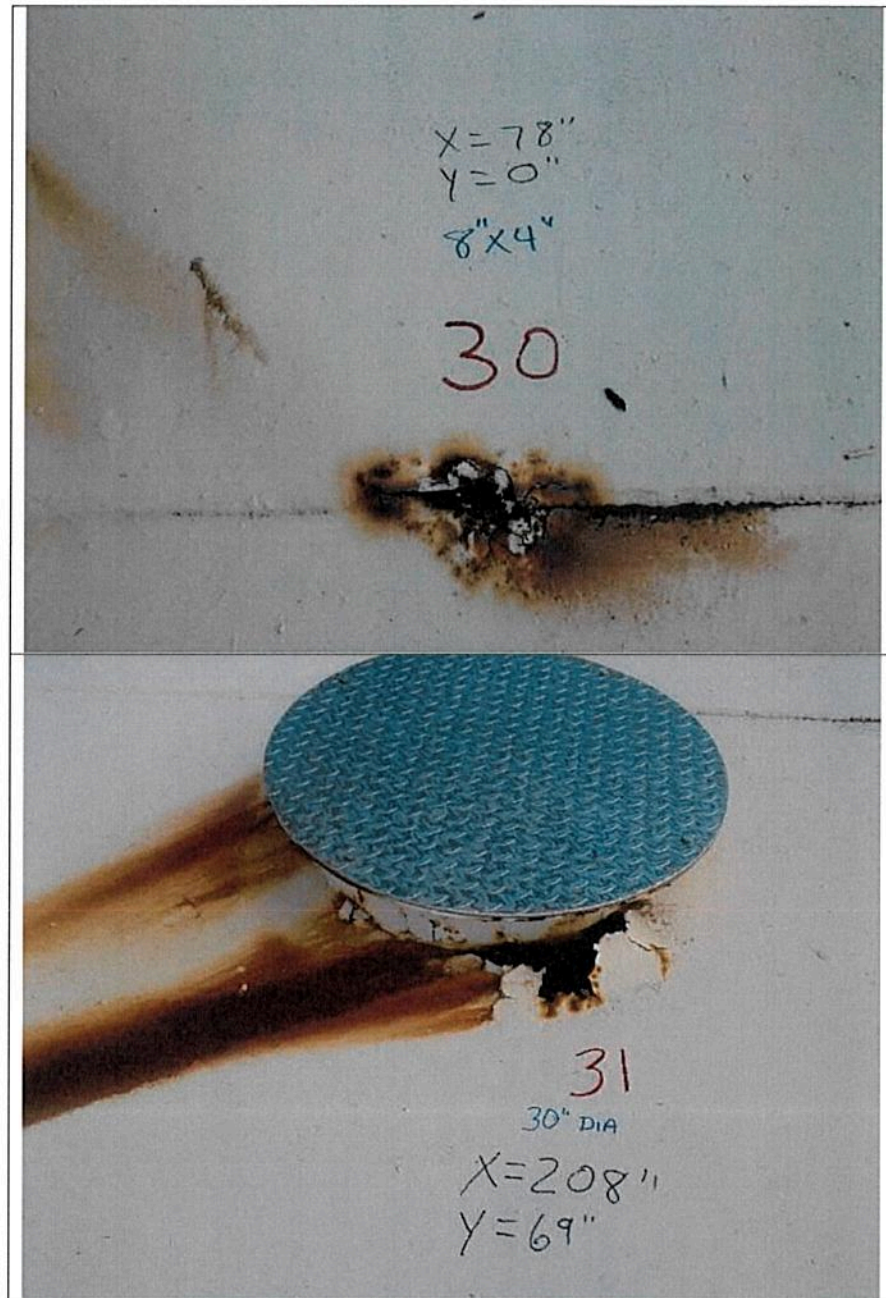
The roof coating was found generally weathered, chalked, and cracked with numerous areas of localized severe active corrosion found along the peripheral edge of the roof and scattered across all areas of the tank roof, including vent nozzles, roof access hatches, and underneath the handrailing system appurtenances. The severe corrosion found on the tank roof along the edge and on the roof plates were identified on the attached tank roof drawing. The localized corrosion on the tank roof plates were each identified individually by numbering from 1-57 and each location was measured on an X and Y axis with the starting point being the Southwest corner of each roof plate. Nineteen (19) areas of heavy corrosion were noted around the peripheral edge of the tank roof that varied in lengths from 1' to over 20'+. Fifty-seven (57) areas of severe localized corrosion were found scattered across the tank roof plates that varied in overall size from 2" to 20"+ in overall size. The depth of the corrosion was unable to be measured at the risk of putting holes in the tank roof, disturbing the underside of the roof plates and contaminating the water from falling scaling, and disturbing internal anodes hanging from the tank roof. Each area of corrosion was identified with a physical marking and photograph were taken of each location with the corresponding coordinates written and shown in each photograph. The tank roof has two (2) 24" atmospheric vents in place on the north and east sides of the roof with significant corrosion that was noted on the vent nozzle as well as the top plates on the vents. A mesh screen was used as the vent medium and secured by banding. A 24" roof hatch with a diamond plate cover was found on the southwest side of the tank roof with

severe corrosion to the hatch nozzle as well as the roof connection weld and adjacent roof plates; the area was identified as Corrosion Area #31 and written to be removed and lap patched. The scaffold ring in the center of the tank roof has severe active corrosion on its associated reinforcing plate, creating a loss of profile.

**BELOW ARE ROOF CORROSION AREAS WITH IDENTIFICATION, SIZE, and LOCATION.**

1. Perform weld build-up on the nineteen (19) areas of external corrosion on the peripheral edge of the tank roof that was identified on the associated inspection drawing.
