Sanitary Survey

Joint Base Pearl Harbor-Hickam

PWS 360

April 4-5, 2017

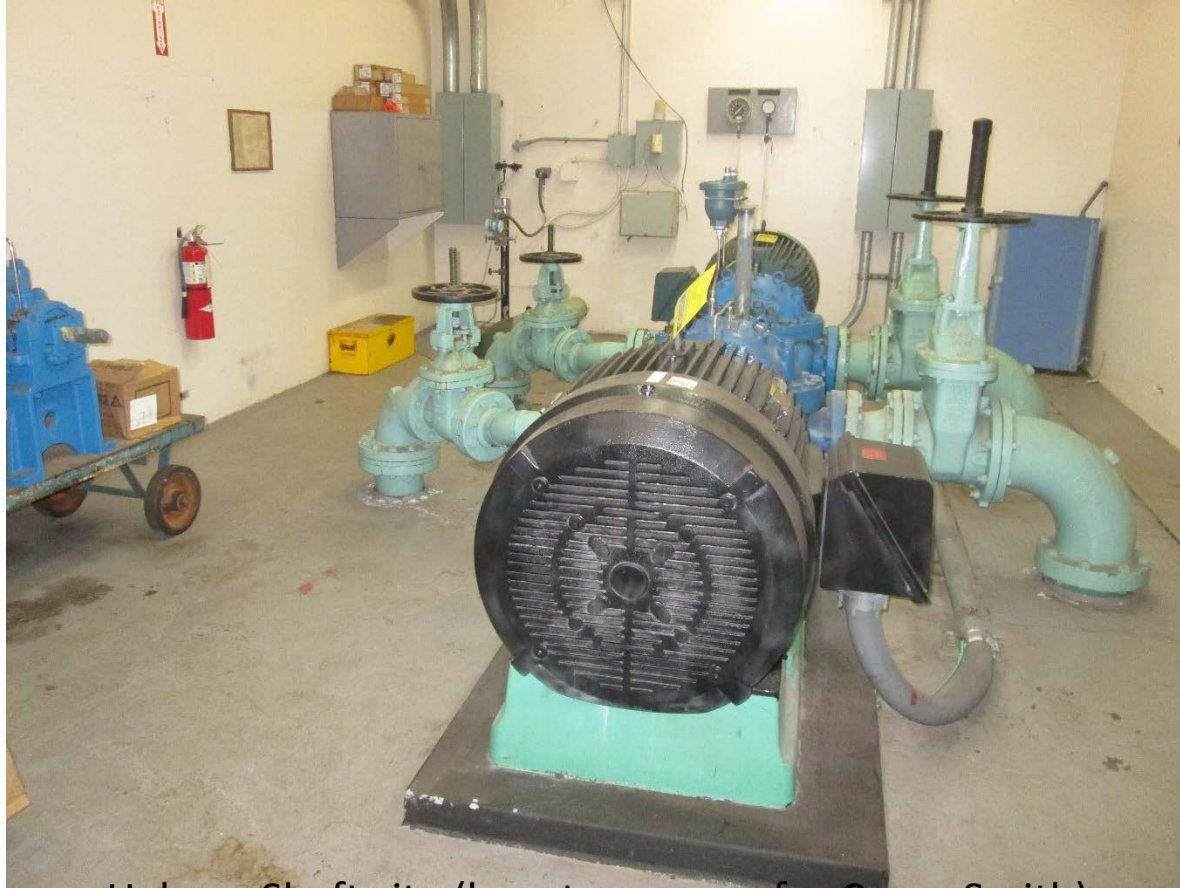
Halawa Shaft site (booster pumps for Camp Smith)

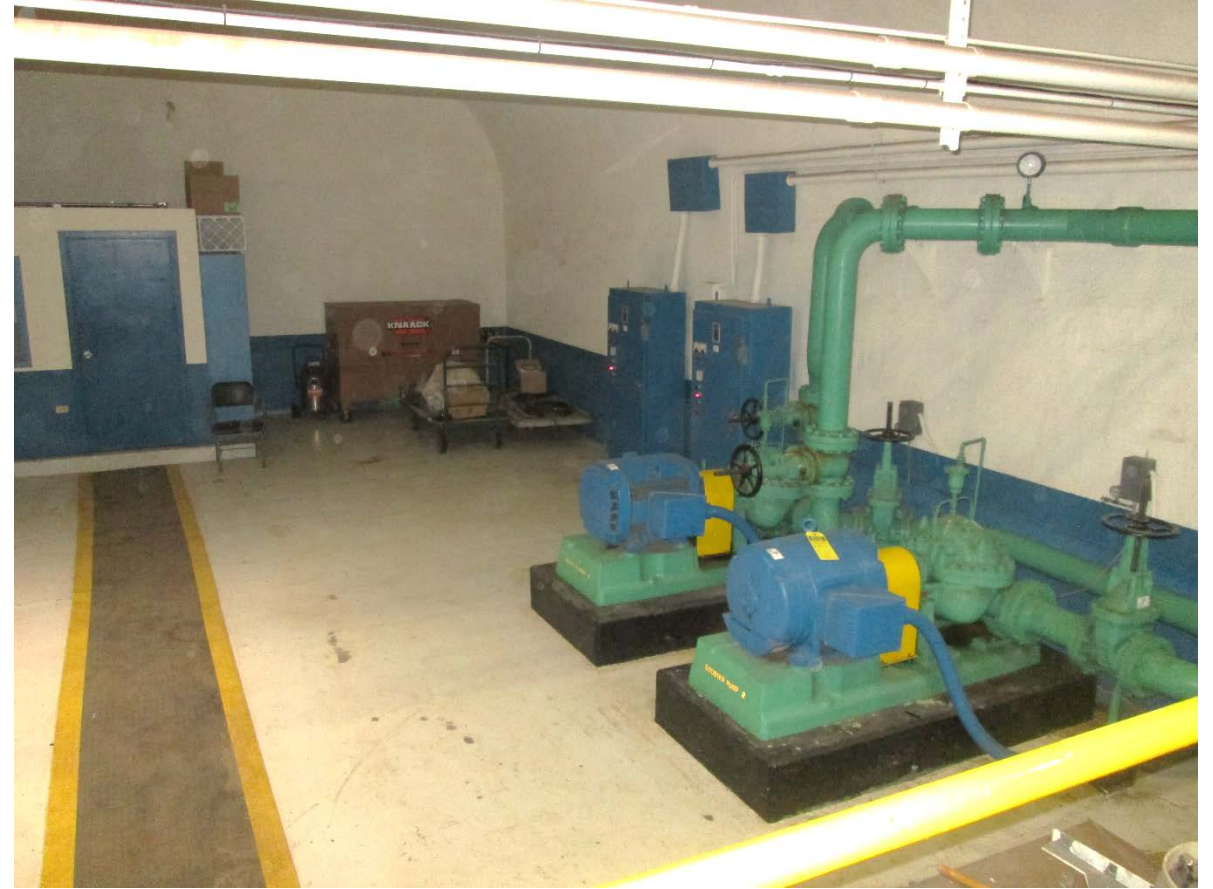
Red Hill Shaft site (Red Hill Booster Pumps)

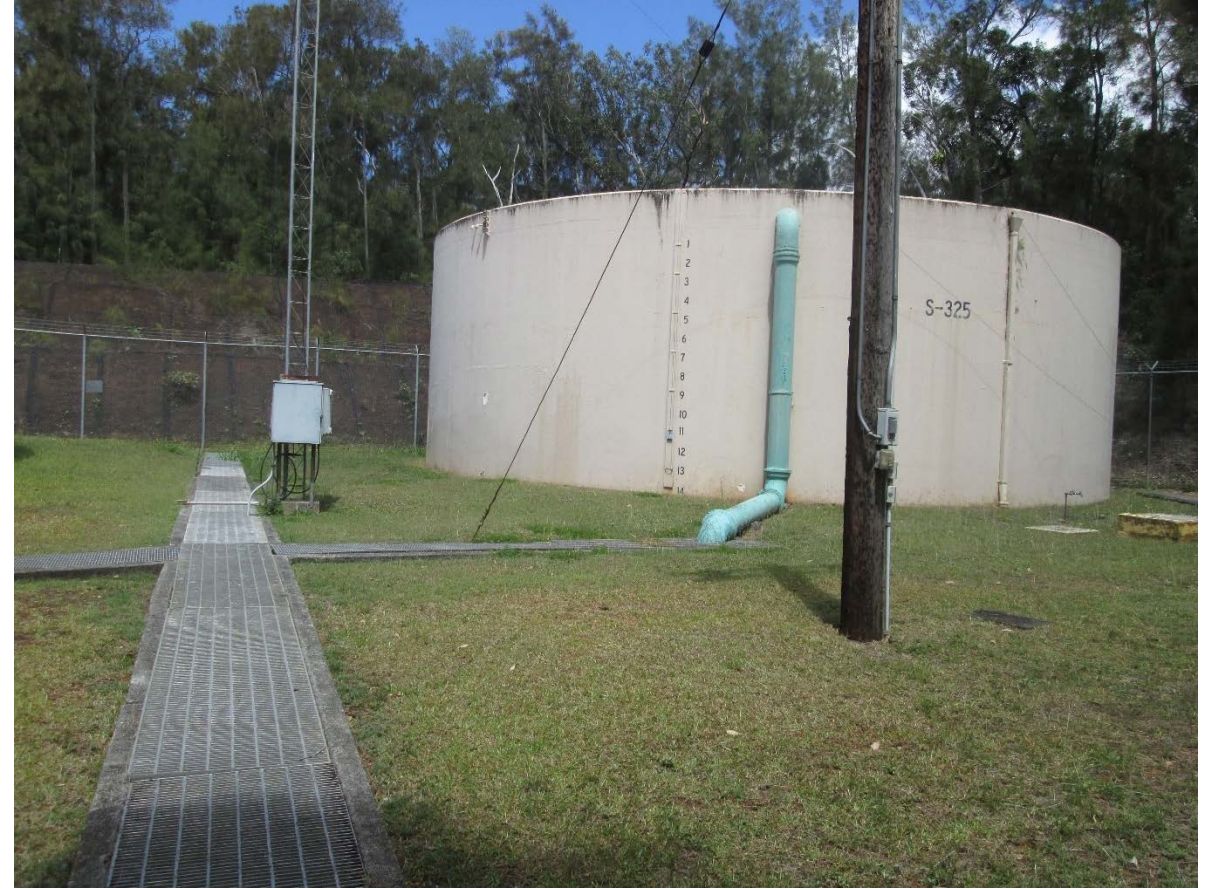
S-325 Tank

7. S-325 Tank: vents on the tank are inadequately screened to prevent insects from entering the tank. The vents should be wrapped with an insect screen. **The photo submitted is of the wrong tank. Will send correct photo when completed.**
